Load Tests of Common Shoring Towers: Typical Detailing and Resulting Capacity Reduction

Aaron K. Larosche¹, Stalin Armijos M.², Keaton E. Munsterman³, Todd A. Helwig⁴,
Michael D. Engelhardt⁵, Randall W. Poston⁶

Abstract

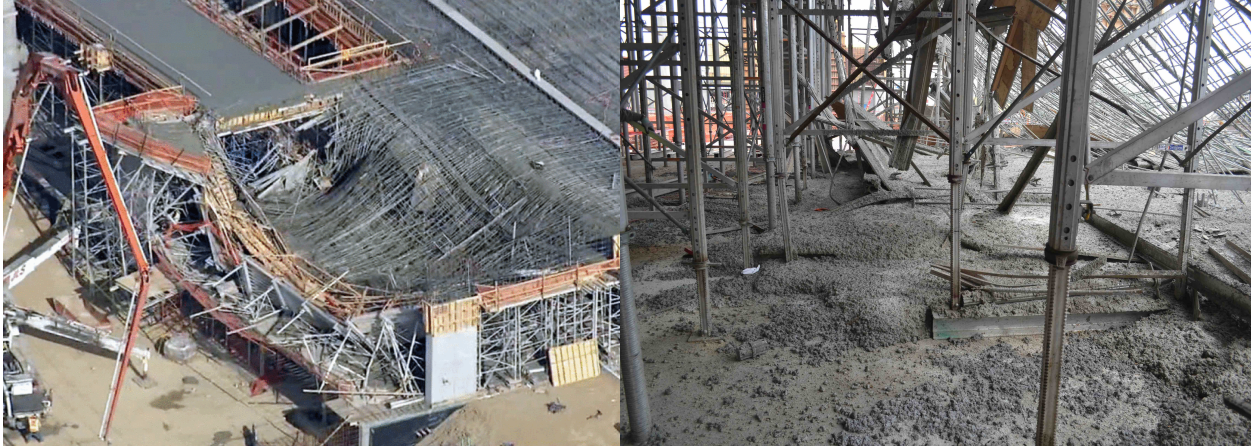
In March 2014 during the placement of an elevated concrete slab, a collapse of the supporting shoring occurred. Fortunately no workers were seriously injured, although five men rode the debris to the lower level. Photographs of the collapse are shown in fig. 1. The ensuing investigation led to analyses and eventually experimental testing which was able to show that the stated capacity of the shoring system was overestimated as a result of a stability limit state not adequately considered in its design.

Figure 1: Photographs of Collapse, Ariel View and Below Level of Collapsed Shoring

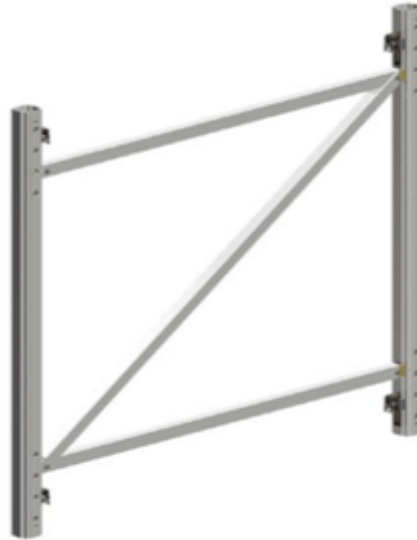
The frame legs making up a tower are provided in sections containing a pair of legs connected by a system of aluminum tube braces. An example of a frame section is shown in fig. 3. The frame legs are fit with adjustable height extensions that are placed at both tops and bottoms of the legs. The leg extensions are in turn connected to either a base plate or stringer-seat depending on location. The extensions are smaller in cross section than the frame tubes and are connected by sliding the smaller extensions into the larger frame legs.

Figure 3: Common Frame Section

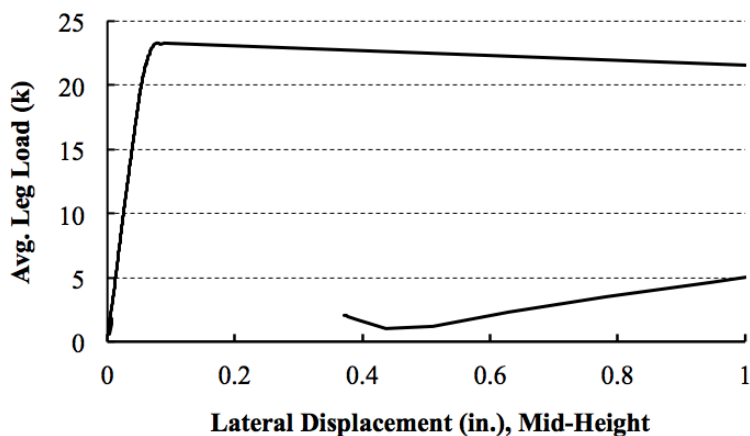
The test was concluded with an elastic buckling failure of the frame. The failure occurred at a total applied load of approximately 93.2 kips, or 23.3 kips per leg. The failure occurred with two frame legs displacing in the direction of the permanent aluminum bracing. Recorded load versus mid-height frame leg lateral displacement is plotted in fig. 7. The displacement record shown in the figure was selected from a mid-height string potentiometer located in the plane of the buckling direction on one of the two failed frame legs. As anticipated, the load versus displacement behavior shows little lateral displacement (0.08 in.) up to the point of buckling. The magnitude of load shown in this figure is one quarter of the total applied load.

Figure 7: Test No. 1, Average Leg Load versus Displacement

The guide used to design the frames noted an allowable load of 9.7 kips per leg where extensions are set to 39 inches. Multiplying the allowable value by the stated factor of safety, 2.5, provides an ultimate leg load of 24.3 kips per leg. The observed failure in test 1 occurred at an applied load of 96% of the purported ultimate leg load.

For comparison, the elastic critical load of the frame assuming a uniform cross section equal to the frame moment of inertia, and assuming pinned end conditions results in a predicted failure load of 13.5-14.4 kips per leg. In comparison to the calculated pinned end critical load, the measured failure load in the test may reflect the contribution of the rotational stiffness of the base plates at the bottom of the column extensions, and possibly the rotational stiffness of the stringer-seats and HSS members at the top of the column extensions.

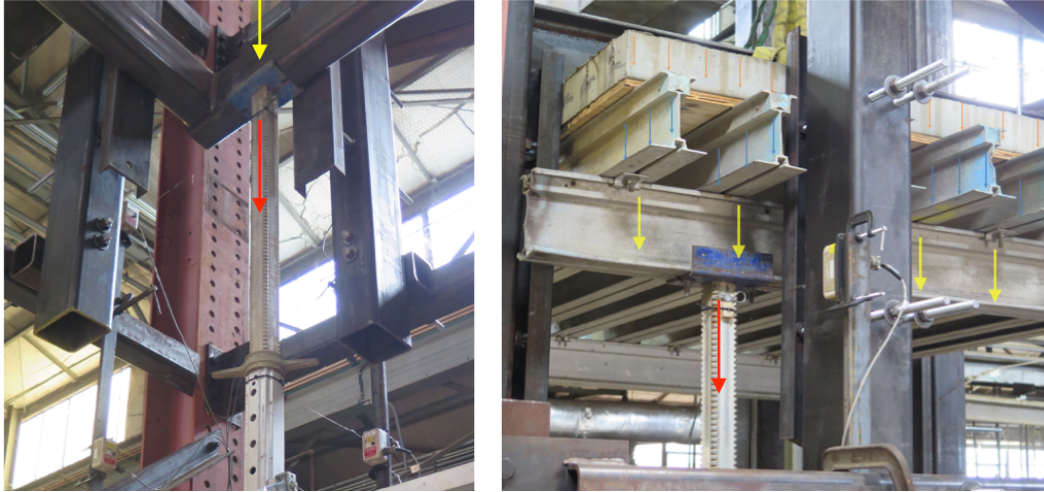
each of the four stringer-seats placed atop the top extensions (ref fig. 8). Consequently, there was no destabilizing beam-over-column detail represented in this specimen, due to the large torsional stiffness of the HSS members. The specimen of this test was configured to replicate that of the reported tests used to develop the published capacities of the frame members.

Figure 8: Load Application, Test No. 1 Left, Test No. 2, Right

The second test was performed with the same frame dimensions as the first test. The test was modified to include a system of cribbage of beams, stringers, and 3/4 in. plywood, with concrete slabs placed over the plywood. Photos in fig. 7 show the top of the specimens, and the resulting load path differences between Test No. 1 and Test No. 2.

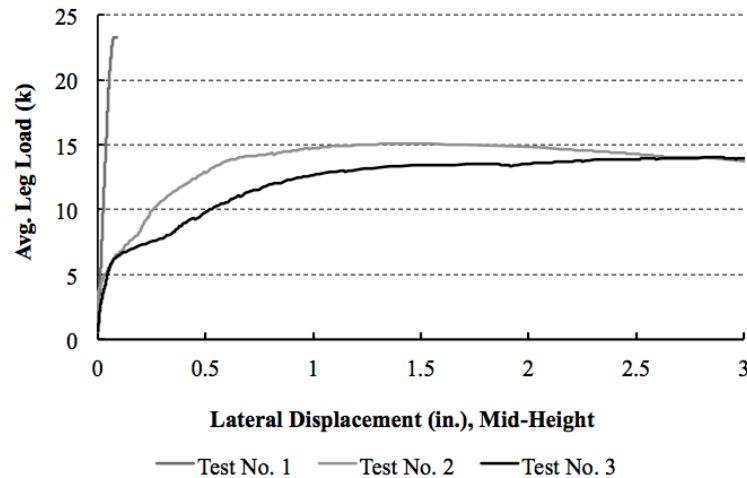
The load versus lateral displacement behavior of the third test is shown in fig. 10. The results of Test No. 1 and Test No. 2 are also shown in the figure. Within the first 1.5 in. of lateral displacement the maximum load applied was approximately 13.4 kips per leg. Beyond this displacement the test reached a maximum applied test load of approximately 13.9 kips per leg at a displacement of 2.9 inches. As seen in the fig. 10, the applied load is nearly constant with increased lateral displacement in the range of 1.5 – 1.8 inches. At a displacement of approximately 1.9 in. load began to increase slightly again. This additional post-peak load capacity occurs at very large lateral displacements, and is therefore not considered indicative of the practical load capacity in the field, as displacements of this magnitude would likely be prohibited in practice.

Figure 10: Test No. 3 (Black), Average Leg Load versus Displacement

The results of the test do show a noticeable decrease in the load capacity of the system as a result of the inclusion of a second set of frame members. In comparison to Test No. 1, the maximum Test No. 3 load of 13.4 kips per leg is 58% of the maximum Test No. 1 load and 55% of the ultimate load given by the design chart. The test shows that the increased height results in a decrease of the system capacity, approximately 11% in comparison to the second test. It should be noted that documents reviewed did indicate that frame towers constructed with stacked frame elements were tested in the development of the frame capacity chart.
