Stability Considerations for Concrete Forming Support Systems

Cliff D. Bishop¹, William Trono², Morgan Griffith³

1.1 The Failure and Investigation

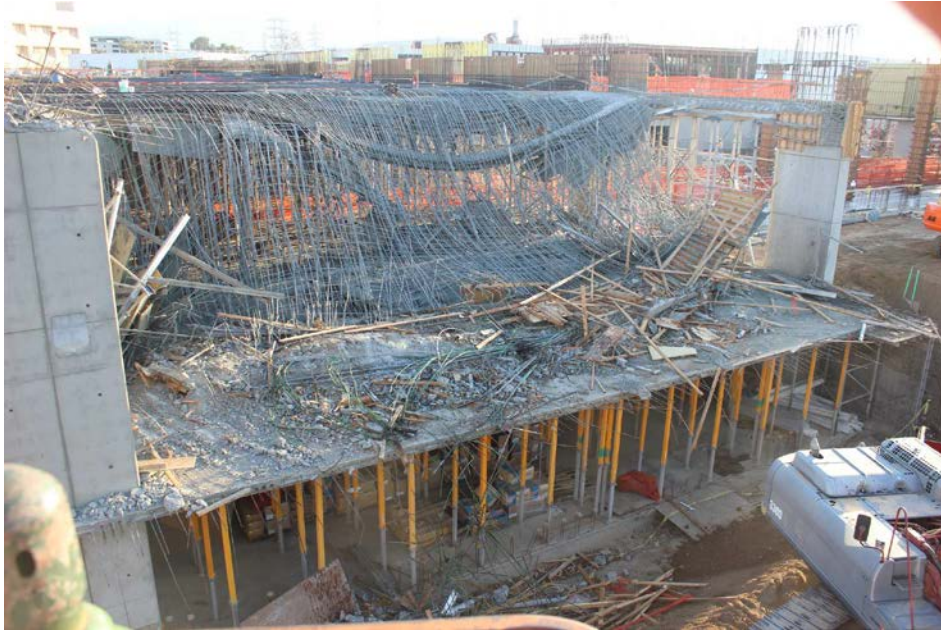
In 2014, a parking deck under construction experienced a partial collapse during a concrete pour. The system had been shored using aluminum shoring that supported wood formwork. Figure 1 and Figure 2 show the collapse and a close-up of the shoring and formwork, respectively.

Figure 1: Partial garage collapse during concrete pour

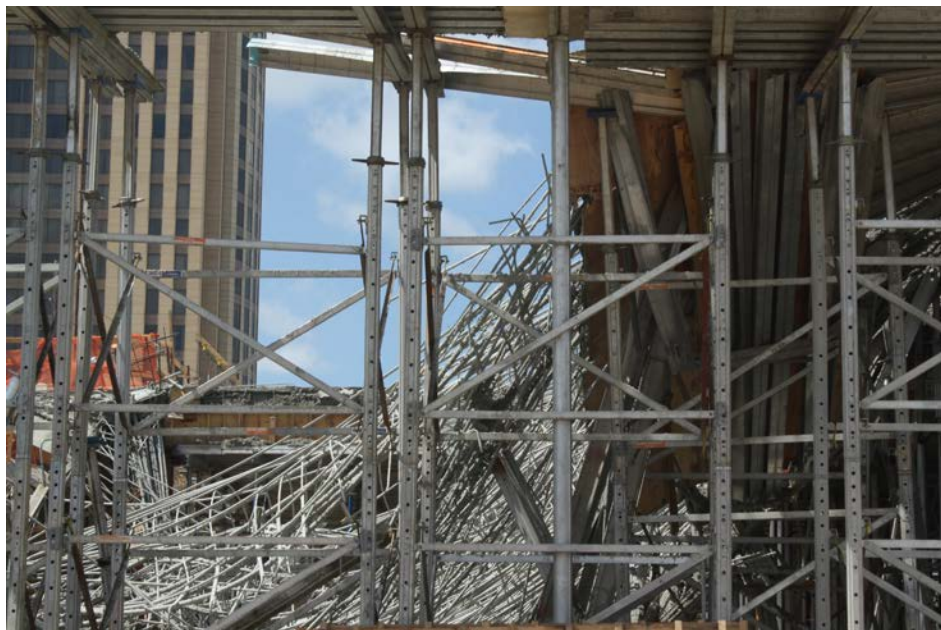
Figure 2: Close-up of aluminum shoring/forming system

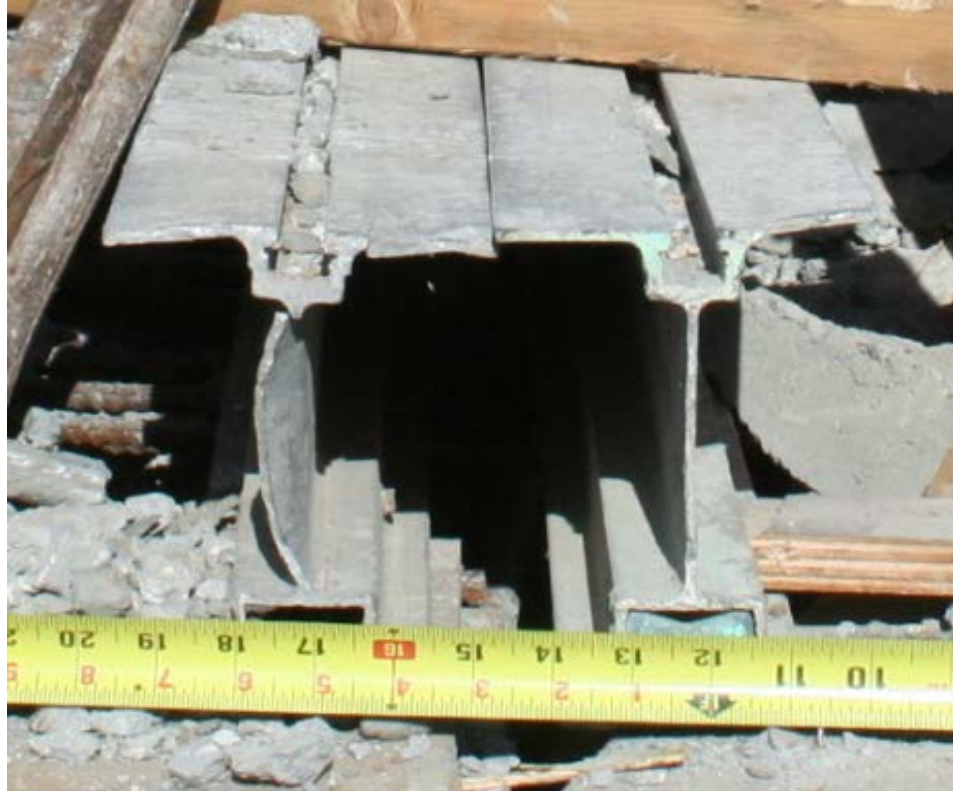
At the underside of the formwork, there were stringers that supported the joists and forming. The stringers were supported by the upper leg extensions as shown in Figure 4. In some instances, there were rows of stringers placed on the hardened slab below the frames to provide a base for the tower leg extensions. Such stringers were not shown on design drawings and were likely used by the contractor as a workaround during the construction phase, potentially to compensate for using a five-foot tower height in particular areas of the project. The stringers are shown in cross-section in Figure 6, including one such example showing fracture and local buckling of the stringer web.

Figure 6: Aluminum stringers; left example shows web fracture and buckling

The addition of stringers had the most dramatic effect. If stringers are considered in the analysis below the bottom leg extensions, a significant reduction in capacity is predicted to occur. The capacity decreases from 34 kips for the case without stringers to between 3.4-10.0 kips for the cases including a bottom stringer (where the specific resulting capacity depends on what length of stinger web is considered to participate). Consequently, the effect of modeling the stringers is on the order of the result predicted in OpenSees by modeling the frame assembly (without stringers) as a pinned end (11.5 kips). Contractors should not use sections of stringers with unbraced webs to extend the shoring height.

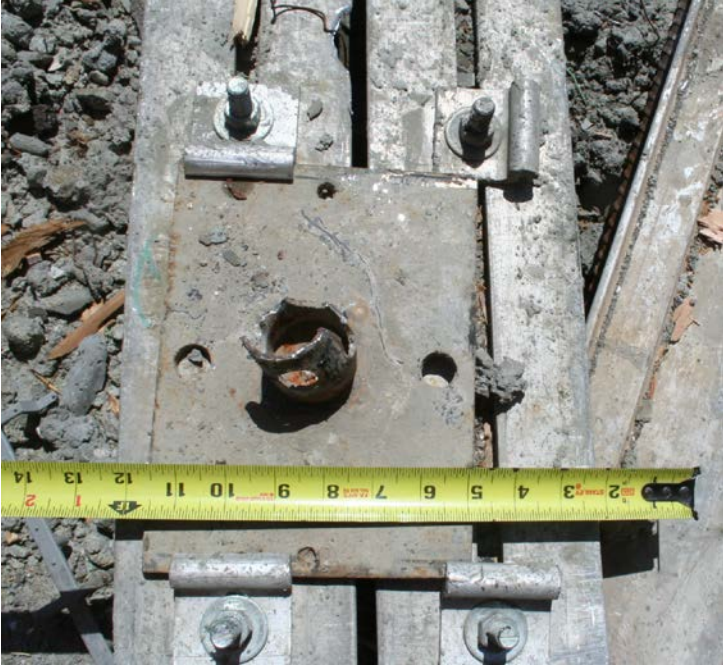
It should be noted that the assumption about concentric loading of the stringers does not hold true for all observations as evidenced by Figure 7 showing a base plate that is offset from the center of either of the two stringers below. While the loading offset effects the buckling capacity of the stringers, the effect is considered negligible for these analyses.

Figure 7: Offset in stringer loading
