ACHIEVING DUCTILE BEHAVIOR OF MOMENT CONNECTIONS

The results of recent tests suggest that weld metal toughness holds a key to achieving better moment connection performance in earthquakes

By Eric J. Kaufmann,
Ming Xue, Le-Wu Lu and
John W. Fisher

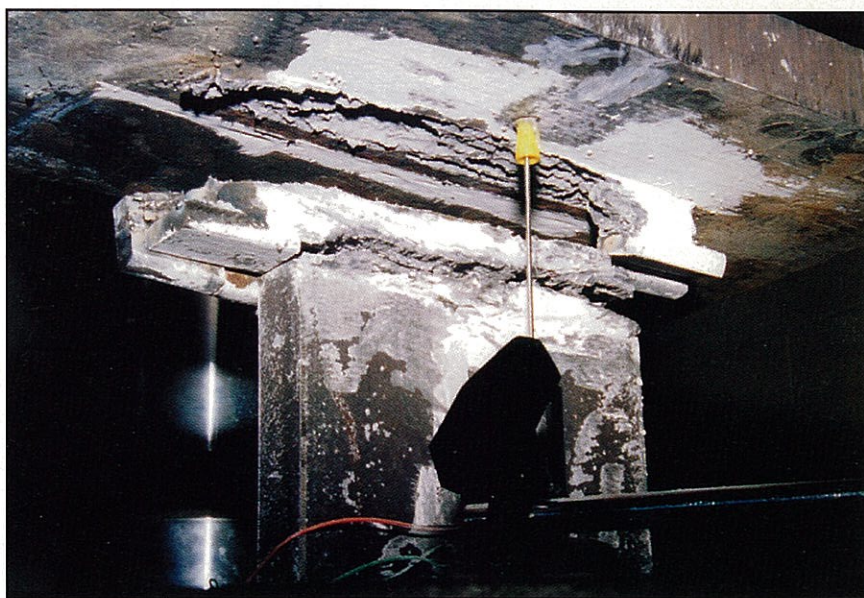
Figure 5a: (top)
"Pre-Northridge" simulated
beam flange to column test
fracture

Brittle fracture developed in the "pre-Northridge" specimen (Figure 4a) shortly after the beam plate yielded. The A36 beam plate in these tests had a yield strength of 40 ksi. The fracture origin was identified at the weld root adjacent to the notch introduced by the back-up bar at a location with inadequate root penetration (see Figure 5). Figure 4b shows the result of an identically fabricated specimen with the back-up bar removed. Brittle fracture again occurred although after greater plastic deformation of the beam plate (see Figure 6). In this case the fracture initiated within the weld metal and not close to the

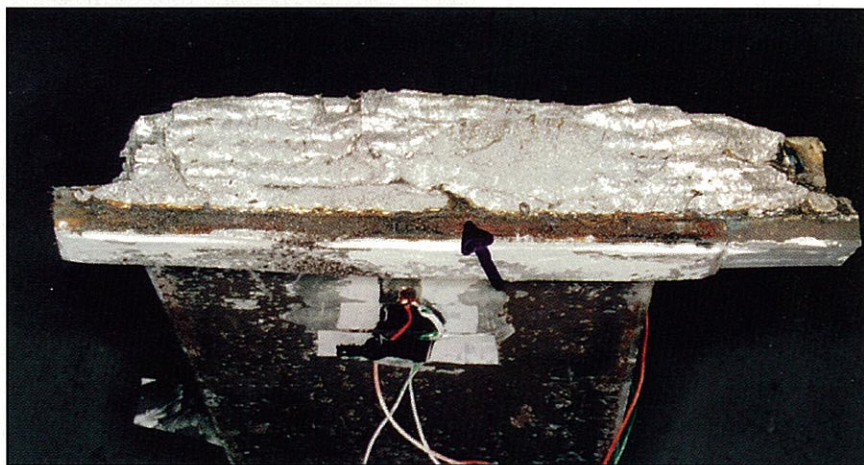
Figure 5b: (middle)
The fracture surface shows
the origin is a weld root
defect (arrow) at back-up
bar

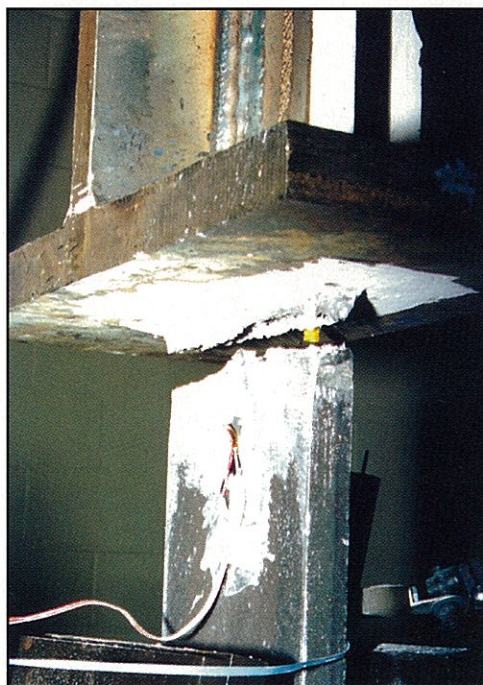
Figure 6: (left)
Retrofitted "pre-Northridge"
test specimen fracture
