# SEISMIC DESIGN

## DESIGNING AFTER NORTHRIDGE

A California engineering firm redesigned a project's connections to ensure adequate seismic performance

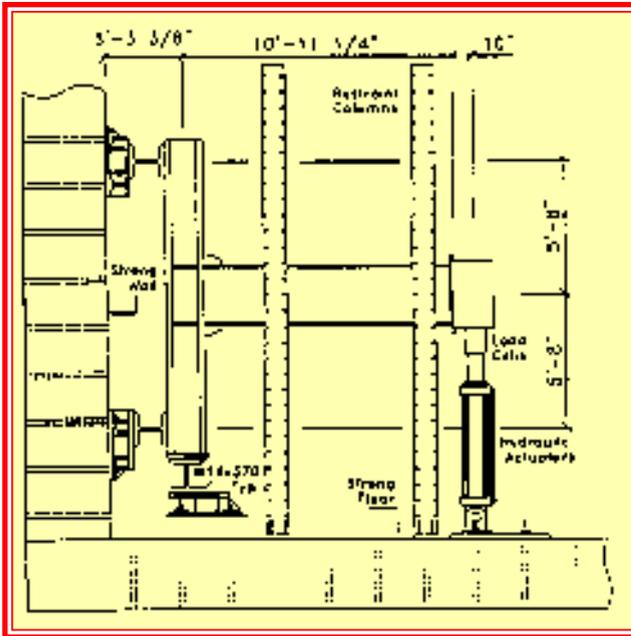
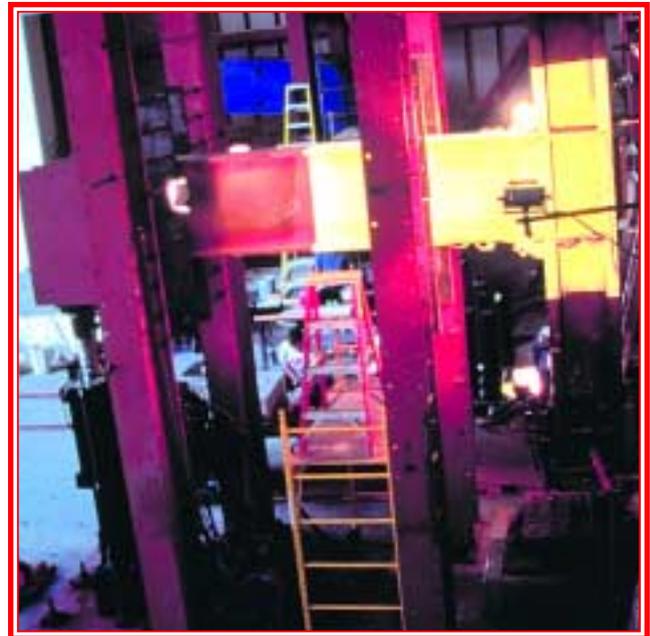
*Pictured above is the test setup for Ove Arup’s design.*

The scope of the full-scale moment connection testing, which was conducted at the Charles Lee Powell Structural Laboratories at the University of California (San Diego) was set as three strong-axis and three weak-axis connections. A572 Gr. 50 steel was specified for all beams, columns, shear plates, continuity plates and rib plates. The specimens were fabricated and “field” erected by AISC-member Herrick Corporation and other fabricators. The beam flanges were tapered by a computer-controlled flame cutting process to within  $\frac{1}{16}$ ” of the specified profile. The flame cut portion was then ground with a hand held grinder in a direction perpendicular to the mill rolling direction.

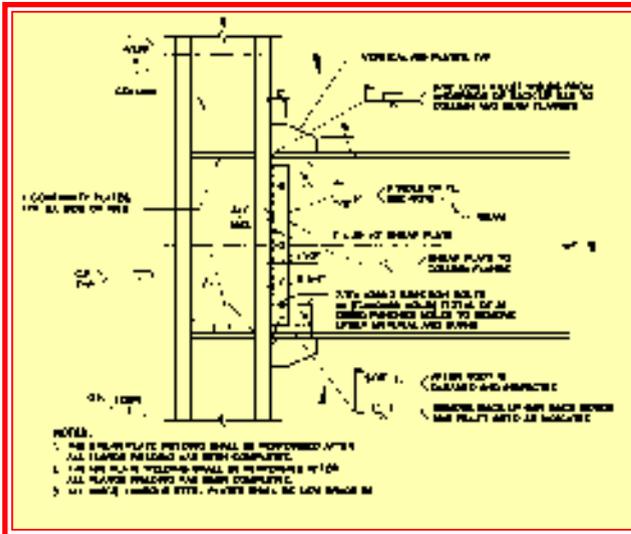
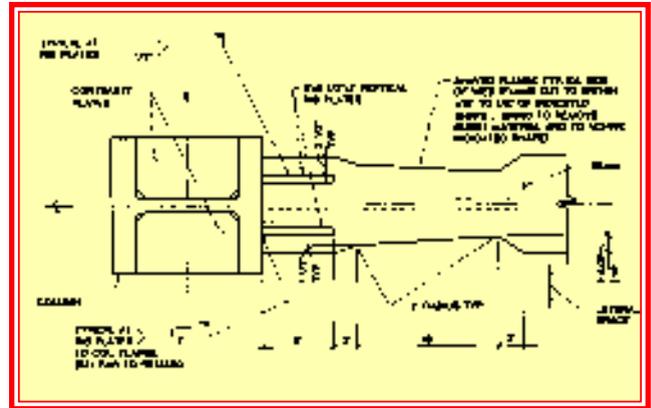
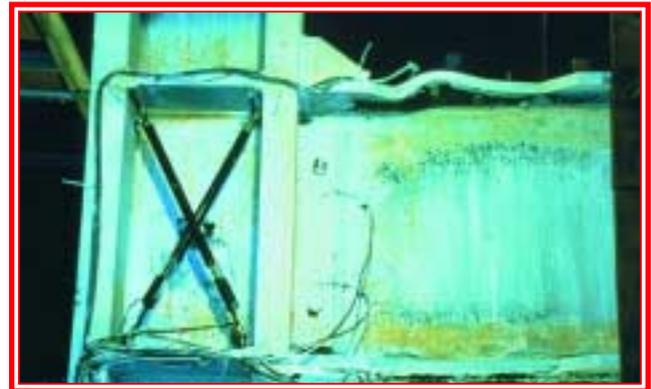
Shown is the strong axis connection with a W27x178 beam and W14x455 column.

The panel zone and column response were in the elastic range. The maximum beam plastic rotation was 6.4% and 3.5% radians, in the positive and negative directions respectively. This is based on a span (= 106") from the beam tip to the midpoint of the reduced section.

The flange yielding at the reduced section was uniform and intensified with increased beam tip displacement. Minor WLB developed prior to the FLB. However, the initial WLB did not cause strength degradation.

The final failure of the specimen was by fracture at the narrowest section of the top flange in the second negative 5" cycle. Subsequent to the top flange fracture, the beam tip displacement was reversed in the opposite direction in an attempt to rupture the bottom flange. The actuators reached their stroke limits before the bottom flange could be ruptured, and the test was stopped. The modified external lateral restraint adjacent to the reduced section effectively minimized LTB. The strength degradation, even at high plastic rotations, was minor.

No damage was observed at the vertical rib plate to column welds nor at the beam to column and beam to shear plate connections. Most of the yielding was concentrated within the reduced beam flange region.

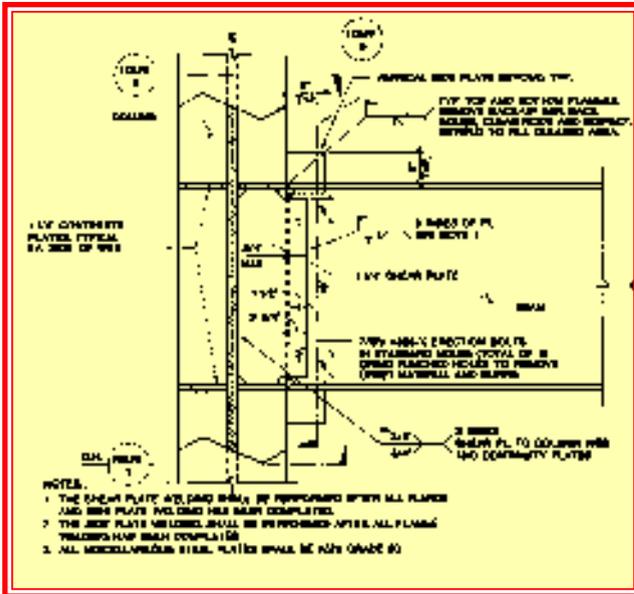
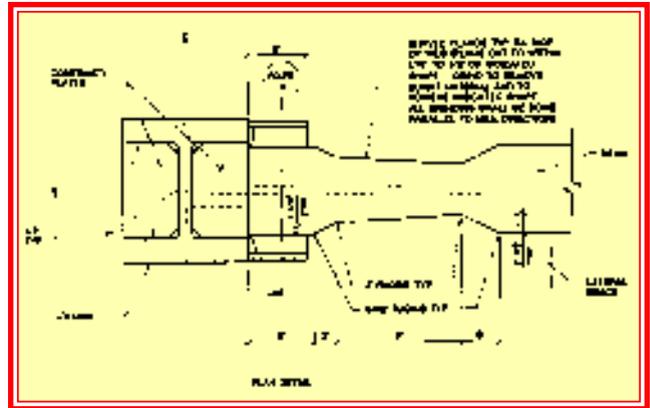
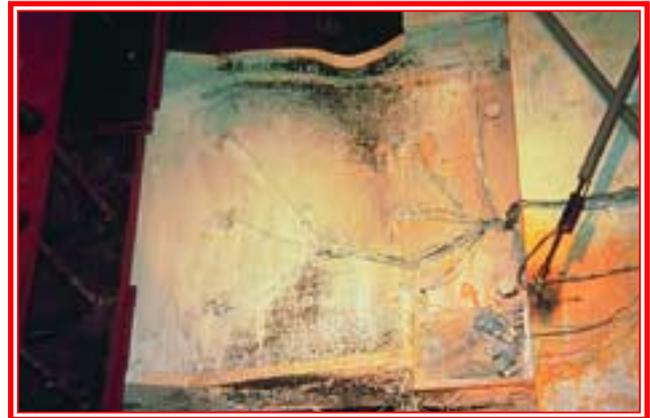
Shown is the weak axis connection with a W33x152 beam and W14x455 column.

The column response was in the elastic range. The maximum beam plastic rotation was 4.6% and 3.9% radians, in the positive and negative directions respectively. This is based on a span (= 103") from the beam tip to the midpoint of the reduced section.

The flange yielding at the reduced section was uniform and intensified with increased beam tip displacement. WLB developed prior to FLB. However, the initial WLB did not cause strength degradation.

The WLB, FLB and LTB became more apparent at a displacement amplitude of 4". A small crack in the narrowest section of the beam top flange was observed at the first cycle of negative 4" displacement. The final failure of the specimen was by fracture at the narrowest section of the top flange in the first negative 5" cycle. The test was stopped after the first positive 6" cycle.
