BRIDGE REHABILITATION SAVES A LOST ART

Once a popular bridge design,
lenticular truss bridges are now few
and far between

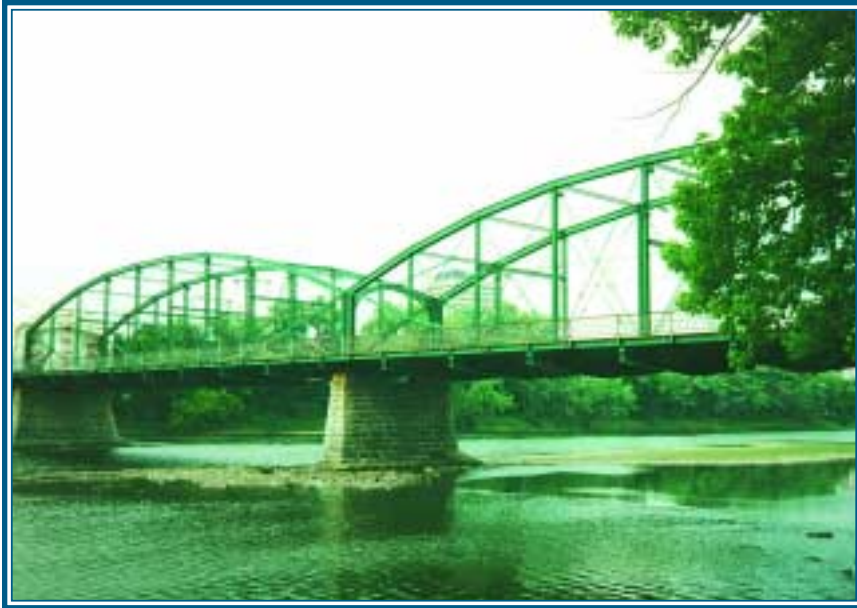
Built in 1886 by the Berlin Iron Bridge Company, the South Washington Street Bridge in Binghamton, NY, is one of the last lenticular truss bridges in the U.S. The bridges existing timber and open steel grid deck was replaced panel-by-panel with new floor beams and stringers.
