NORTHWEST PASSAGE

A turn-of-the-century mining railroad in Alaska, British Columbia and the Yukon Territory has been successfully converted into an amazing tourist attraction

By Todd Nottingham, P.E.

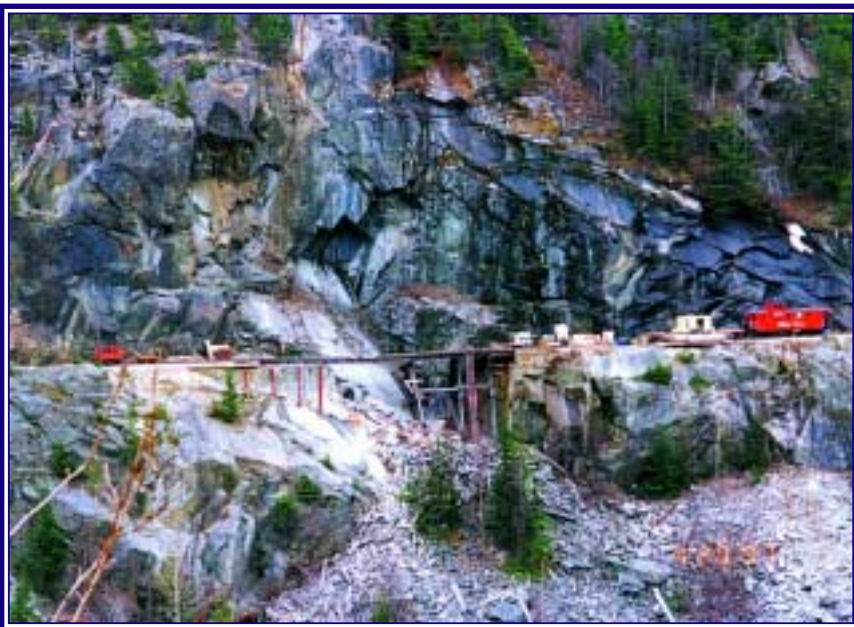
The original, seven-span timber trestle Bridge 7B (above) on the White Pass & Yukon Route was destroyed by a rockslide shortly before the start of the tourist season. The two-span steel replacement (top) was designed, fabricated, erected and re-opened to traffic less than three weeks after the rockslide.

1997 Railroad Bridge 7B — Bridge 7B, a seven-span timber trestle was severely damaged on April 13, 1997 during a rock slide, which was caused by severe freeze-thaw degradation of the overhead granite slopes. Several of the bridges support bents were destroyed and the bridge was shifted several feet down hill during the event. Summer season passenger train operations were scheduled to begin within three weeks of the accident; therefore time was of the essence.

A bridge had previously been designed and the main structural bridge girders had already been fabricated and were currently located in Skagway scheduled for placement during the fall construction season. It was determined that the fastest method to reestablish the bridge crossing was to proceed with construction of the new design, rather than replace the timber bridge in-kind.

The two-span bridges (57' and 28') had concrete abutments and a steel column pier. The superstructure consisted of four wide flange girders fabricated in pairs with open timber tie deck. The total weight of structural steel was 90,000 pounds. Demolition of the remaining timber trestle and construction of the pier and the abutments began immediately. The bridge superstructure was placed with a backhoe and a small hydraulic squirt boom crane, which was the only equipment available that could access the site. Bridge construction was completed by the first week of May with only minimal loss to traffic.

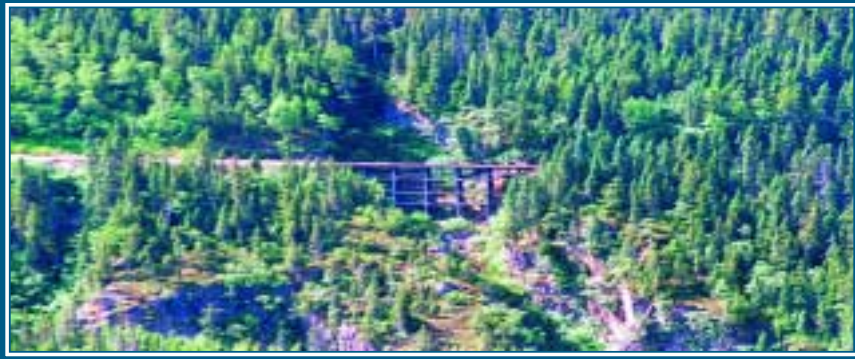
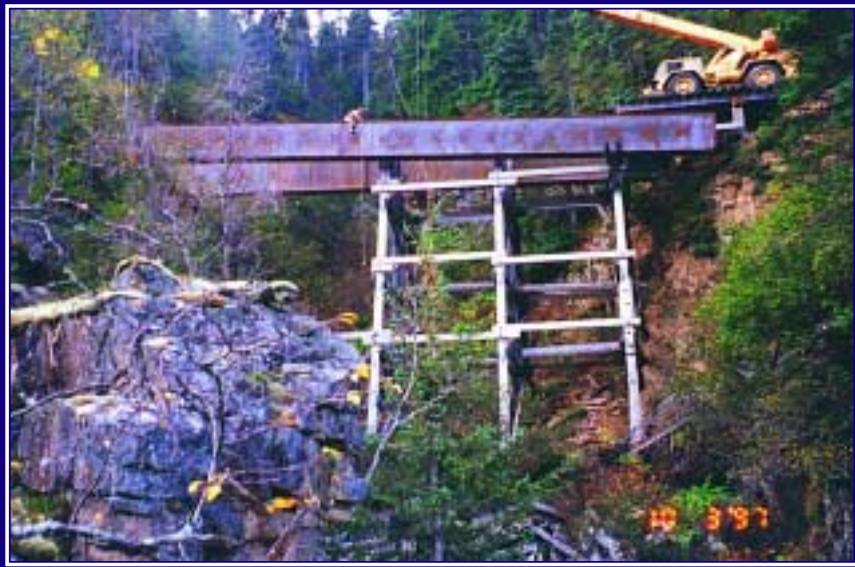
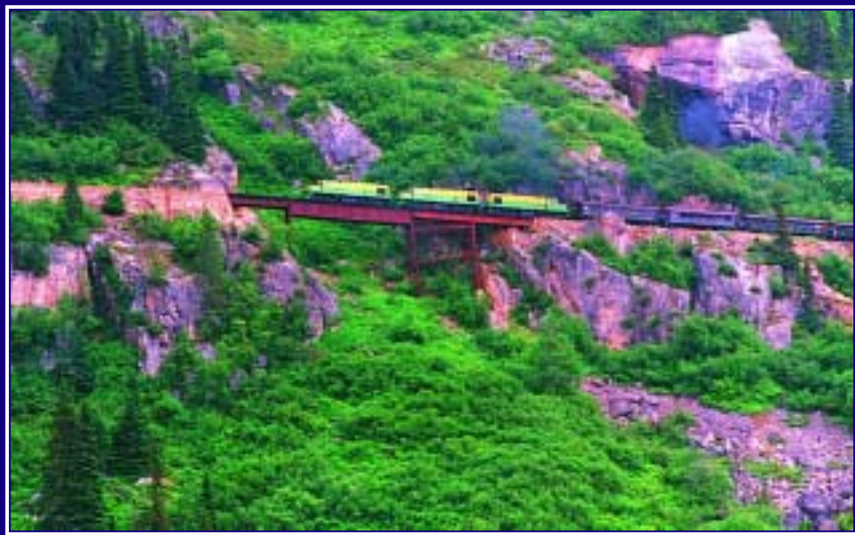
During a routine annual inspection, it was discovered that the seven-span, tiber trestle bridge 12A (top) had suffered mechanical damage. It was replaced with a new steel girder bridge (middle), which was installed in the fall—after tourist season was over. One of the major challenges faced the project team was the remote location and difficult site conditions. Bridge 15A (above) is located amid steeply sloping terrain. Though the steel bridge has been damaged by rockslides several times, it has always been quickly repaired—and some of its original, 50+-year-old riveted portions remain.

1997 Railroad Bridge 12A — Bridge 12A a seven span timber trestle was in operation through the summer of 1997, however the annual detailed bridge inspection noted substantial degradation of the timber structure, including some that required immediate temporary repair. Damage to the structure was attributed to age of construction and increased traffic. Because of the success of the recently completed 7B bridge, the decision was made to replace the bridge with steel.

Because of foundation considerations and the need to maintain constructability with available equipment, the length of the main span was required to be 84' with a 20' second span. A double steel box girder with open timber deck was selected for the superstructure. The box girders were fabricated from ½" and 1" plate. The total weight of structural steel was 120,000 pounds.

On-site work began with construction of column footings and column erection in September of 1997. Fabrication of the bridge superstructure was completed and shipped on September 19. On-site bridge construction was completed in mid October. Designer was Peratrovich, Nottingham & Drage Inc., Seattle, contractor was Hamilton Construction and WPYR, Skagway, AK, and fabricator was AISC-member Keiser Steel Fabricators.

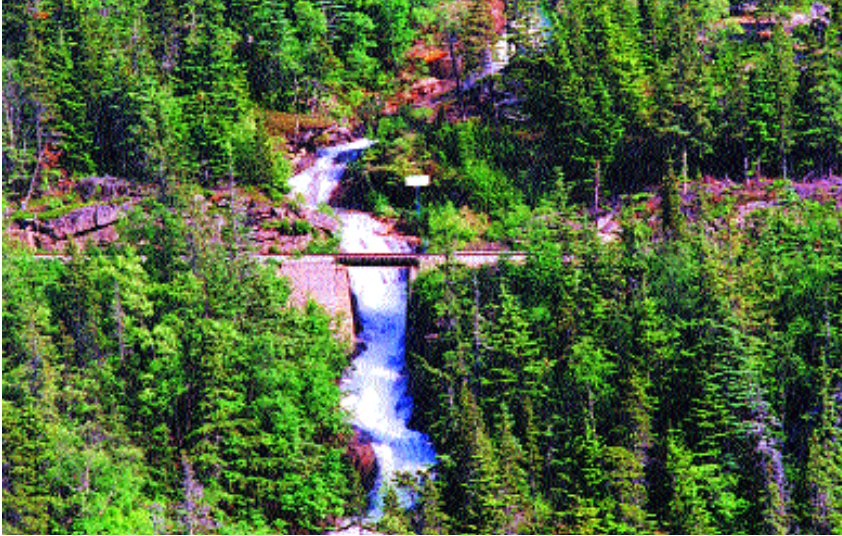
While most of the original bridges on the turn-of-the-century rail line were timber, some were built of riveted steel, including Bridge 9A. The 30', single-span bridge still bears a plaque noting fabrication in 1905—and was still in good condition more than 90 years later.
