# SITE, TIME RESTRAINTS COMPLICATE BRIDGE REHABILITATION

A 180' double-track truss had to be replaced with only a 54-hour track closure

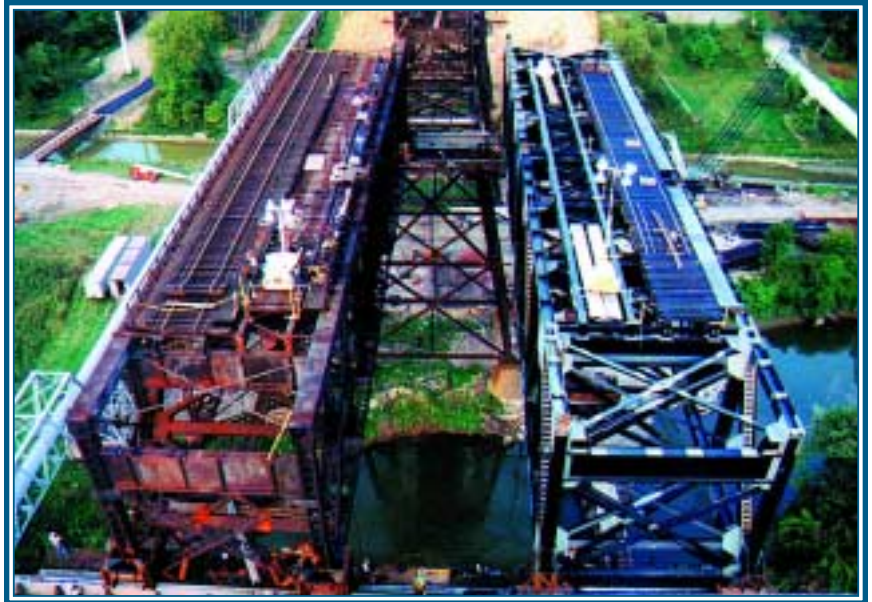
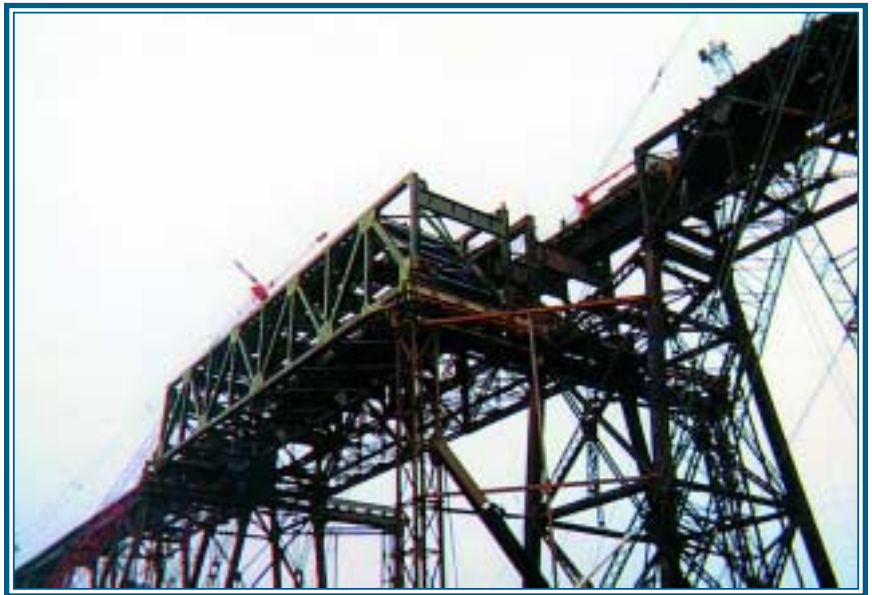
*Pictured above and at top is the 180' truss during roll-in.*

Installing the new 180' truss was also cumbersome. The truss had to be assembled on falsework and rolled into its final position. The following conditions had to be met for installing the new truss and designing the falsework.

The lifting devices allowed the trusses to be jacked up using four 100-ton capacity jacks under each of the four corners of the trusses. Four 50-ton capacity rollers were then installed under each of the four corners of the trusses. The rollers allowed movement of the trusses when they were pulled. The trusses were then pulled into final position.

The trusses were rolled into position by attaching an air driven winch to each end of the truss. Each air winch was capable of developing a 10 kip pull. They were anchored at the base of the north falsework towers. A wire rope extended up the north falsework tower to a four-to-one block and tackle that was attached to the bottom members of the trusses. At a verbal command, both air winches were started and the truss slowly moved along the runway beams. If the truss became skewed to the runway beams, each air winch could be operated independently to re-align the truss. The same procedure was used to roll out the existing truss and roll-in the new truss.
