Renovating Concrete

Structural steel moment resisting frames are proving to be an attractive alternative for retrofitting concrete structures in seismic areas

By Hratch Kouyoumdjian, S.E.

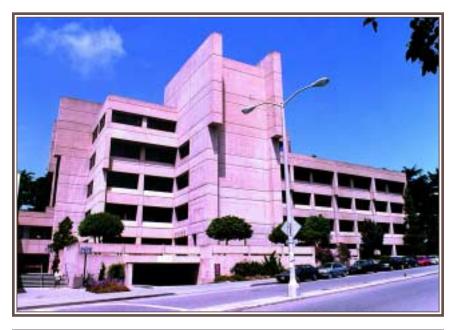
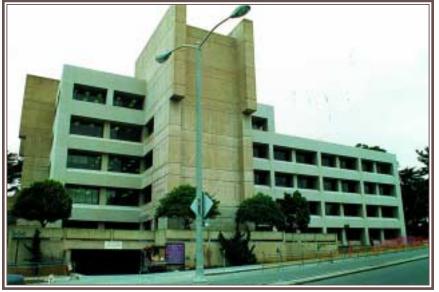
Shown at top is the SFSU Administration prior to renovation; shown above is the building after the renovation was completed.

Recently, the application of structural steel moment resisting frames to economically retrofit an existing building was used for the Administration Building at San Francisco State University. The Administration Building is a six-story, 130,000square-foot, concrete-framed building that was constructed in early 1970. It has a rectangularshape and is approximately 218' long and 113' wide. The structure was originally designed with concrete waffle slabs for all floor and roof levels and concrete moment resisting frames along grid lines in both directions augmented with a few limited capacity shear walls.

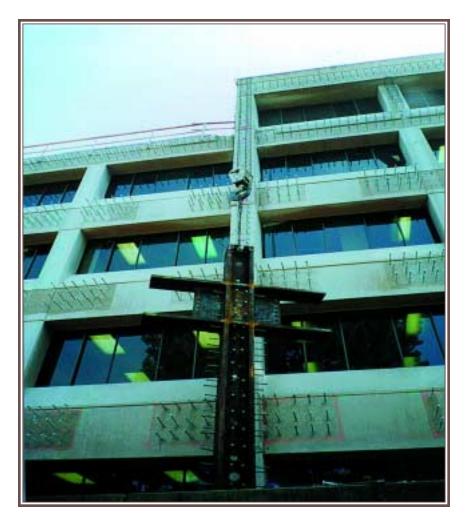
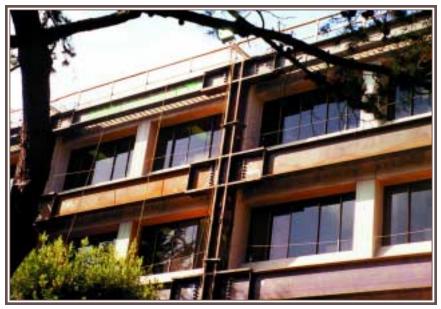
Pictured on bottom, is the steel retrofitting in place on the SFSU Administration Building.

The steel frames alone could provide the necessary lateral resistance, as well as eliminate column failures and address the concerns mentioned previously. Additionally, the frames could be placed along the building exterior only, thereby leaving interior spaces unaffected and without disruptions. Steel moment frames also eliminated the obstruction of windows, and retained and spread out the lateral resistance to various elements along the length of the buildings, thereby increasing redundancy and reducing overturning effects.

Typical frames included W14 x 426 column sections and W36 x 170 girders to provide the necessary strength, stiffness and ductility. Materials specified for columns were ASTM A572, and for girders ASTM A36. Connection bolts were specified as 1-1/2-inch diameter A490 SC, and all penetration welds were to be made with E7018 rods. Several "push-over " analyses verified that the retrofitted structure could resist seismic forces well in the range of 1.0g and could undergo large drifts while remaining stable, thereby fully satisfying CSU's Seismic Safety Program.

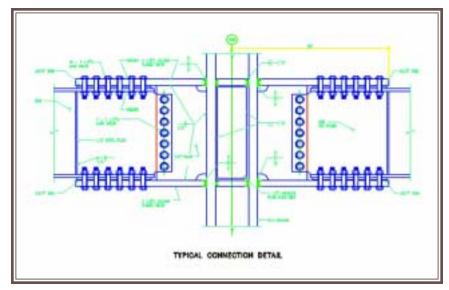
Shown top left is a typical connection detail.

In the course of this work, a new moment connection was developed by HK&A reflecting many of the lessons learned from Northridge, Kobe and other earthquakes. This new connection is shop fabricated and welded into a tree-shaped assembly,

and girders are field-bolted into a standard and repetitive connection, thereby eliminating many previous concerns associated with field welding of heavy moment sections as in pre-Northridge earthquake designs.

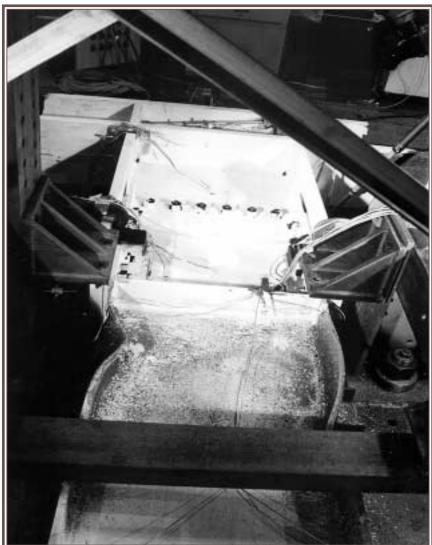
The photo below, left, shows a connection test.

A representative full-scale assembly of the new moment connection developed by HK&A was tested at the ATLSS Lab at Lehigh University prior to construction. It was used to verify joint stability and satisfactory inelastic performance of the assembly - which proved to be completely satisfactory. This connection delivered the necessary strength and inelastic rotations of more than 7 radians without any joint overstress, degradation, or yielding in the joint, and every bolt and weld remained intact. The project was completed early in 1998, well below budget, and the building is in full use today.
