Carmel High School

Carmel, Indiana

The Carmel High School basketball arena was originally constructed in the 1950s, and the superstructure consisted of wood bowstring trusses spanning 151' over a bowl-type arena with a seating capacity of 4,000. In recent years the trusses had suffered significant distress, and conventional repairs had been made, such as the installation of tension rods along the bottom chord to reduce the tension in the original chord. Several engineering consultants had performed analyses of the original roof framing system, and all agreed that the long-term viability of the structure was in question.

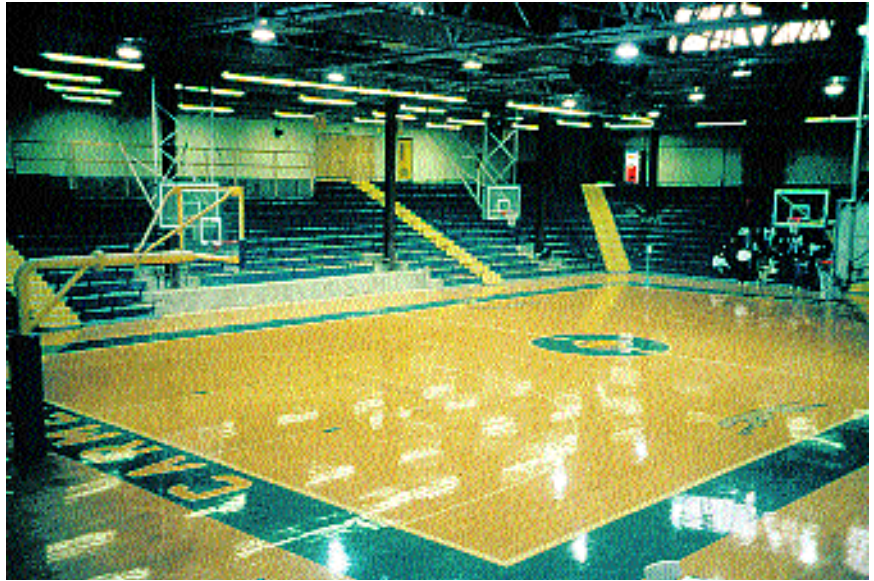
During the second summer, the original roof and bowstring trusses were removed. The tie members were erected from the gym floor, and the tied arch system was completed. The portion of the temporary column below the tie member was then removed. A bolted cap/base plate was provided, in the temporary column at the bottom of the tie, to allow for easy removal of this member and eliminate the need for any additional field welding or repairs at one of the most critical points in the system. The column bases were cut with a conventional torch and removed. The actual deflections that occurred, when the load transferred to the final structural system, matched the calculated deflections.

In the completed structure, the tied arches are spaced at 30' on center, with W14 purlins 7' on center spanning between the arches. Acoustical metal roof deck of 1½" wide-rib was used to span between the purlins. Horizontal x-bracing in the plane of the roof and vertical x-bracing at each corner provide lateral resistance to wind pressures. All of the roof-framing members, bracing, decking, and roofing were installed during the first summer to ensure stability. Following installation of the final tied arch members, x-type bridging was provided to stabilize the tension chord. Sag rods were utilized to prevent deflection of the horizontal bottom chord, an 84' long W10x68. Following completion of the
