Merit Award: Reconstructed

Franklin Square Bridge

Brooklyn, New York

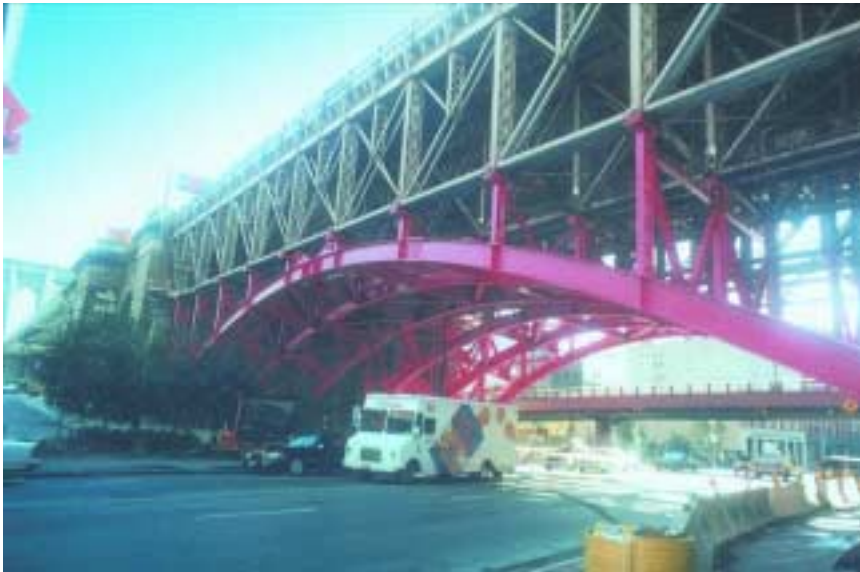
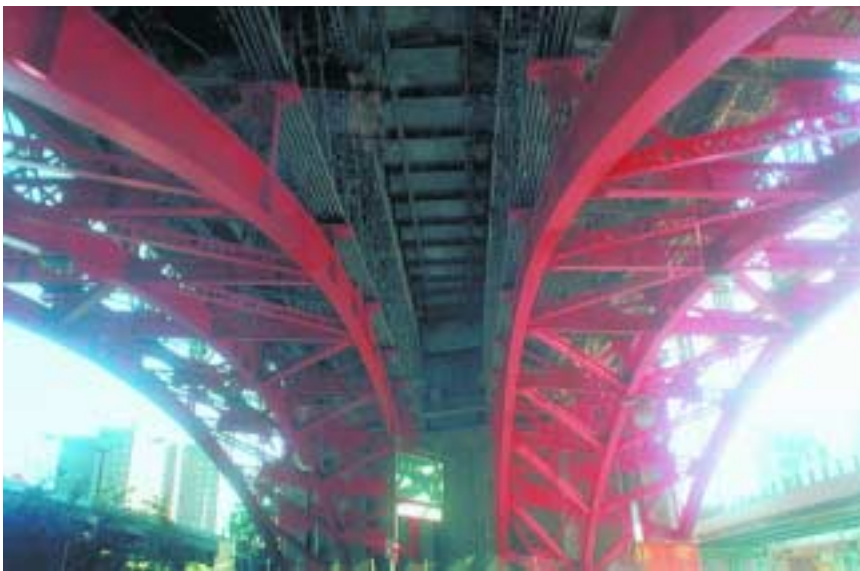
The 200' Franklin Square Bridge is part of the Manhattan approach to the Brooklyn Bridge. Due to its trapezoidal span, each of the six pin-connected eyebar trusses that support the bridge have a different span. Since 1883, various alterations have increased dead load significantly. Preliminary analysis suggested, and subsequent sophisticated analysis proved that, the bridge wasn't safe. The New York City Department of Transportation (NYSDOT) issued an emergency contract for retrofit to the consulting engineer who performed the analysis. The final design employed six steel arches founded into the original masonry abutments to support the six wrought iron trusses.

The final design employed six steel arches spanning the full length of the bridge to support the original six wrought iron trusses; the arches were founded into the original masonry abutments. While steel arched bridges are not uncommon, the client's request that the engineering consultant use arches to support the existing trusses, in order to minimize traffic interference and for aesthetic reasons, was unusual and contributed sig-

It was desirable that all the arches be sprung at the same elevation and that the crowns be as close as possible to the existing structure above. As a result, the arches all had different radii. Each arch was composed of three elements, which were spliced together in the field to facilitate erection. The arches were designed as three centered arches with the radii changing at the splice points and selected to approximate a parabolic shape. In order to reflect the solid plate top chord, the arch ribs were I-sections fabricated from steel plate; bracing and columns were rolled sections with webs pierced to reflect the lattices of the existing bridge.
