Raising the Hunley

By Perry L. Smith, P.E.

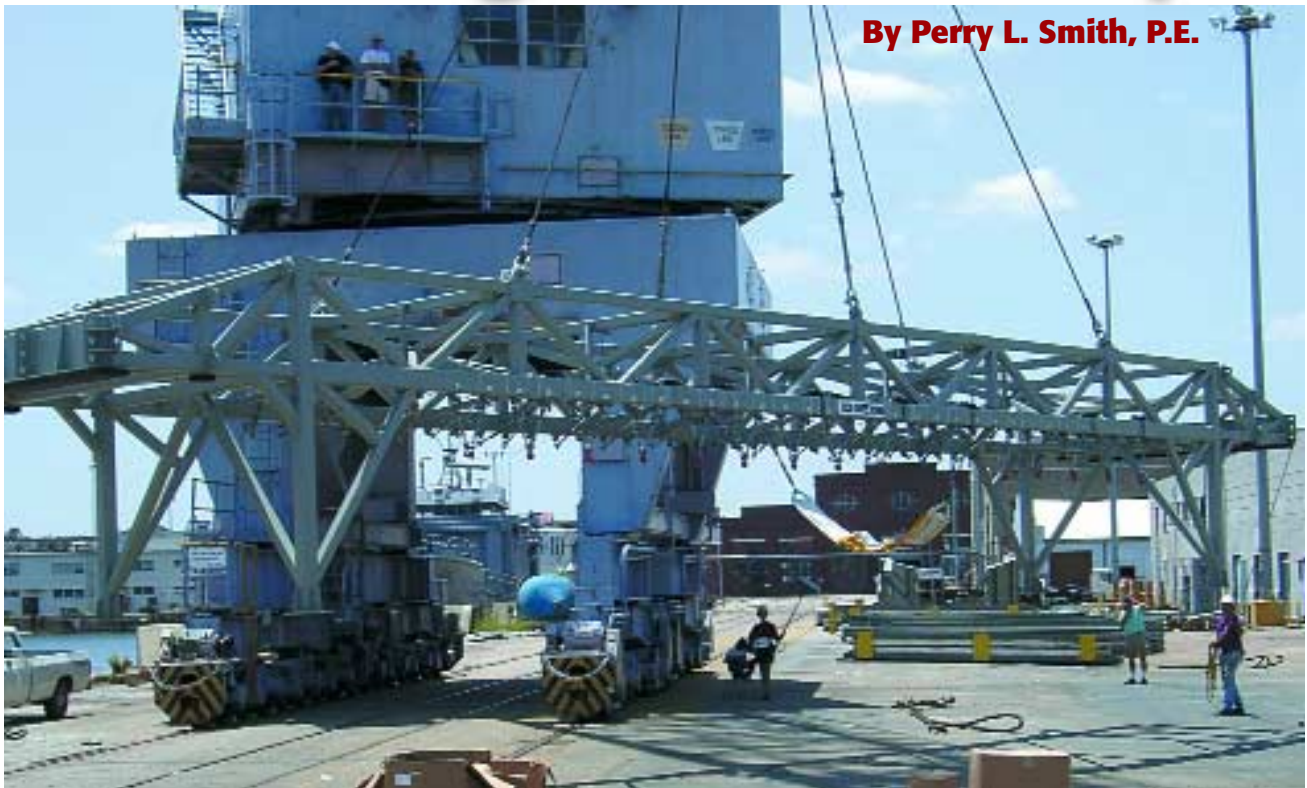
Oceaneering's recovery method consisted of two 18' diameter foundation suction piles and a 63' span steel truss. Nylon slings, suspended from the truss, acted as a cradle to provide continuous support for the Hunley during recovery and transport. A jack-up rig, positioned alongside the Hunley, set the piles and truss and made the lift to recover the sub. Oceaneering transported the sub in the truss to the former Charleston Naval Base at the Lasch Conserva-

The general arrangement plan to recover the Hunley consisted of a 63' long span steel truss supported by two 18' diameter steel suction piles located fore and aft of the submarine. The truss utilized 32-12" wide nylon slings attached to the bottom chords on the port and starboard sides. The slings were attached to the port side of the truss, slipped under the sub and terminated on the starboard side.

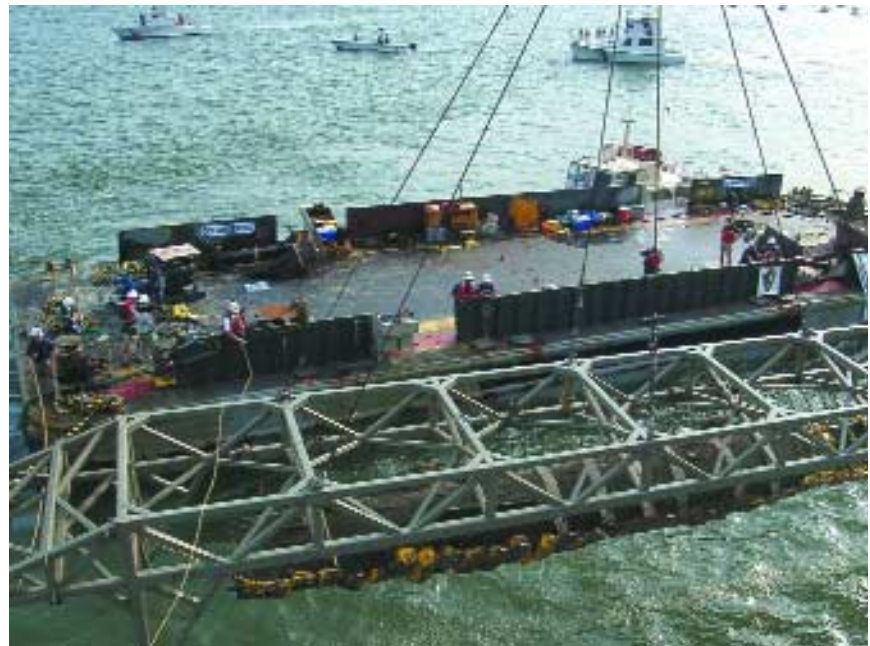
Hunley sub being lifted out of the ocean.

The truss supporting the Hunley was recovered using the jack-up rig's 330-ton crane. The truss and sub were placed on a materials barge, secured to the deck and towed by two tugs into Pier Juliet at the former Charleston Naval Base. From the pier, a 200-ton rail gantry crane transported the sub approximately 200 yards to the conservation lab.

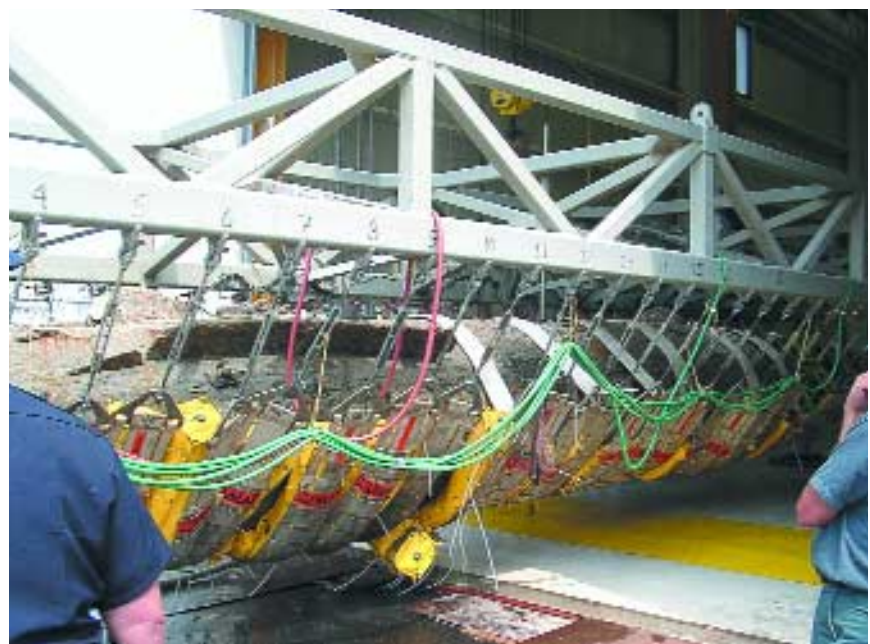
Hunley sub on dry land, cradled in by support slings.
