Steel Speeds Recovery

Steel industry coordination permitted the Webbers Falls Bridge to reopen just two months after being damaged.

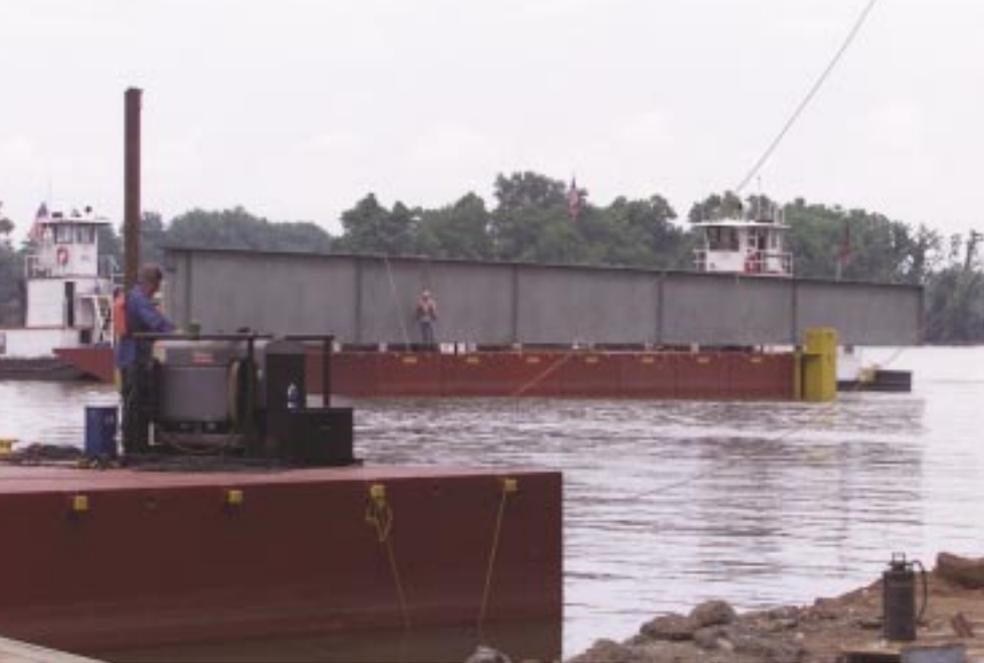
The last girder is transported to the job site.

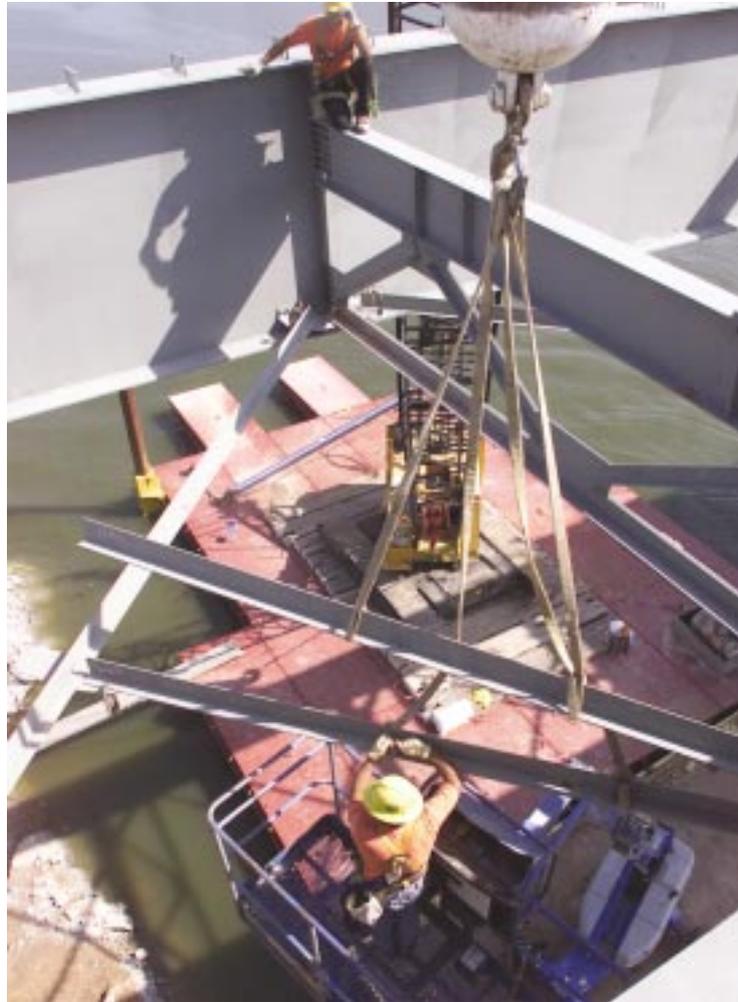
Workers install lateral bracing for the girders.

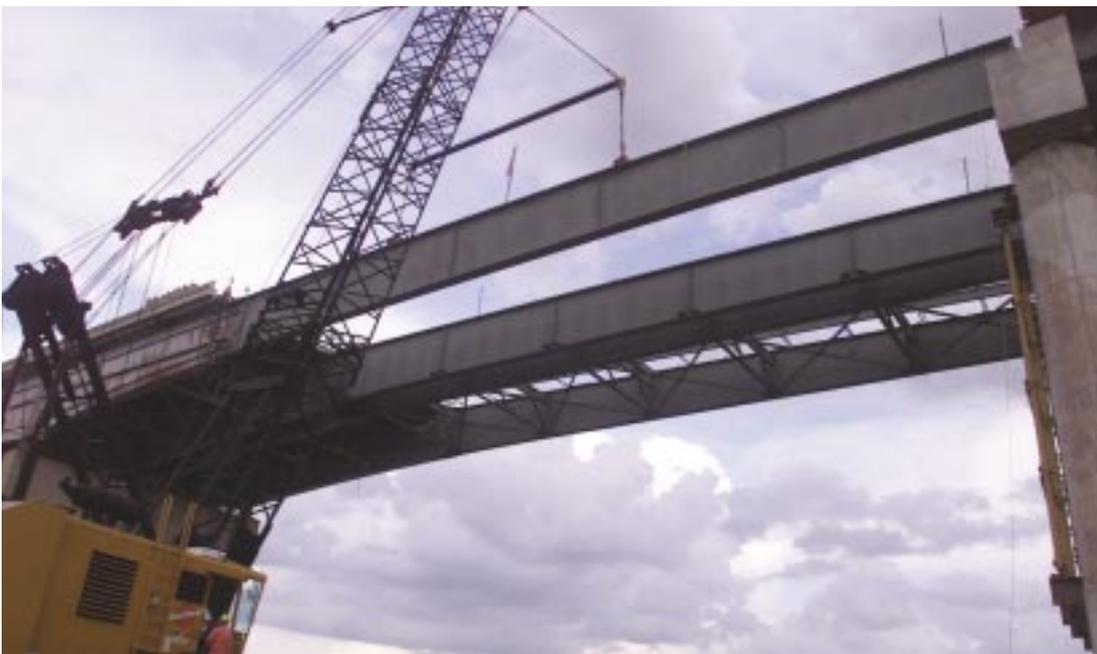
The last bridge girder is lifted into place.
