Home Team Advantage

By Michael Gustafson, P.E.

Exposed structural steel was a key player in the design of this one-of-a-kind collegiate soccer stadium for Creighton University in Omaha, NE.

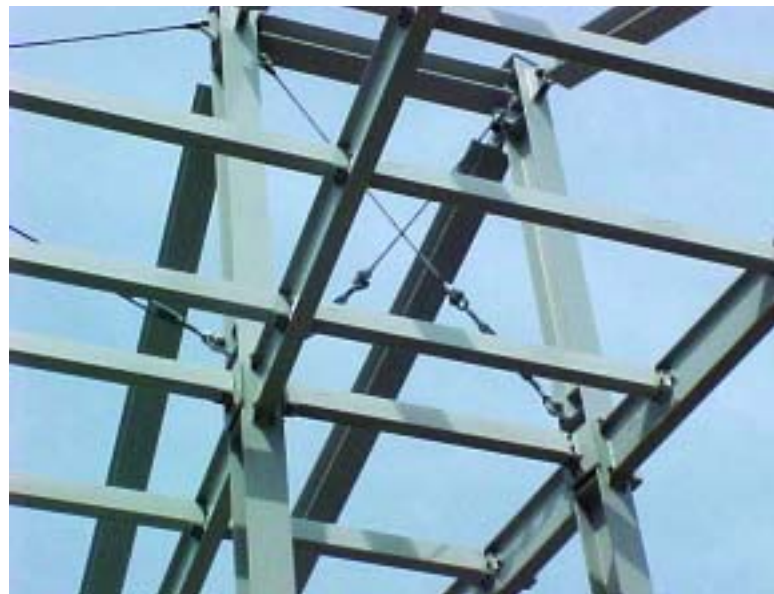
In the longitudinal direction, braced frames featuring rods in tension resist lateral loads, particularly those imparted by wind screens at either end of the spectator seating area.

The structure has a unique lateral system for each direction of lateral loading. For the transverse direction (in the direction of the canopy frame), the canopy frame provides lateral resistance through the use of a cantilever supported by a king post. For the longitudinal direction (perpendicular to the canopy frame), braced frames were used to pick up wind loads from the stadium. They also pick up wind loads from wind screens located at the ends of the seating areas.

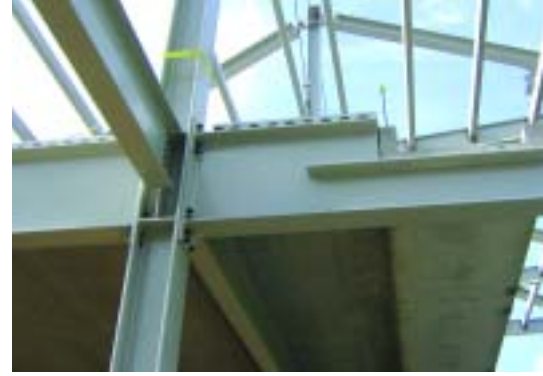
Steel framing supports precast concrete seating risers.
