# Salvaged Steel

BY JOHN C. LYONS, P.E.

**A salvaged steel roof was the cornerstone for this convention center expansion in Richmond, Va.**

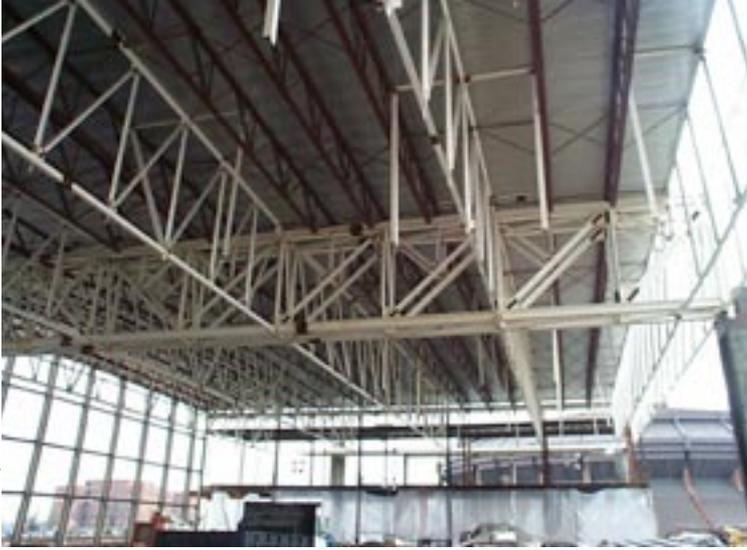
Twin steel girder trusses, consisting of wide-flange chords and double angle webs, span between the mast columns to support long-span joists on each side of the exhibit hall roof.

The existing roof would serve as the northwest corner of the exhibit hall roof. Six new cast-in-place mast columns were spaced at intervals of 124' or 150' on center along an axis running through the east row of columns supporting the existing exhibit hall roof. Twin steel girder trusses, consisting of wide-flange chords and double angle webs, span between the mast columns to support long-span joists on each side of the exhibit hall roof. In the all-new portion of the exhibit hall roof, the girder trusses were 14'-3" deep and supported joists on top. Girder trusses supporting the existing roof were only 12'-7" deep to avoid interference with existing joist diagonals. This roof-framing scheme resulted in a floor plan that was considerably more open and versatile.

Next, the erector placed the outer steel girder truss. The erector then placed W21 load-distribution members, at 7'-3" on center, between the top of the new twin girder trusses and the top chord of the existing truss. Steel plate shims were used to account for irregularities and to ensure a tight fit between the new and old construction. When all permanent bracing was installed, the erector cut the old steel columns, permanently transferring the existing roof's weight to the new twin steel girder trusses and cast-in-place mast columns. Load was transferred from 22 existing steel columns to the four new cast-in-place mast columns, which produced an open and highly functional exhibit hall space below.
