A New Angle

A conversation with
the steel fabricator of
the new Hearst Tower.

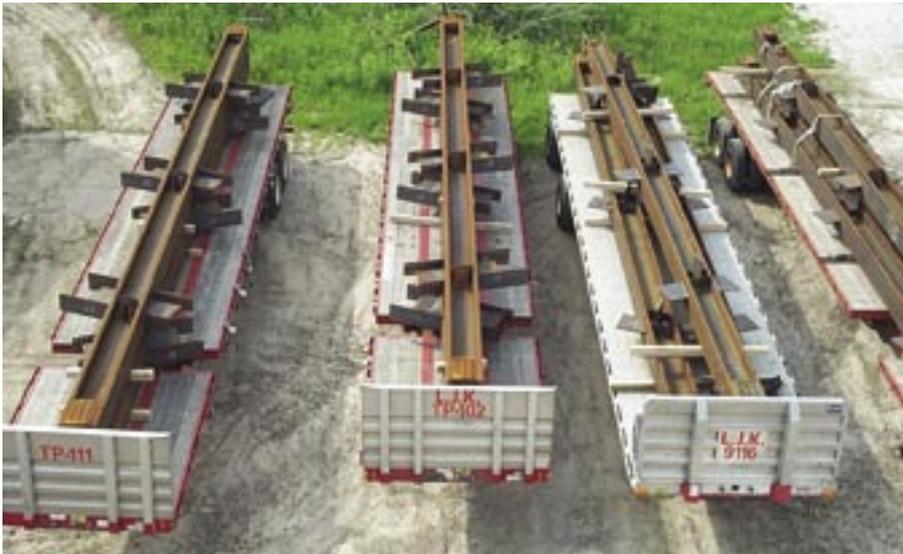
Tuttle: Yes. There was a big 10" node plate system and then the columns were bearing on the nodes. We had paddle plates coming off the nodes, bolting through plates that welded onto the toes of the column. So it was a bolted column to the node, yes.

Tuttle: Yes. There was a shear tab connection coming into the nodes. Actually, the beams come more into the center of these nodes. It's like an upside down V and a right-side up V in a given node system, and you have four columns coming into that. The 10" plate kept the columns away from the centroid of the nodes a fair amount and allowed room to connect the beams into the center of the nodes.

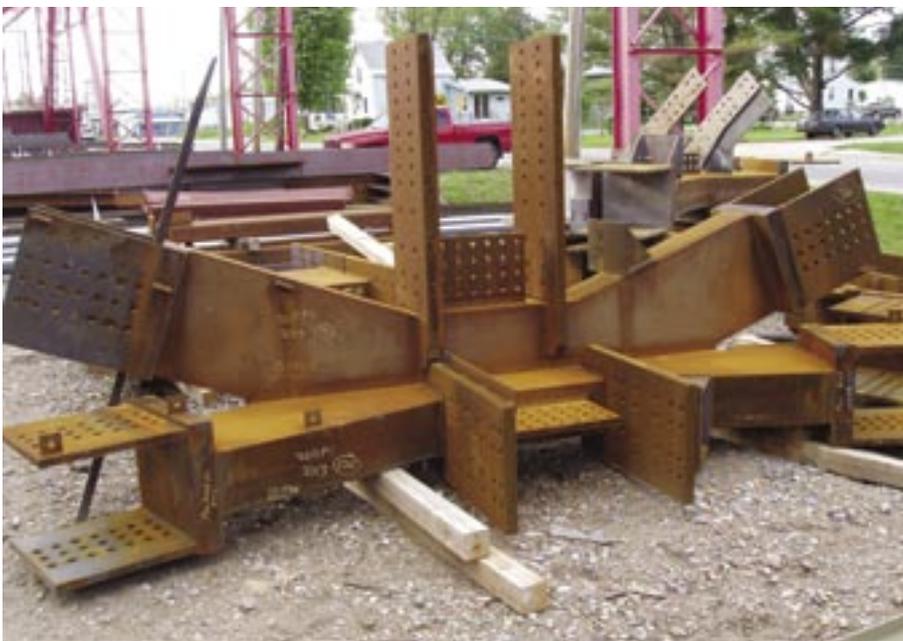
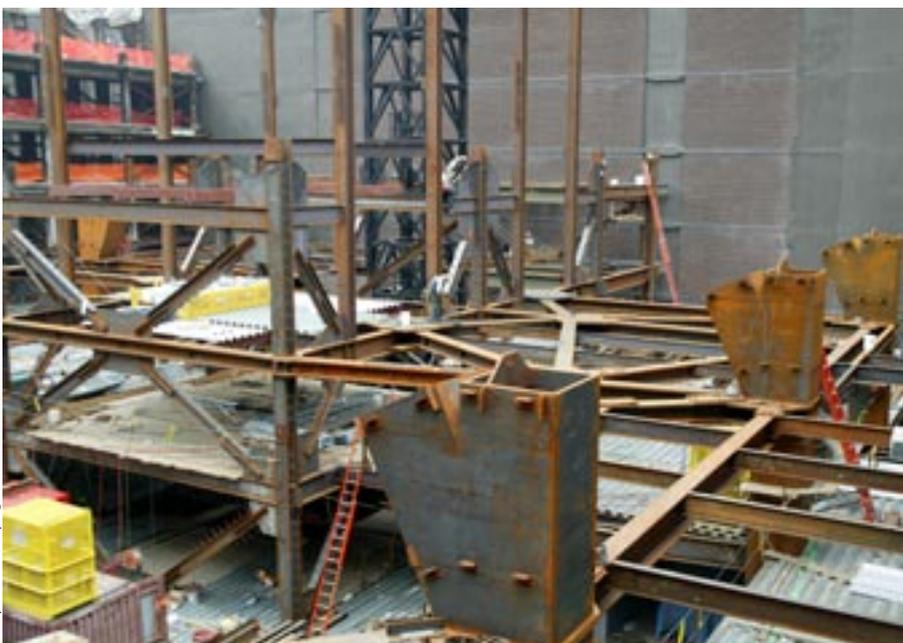
with one or two points in trying to make all the bolts fit because there were so many bolts coming into some of the corner nodes [also called the “bird’s mouth” nodes], but all in all it fit very well. The New York City Erectors Local No. 40 sent a letter saying it was some of the best fabricated steel they’d ever seen for this complex a structure.

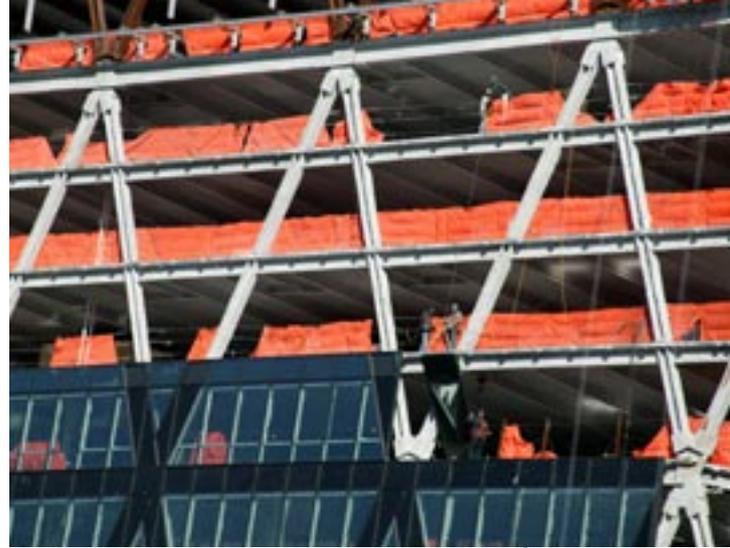
The engineer had actually designed the plates with four pieces of 5” plates welded together to build these bird’s mouth nodes, but we ended up coming up with a design to use two 10”-thick plates. There were 84 of the internal 10” nodes and 16 of the bird’s mouth nodes.
