Cowboy Corral

An extensive refurbishing gives Oklahoma State University's Boone Pickens Stadium a needed makeover.

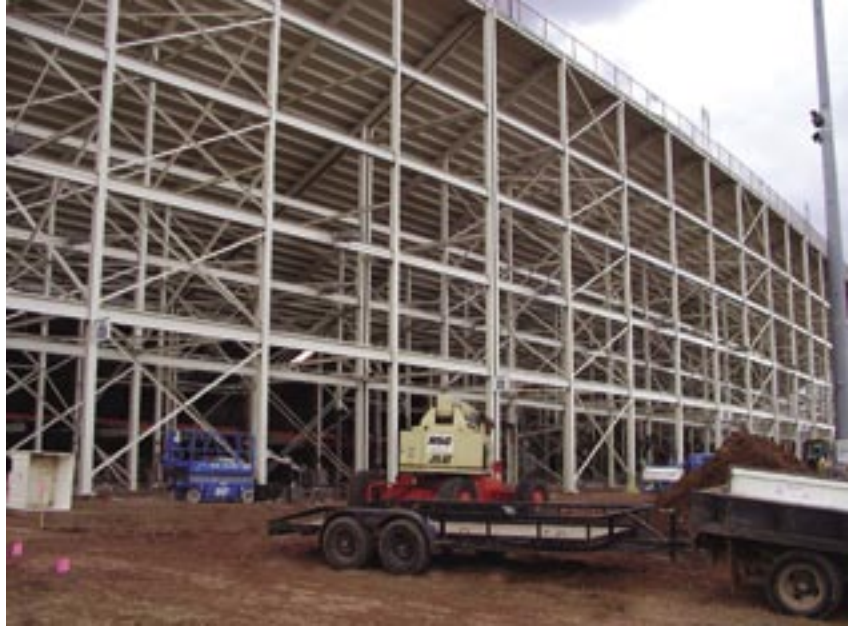
Right, top: The old stadium was supported by a forest of steel members.

The existing south and north grandstands were originally built in the 1920s and expanded in the 1940s. Typical construction at the time included steel columns on a 20 ft by 20 ft grid braced in both directions with horizontal and diagonal struts and X-braces. The result was an impenetrable forest of small structural steel members. These existing steel structures had been exposed to the elements for many years with little protective maintenance, and contained considerable amounts of rust and signs of deterioration.

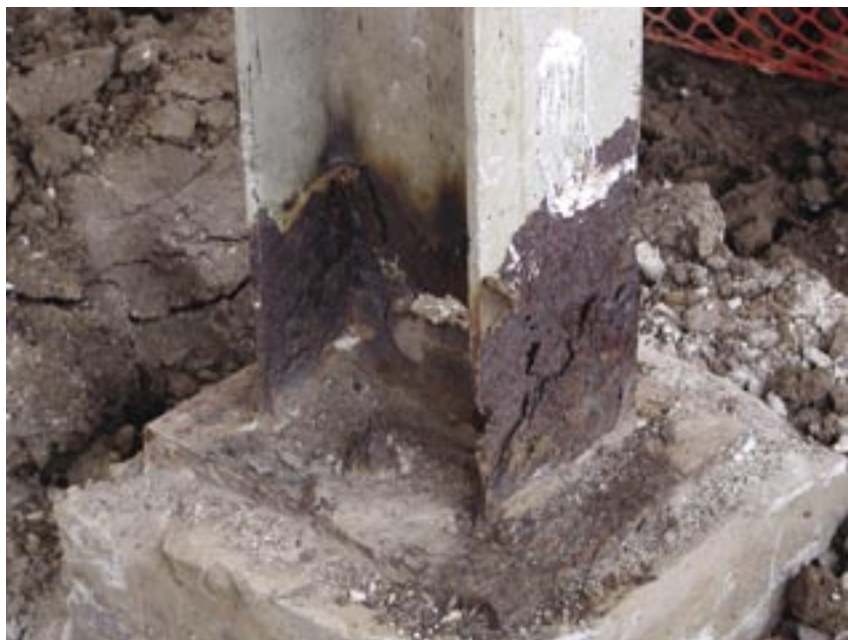
Right, middle: The existing steel had been exposed to the elements for many years, evincing considerable amounts of rust and deterioration.

In preparation for the new construction, contractors first had to demolish a variety of stand-alone buildings that had been constructed within the steel frames. The steel then had to be cleaned, inspected, and repaired where necessary, and protected with a three-part high-performance paint system. Although engineers determined that the structures were in relatively good condition, severe corrosion had occurred at some locations that had been previously covered up and exposed to high levels of moisture. The repairs ranged from minor strengthening of the steel members to the entire replacement of the members.

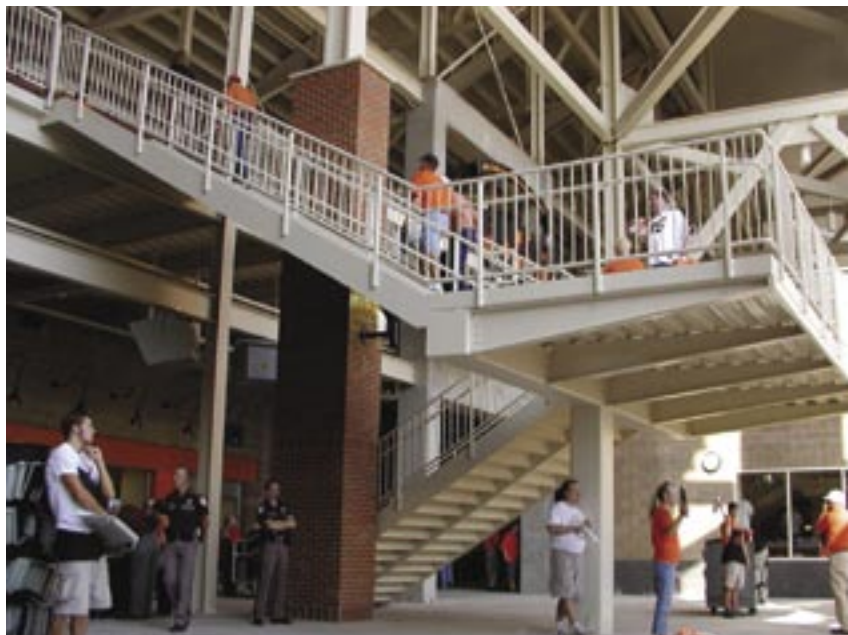
Right, bottom: Open concourses in the renovated structure replace the plethora of steel bracing elements.

new steel members that attached to the existing structural systems. Additionally, several steel braces were relocated with steel columns and beams strengthened to accommodate a new uninterrupted mezzanine-level concourse that accesses the second level of the concession-and-restroom buildings as well as the existing upper vomitories leading to the seating bowl. When completed, an open, brace-free concourse replaced a forest of spindly steel.

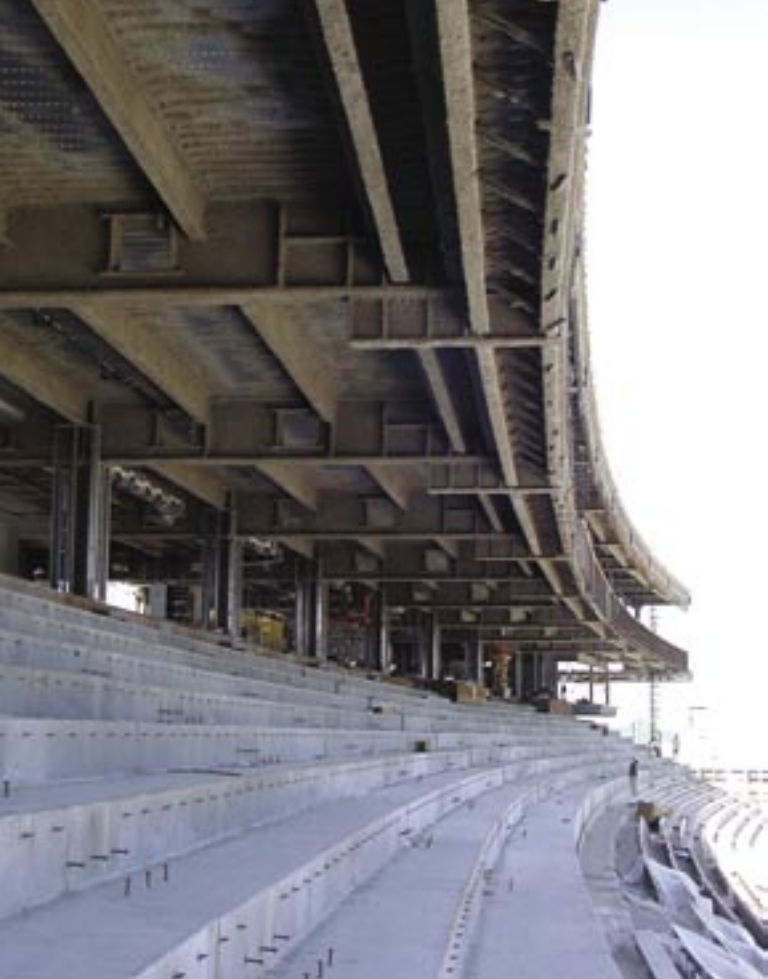
Cantilevers are supported by a series of steel-braced frames with 48-in-deep custom plate girders to provide the needed stiffness in the limited structural height. To accommodate distribution of piping, wiring, and heating ducts, the plate girders were designed to include web penetrations.

In addition to using 30 ft cantilevers with as little as 32 ft backspans, the architect also planned for 14 ft floor-to-floor heights. The shallowness initially concerned engineers, especially in regard to strength and vibration performance of the cantilevers. The solution was found in a series of steel-braced frames that featured 48-in-deep custom plate girders to provide the needed stiffness in the limited structural height. To accommodate distribution of piping, wiring, and heating ducts, the plate girders were designed with approximately 240 total openings total the south and north structures. Erection of the custom plate girders was simplified through early coordination meetings between the steel fabricator, steel erector, design team, and contractor.
