High Performance

Structural steel roof trusses helped solve an acoustical dilemma for the new home of the Nashville Symphony Orchestra.

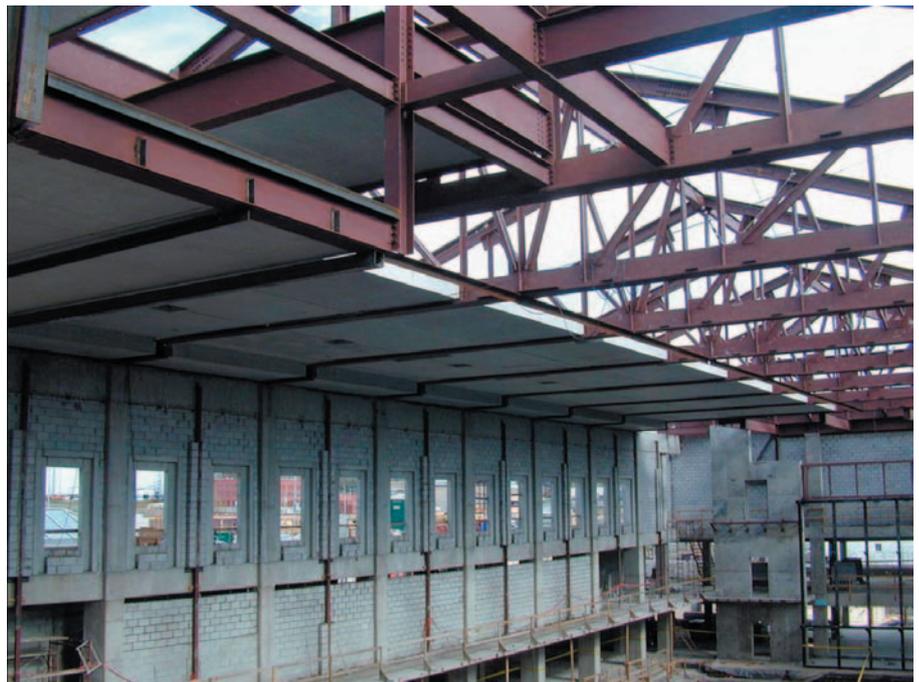
Below: The eastern half of the Concert Hall ceiling. Precast panels have been installed on the bottom chord of the roof trusses.

would not suffice. After consideration of the other options, the decision was made to combine the structural and ceiling systems into one plane by setting precast panels on the bottom chord of steel trusses spanning the 80 ft across the concert hall. The finished plaster system, consisting of several layers of sheathing with a hand-applied plaster finish layer, was to be applied directly to the precast panels. Ceiling coffers provided for
