You Can't Judge a Cable by Its Cover

Making a Statement

The Other Side of the Tracks

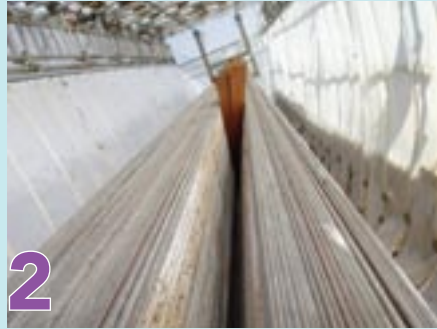
Wedges are driven into the center of the cable so that they can be inspected.

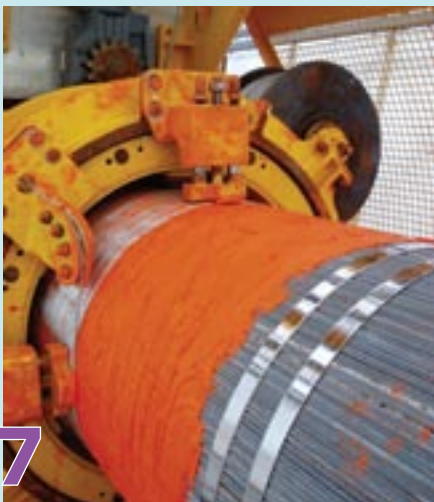
...rewrapped...

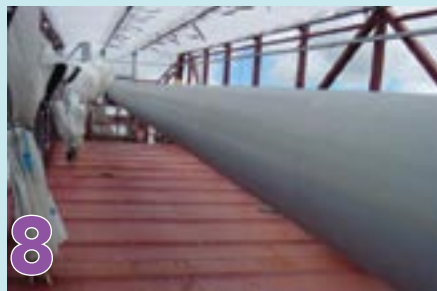
...and repainted.

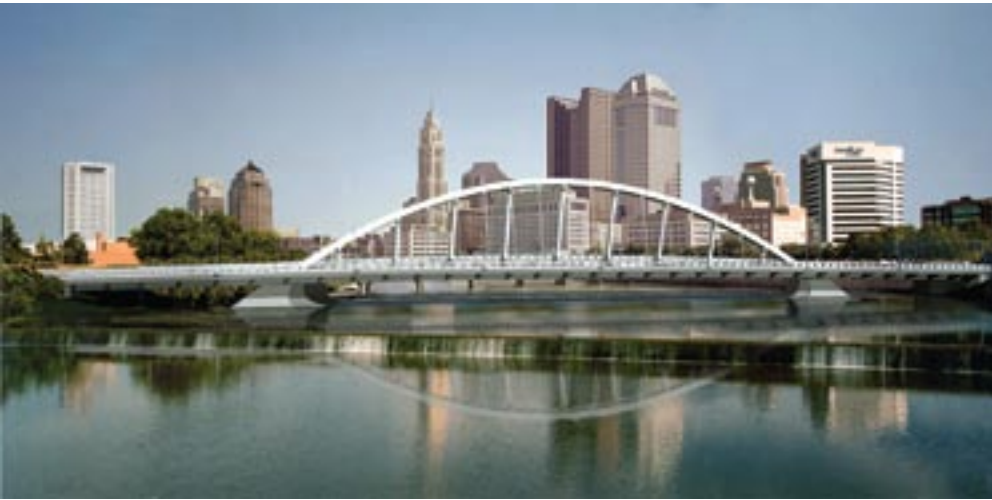
The new Main Street Bridge in Columbus will be completed in 2009.

A paramount design consideration was the use of clean, classical lines that evoke the city's neighboring arched bridges and art deco buildings. The final design is a single rib-tied steel arch inclined at a 10° angle from vertical. The arch emerges through the bridge deck, and steel hangers descend from the arch to support members

The overall length of the three spans is approximately 660 ft. The main span is 400 ft long, and the spans on each end are 130 ft long. The three-lane vehicular deck is 35 ft wide, and the pedestrian walkway is 18 ft wide. The curved pedestrian bridge is connected to the arch by a series of cables and struts that support the structure.

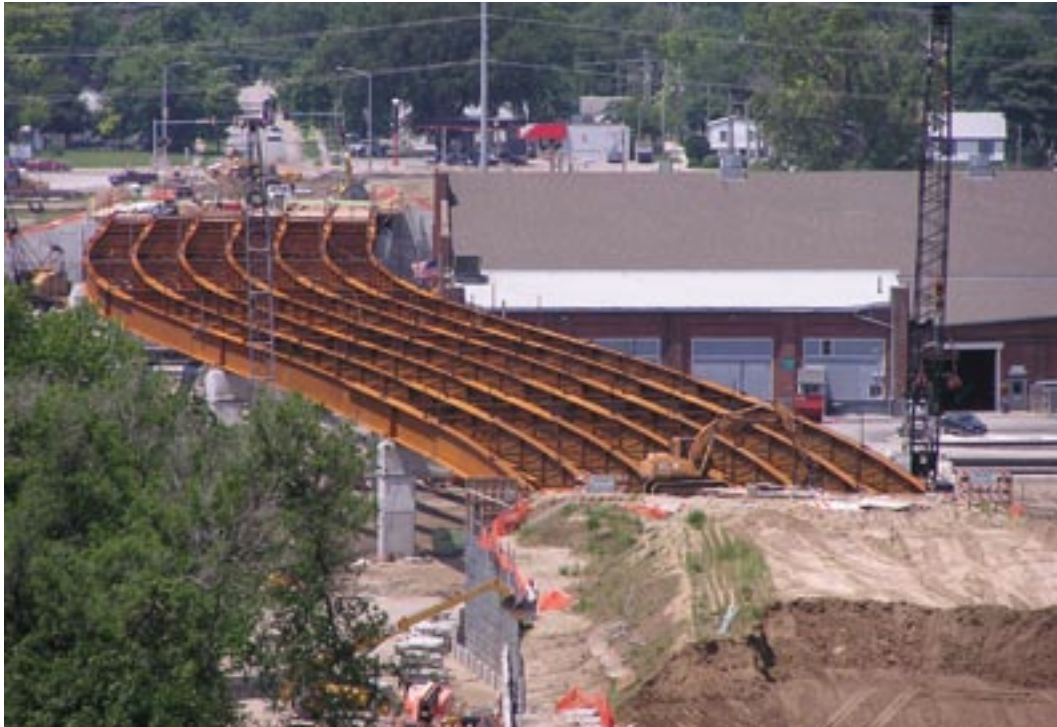
A new viaduct provides motorists with an alternate route over multiple tracks in a western Iowa railroad town.

The Avenue G Viaduct project incorporates a four-lane cross-section in its 54-ft clear roadway and includes a 10-ft wide trail on the south side. The 1,290-ft long bridge crosses two city streets, a

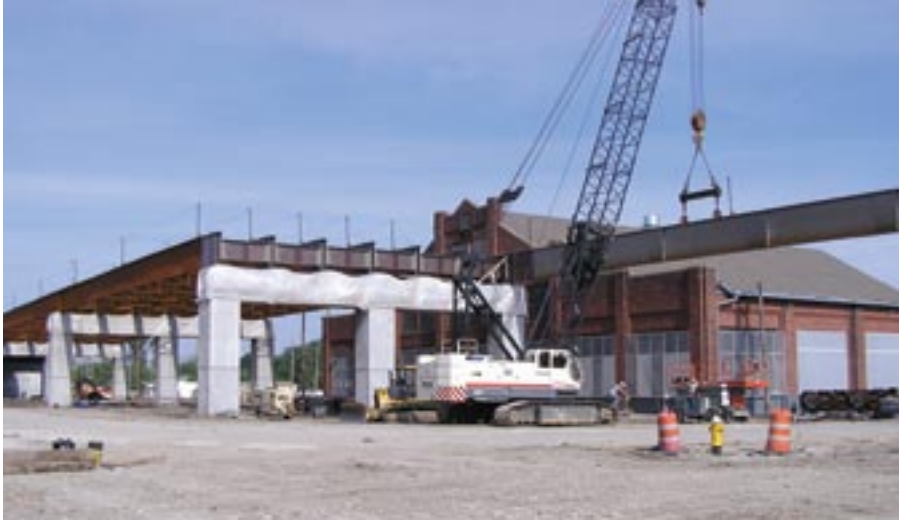
The proximity of the bridge to adjacent industrial structures required a reverse-curve alignment.

The chosen location for the new railroad overpass is north of the primary central business district on an arterial route, the Avenue G corridor, through a primarily residential area of Council Bluffs. As Avenue G crosses the two railroad companies' tracks, it is also flanked by various industrial buildings and a school. The locations of these facilities, as well as numerous primary utilities in the tight Avenue G corridor, eventually led to a partially offset alignment for the overpass. To provide adequate offset to the adjoining buildings, the alignment of the bridge structure required reverse curvature.
