Historic stadiums, such as the University of Illinois' Memorial Stadium, are undergoing renovation work to keep the seats full and the fans happy.

Big Draw

BY ROBERT HYLAND, P.E., AND JEFF ADAMS, P.E.

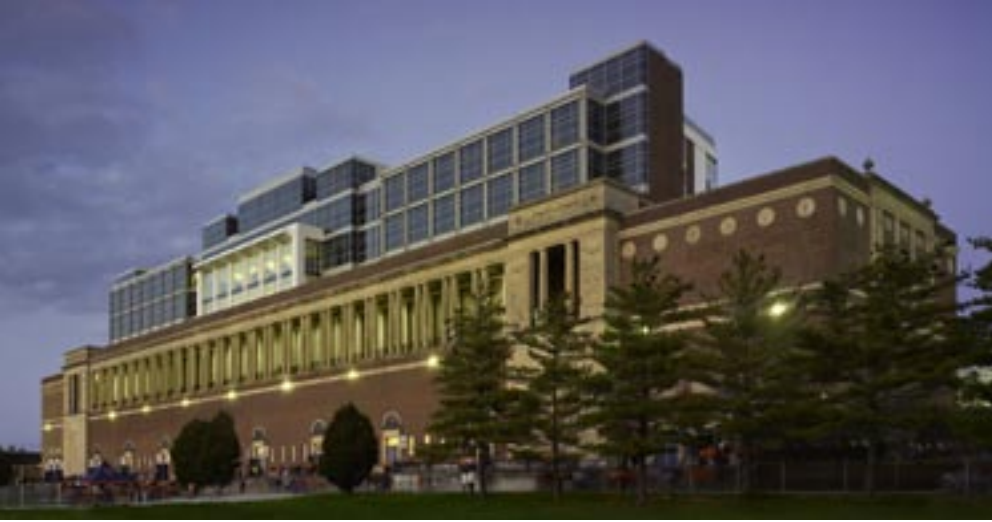
The renovation project kept the stadium's historic façade intact, including the signature columns.
