A severely damaged Wyoming highway bridge gets back on track within a matter of months.

WHEN A NORTHEAST WYOMING HIGHWAY BRIDGE was damaged by a truck on May 13 of last year, not only were travelers faced with a long detour but also the nation's most productive coal mine was cut off from a loading facility for the trains that carry its coal to power plants around the country.

BY GREGG FREDRICK, P.E.

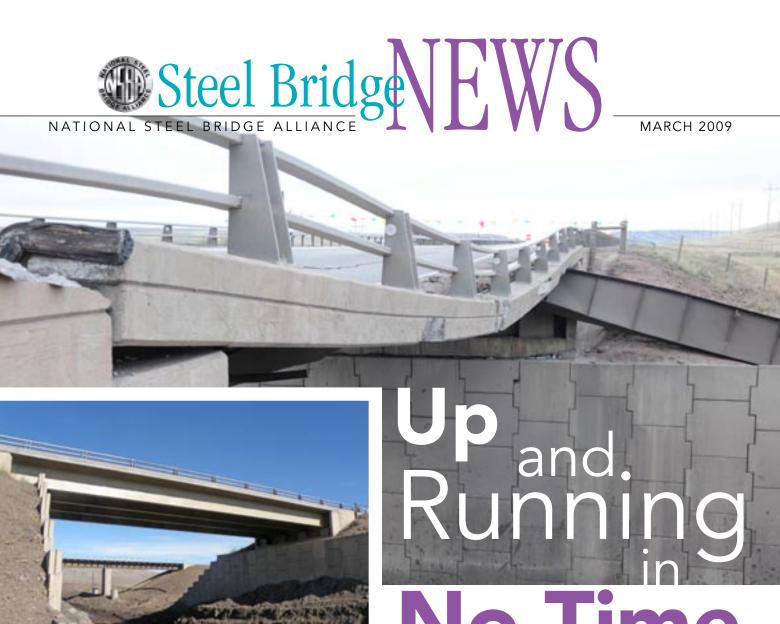
The damaged bridge, about 12 miles southeast of Wright, Wyo., was a simple composite-steel welded-plate-girder span with a back-to-back abutment length of 90 ft and a clear bridge roadway width of 32 ft. The bridge's exterior girder had been pulled from the deck and both bearings, ending up on the abutment slope perpendicular to the bridge's centerline. The second interior girder was severely damaged as well, and many of the intermediate cross frames were distorted. The south edge of the deck deflected approximately 2 ft, but the bridge's abut-

A bridge on Wyoming Highway 450 sustained severe damage last May (above) but was back in commission by September (inset).

Three days later, hydraulic excavators from Black Thunder Mine removed the damaged bridge deck and girders in about four hours. At the same time, WYDOT was beginning the design and details for the bridge replacement.

On Aug. 18 Reiman began erecting the girders, and by Sept. 26 the new bridge was opened to traffic, just 4½ months after the original bridge was damaged and 19 days ahead of schedule.

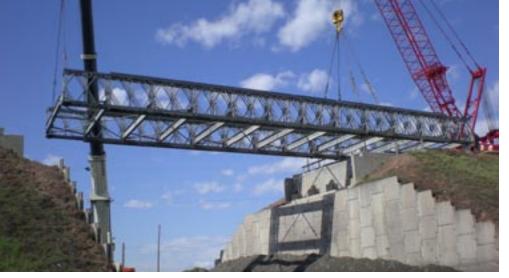
This 140-ft portable prefabricated modular steel truss bridge replaced the damaged span and allows for two lanes of traffic.

On May 19, WYDOT's maintenance crews began constructing a 140-ft portable prefabricated modular steel truss bridge manufactured by Acrow Corp. in Pennsylvania. The two-lane bridge is strong enough to carry highway loads due to its triple-single reinforced three-heavy side truss configuration. "The Acrow bridge is great," said Barry Bowersox, WYDOT's area maintenance supervisor. "It goes up quickly, it's strong, and it allows for two lanes of traffic."

With the aid of Acrow and cranes provided by the mine, the bridge was lifted into place and set on concrete footings behind the bridge abutments. Thunder Basin provided timbers for the back wall and hauled the material for the approach roadway. WYDOT maintenance crews placed and surfaced the approach ramps and bridge deck. By May 31, just 18 days after the bridge was damaged, the temporary bridge was opened to traffic and coal trucks began rolling underneath the highway again.

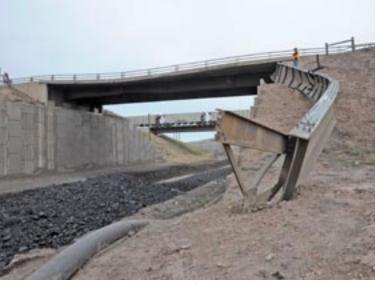
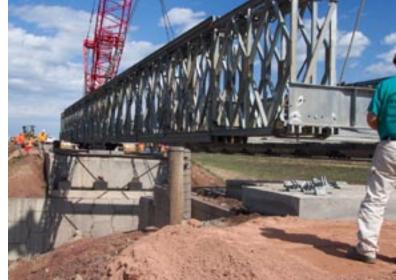
WYO 450 carries an average of 1,800 vehicles a day, and the best available detour around the damaged bridge was 32 miles long.
