From Top

BY STEPHEN METZ, P.E.

to Bottom

Ohio State's main library receives a structural upgrade, from the basement to the attic.

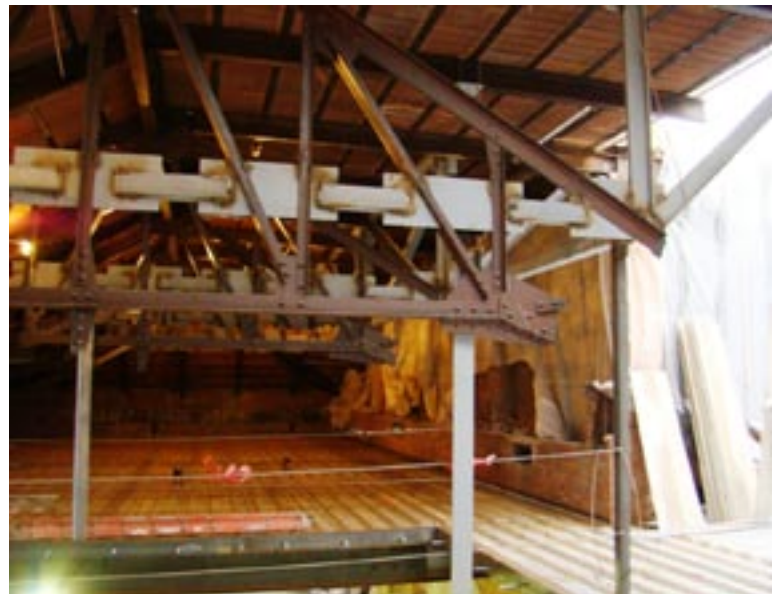
Modifications to the existing trusses in the library's attic.

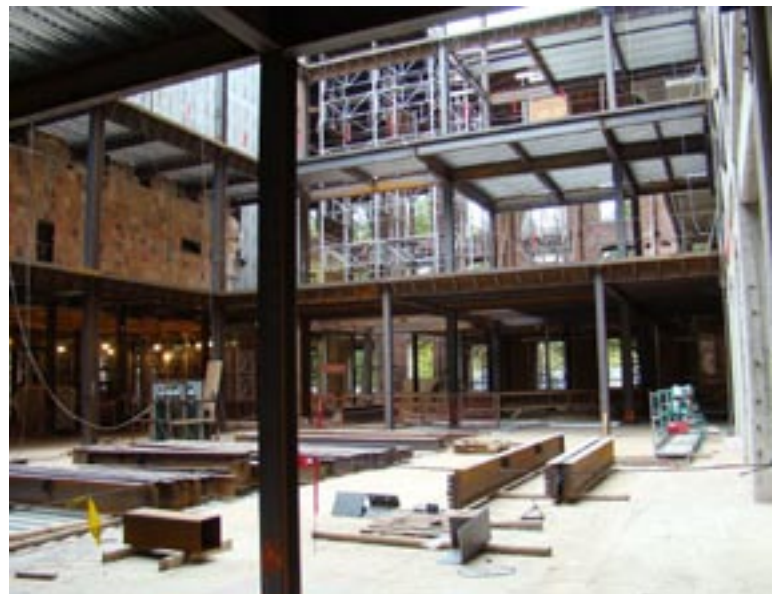
New floor framing at the library's east atrium.

In the 1913 structure, all three of the floors and the basement were partitioned into smaller areas by the interior brick bearing walls, some more than 2 ft thick. The new design of the space called for the basement and first floor to be entirely free of the bearing walls. The walls at the upper floors also had to be removed to allow for the new four story high atrium in the middle of the space. To open the space and allow for the atrium, the bearing walls and large areas of the floors were entirely removed. Temporary shoring was installed during construction to support the floor and roof framing that was left in place. Steel framing was inserted into the building at the locations of the brick bearing walls. The new framing supports the existing floor and roof framing while allowing for the openings at the new atrium.

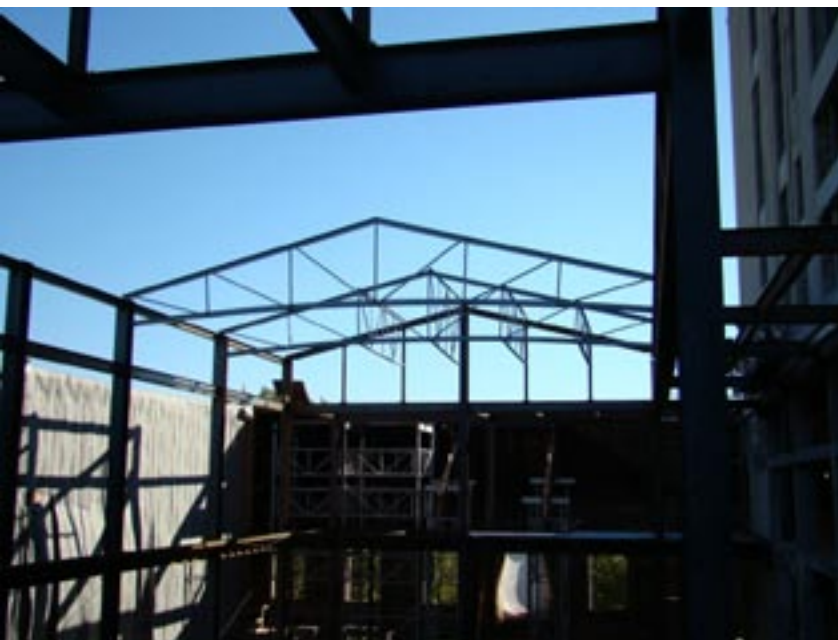
Skylight trusses at the east atrium.

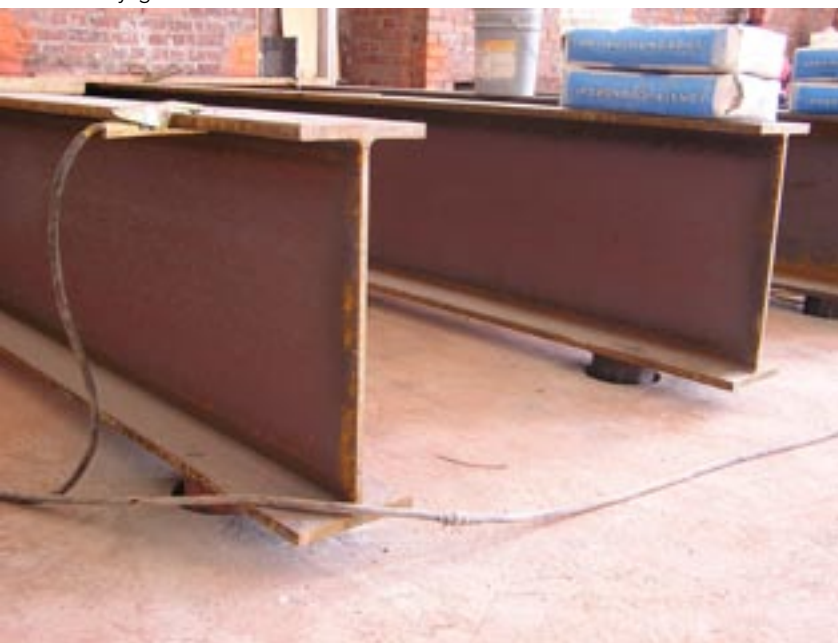
Needle beams for temporary support of the reading room walls.

The north and south walls of the second floor reading room were also brick bearing walls. The historic renovation portion of the project dictated that these walls remained in place so that the original plaster details could remain and be restored. However, the brick walls at the first floor and the basement had to be removed. To accomplish this, temporary shoring was erected to support 30-ft-long W24×94 needle beams that were spaced at four feet on center. After the walls were removed, double W30×235 beams were placed tight to the underside of the needle beams. The W30 beams were supported on new wide flange columns. New masonry was added around the needle beams and the beams were cut off on each side of the wall, leaving a piece of the needle beam in the wall.

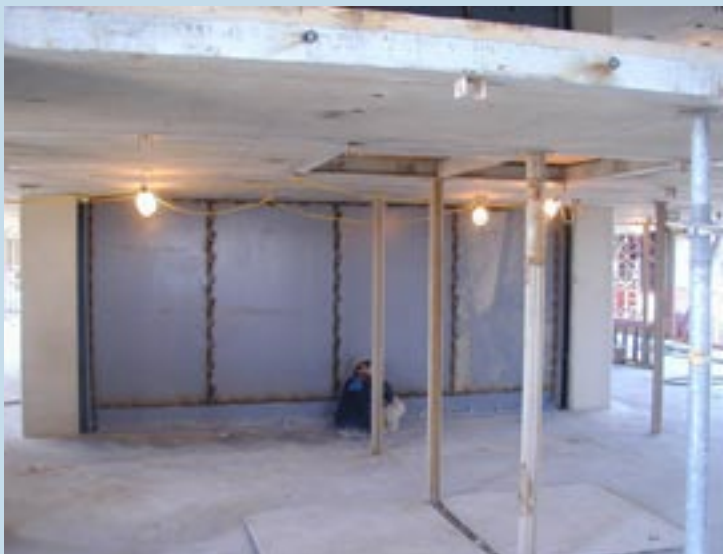
A SPSW in the library's stack tower.

Early in the design process, a seismic analysis of the additions was conducted, revealing a deficiency in the 1952 addition that resulted in the need for a seismic retrofit. The university decided that the lateral load resisting system should be retrofitted to meet the current building code requirements, the 2005 Ohio Building Code. Floors two through ten, with the exception of the mechanical floor at the fifth floor, were programmed to continue being used as book stack space. This resulted in very closely spaced shelving units to provide an efficient use of storage space. The use of conventional braced frames or shear walls would have reduced the number of volumes that could be stored on each floor, due to the size of the members. Hence we opted for steel plate shear walls (SPSWs).

By using the ¼-in.-thick SPSWs, the same number of volumes could be stored on each floor as before the retrofit, which was a tremendous asset to the university. In the end, the SPSW proved to be a cost-effective solution because the university would have had to build additional, unprogrammed space to make up for the lost shelving.

Typical steel plate shear wall systems consist of a steel plate wall, boundary columns, and floor beams. The steel plate wall and boundary columns jointly act similar to a vertical plate girder. The steel plate wall itself acts as the web and the horizontal floor beams act as transverse stiffeners in a plate girder. When loaded, the plate will experience large inelastic deformations, while the VBEs (vertical boundary elements) and HBEs (horizontal boundary elements) must remain elastic. This also needs to be the case under forces generated by fully yielded webs. Thus, the actual-versus-theoretical plate yield strength becomes extremely important in the design of the system. Recent studies have shown that the ratio of expected yield stress to specified minimum yield stress, R_y , for ASTM A36 plate material is 1.3 rather than 1.1, as specified in previous codes. These new findings significantly increase design loads on the system's VBEs, anchor bolts and foundations.
