# Keeping the

New space requirements call for a repurposed lobby and ballroom areas in an Atlanta hotel.

# Party Going

BY ROBERT M. WEILACHER, P.E., S.E., LEED AP, AND DR.-ING. OLAF U. FABER, P.E.

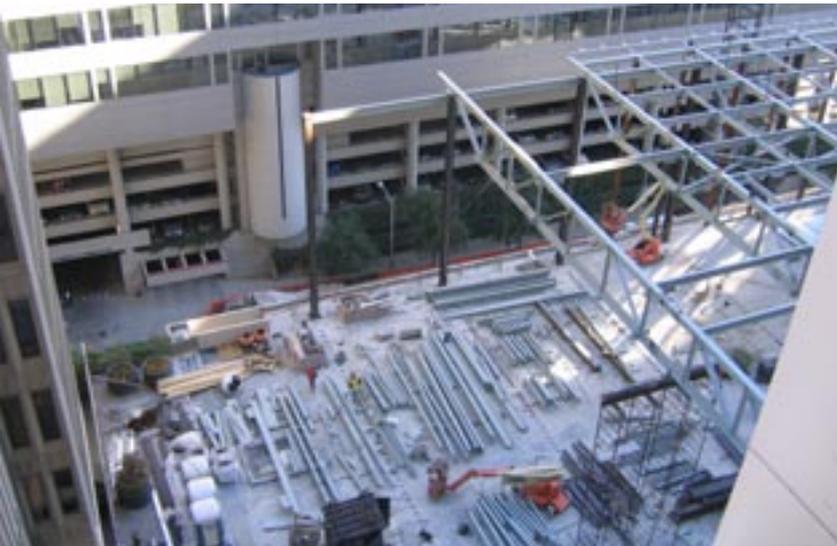
The renovation includes two ballrooms, one on top of the other.

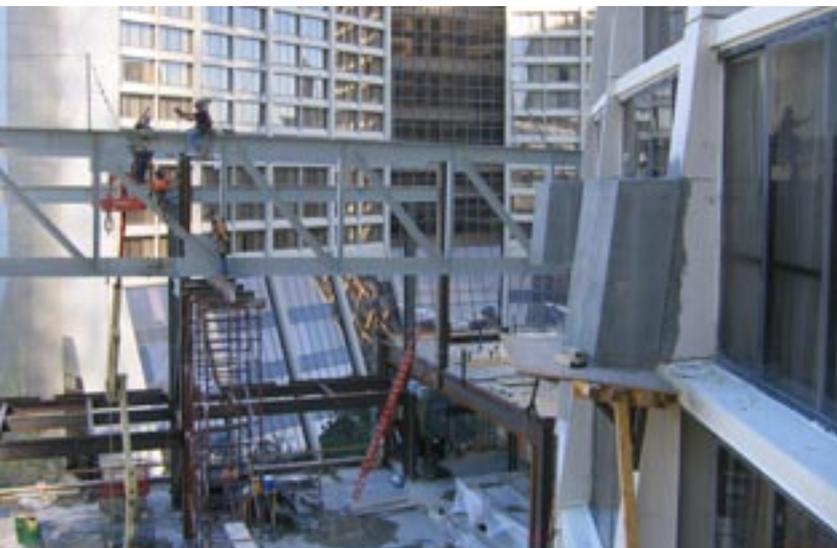
Roof trusses for the Atrium Ballroom.

The most significant portion of the retrofit was the addition of a new roof above the existing atrium level, which in turn became the floor of the new Atrium Ballroom. The new roof is supported by long-span structural steel trusses spanning from 90 ft to 135 ft (WT18 top and bottom chords, double angles for diagonals). The trusses are supported by concrete corbels attached to the existing shear wall structures, using reinforcing steel that was dowelled with epoxy.
