Fast track replacement of deteriorated span quickly gets vehicles back on the road.

Steel Solution Speeds Oce Repa

WHEN A ROUTINE INSPECTION of the Route 90 Bridge over the Assawoman Bay in Ocean City, Md., revealed previously undetected structural damage at the bridge's navigational span, the Maryland State Highway Administration (SHA) closed the bridge for emergency repairs.

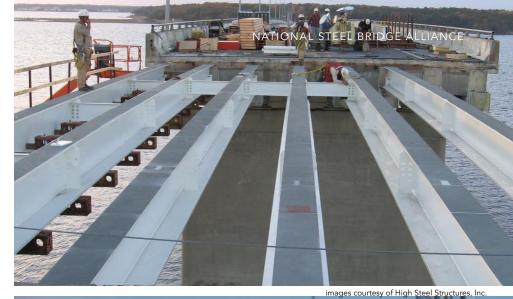
The contractor's use of a large crane expedited removal of the deteriorated span and allowed placement of the steel fascia girders in pairs with the deck overhang formwork pre-installed.

By mobilizing the large floating crane, the contractor was able to expedite removal of the span by lifting it out in just five pieces. Its high capacity allowed removal of pieces with girders, deck and parapets still intact. The crane also allowed erection of the fascia girders in pairs with all of the deck overhang formwork pre-installed.
