An. Inside Job

Converting a nearly abandoned vintage power station into prime office space relied on a detailed erection plan and flawless execution.

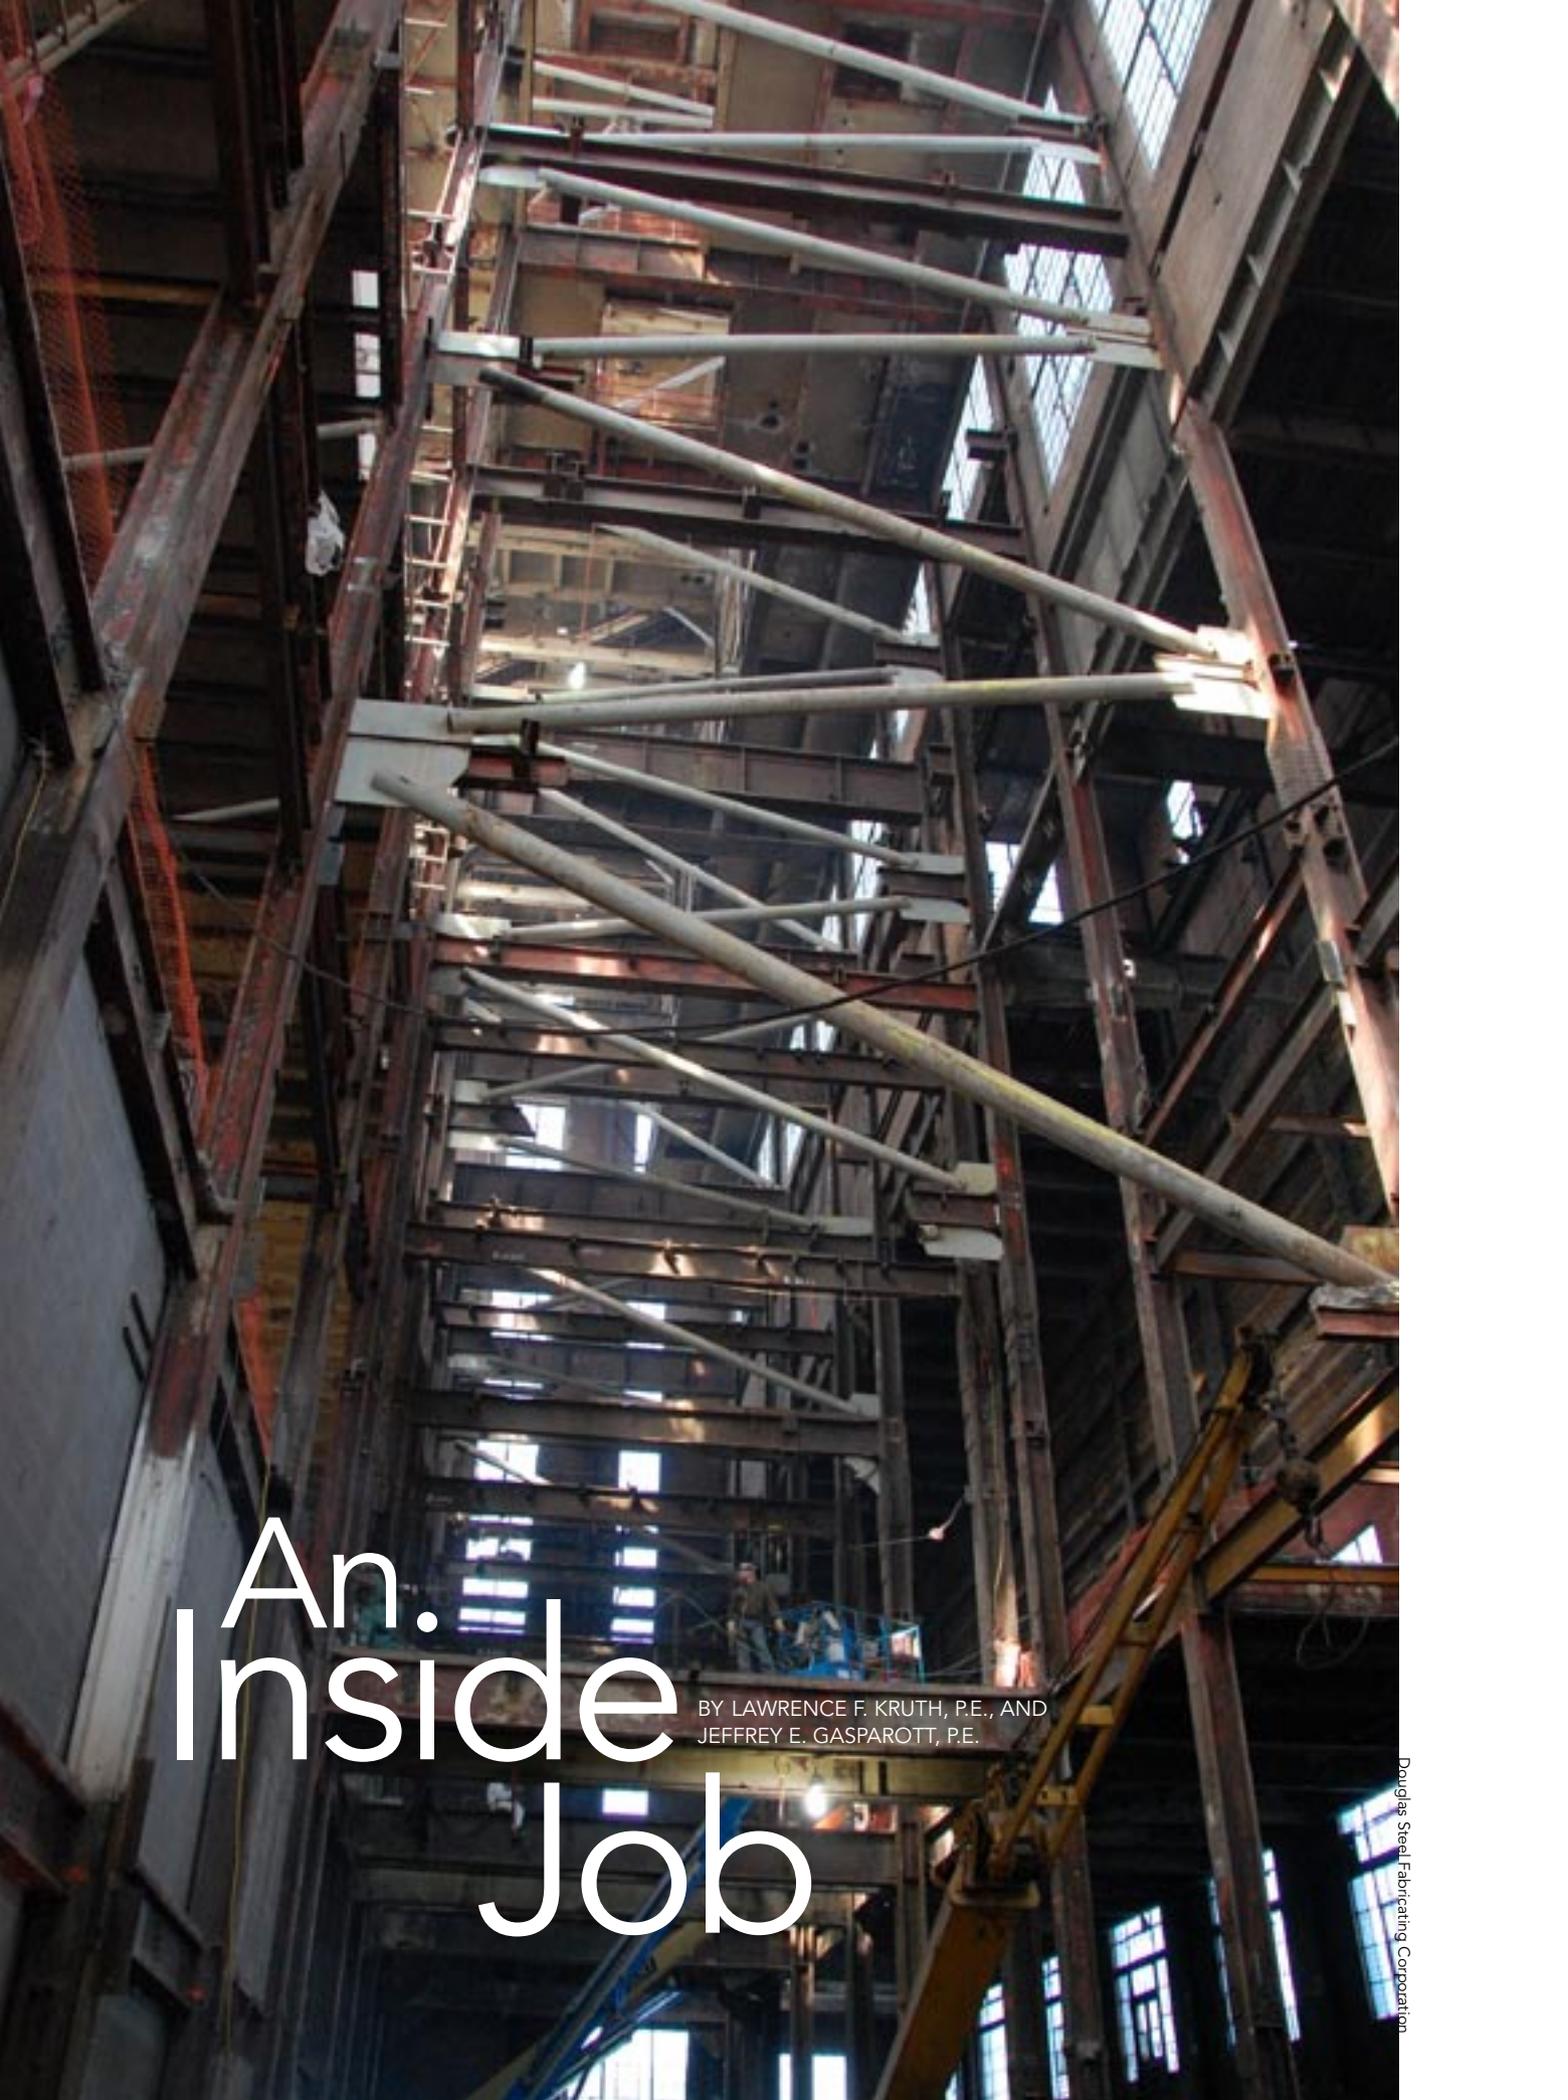
◀ The demolition and removal of old steel and setting the new steel proceeded from the ground up, although the primary portals for moving steel in and out of the structure were two hatches in the roof.

The process involved installing two temporary 14-ft by 40-ft roof hatches in the existing building, hoisting all of the steel from the east or west side of the building through these roof hatches, and setting the new steel from the ground up. That meant that all steel would be set "in the blind"—the crane operator would not see the piece being lowered into position nor would he see the ironworker setting the piece. This required a detailed erection plan with a reliable communication system between the ironworkers and the crane operator. In addition, it would be necessary to demolish as much of the existing steel to be removed and recycled as early as possible in order to open a free path of travel for the hoisted piece from the top of the building to the bottom.

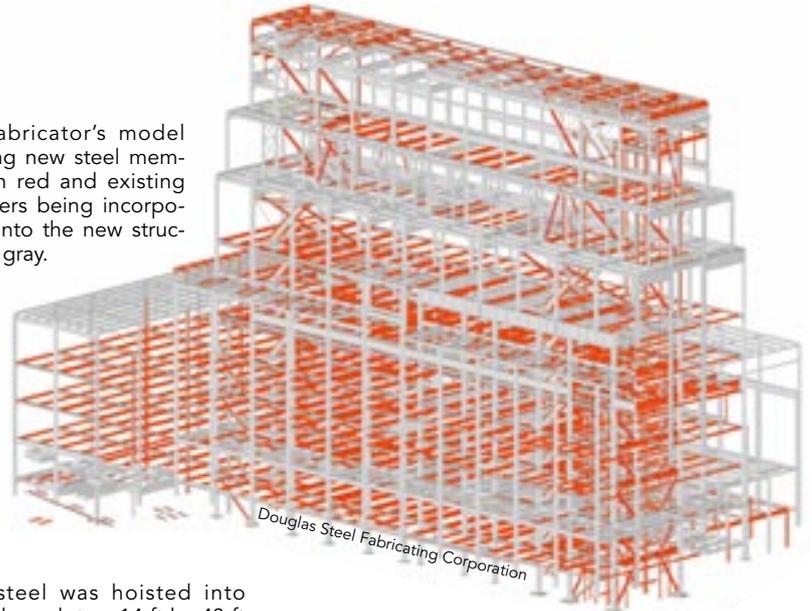
▶ The fabricator's model showing new steel members in red and existing members being incorporated into the new structure in gray.

Initially Arup, the structural engineer of record, used documents from the original 1939 construction of the power plant to create a Revit model of the structure. Engineers then deleted and added members to the model as required to meet the end requirements of the structure, all the while keeping in mind the owner's and architect's requirements as well as the structural strength requirements.

The EOR's new design used the existing columns as part of the new structure as well as most of the existing perimeter beams and some existing interior beams. However, many of the new floors were not at the same elevation as the existing levels in the power plant, so new beams were needed as framing from column to column, infill beams, and additional bracing.

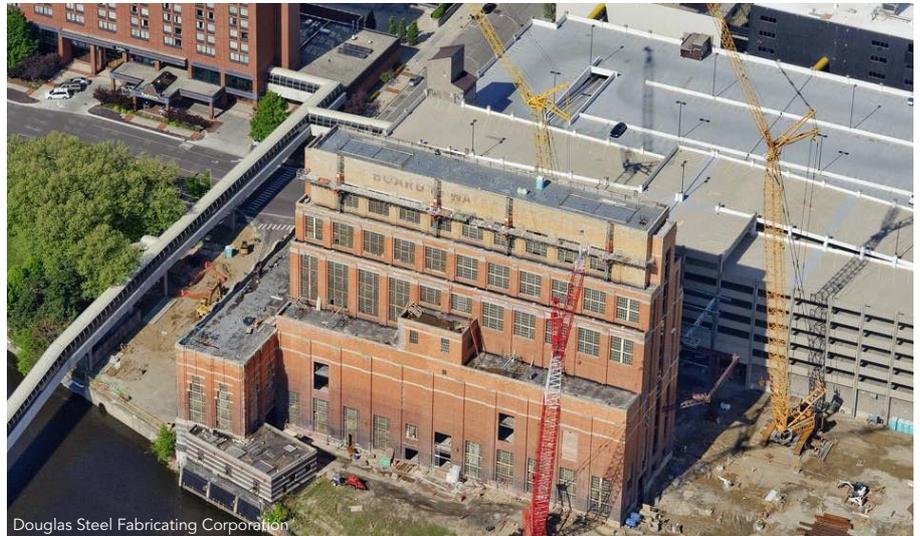
▼ New steel was hoisted into place through two 14-ft by 40-ft hatches installed in the roof.

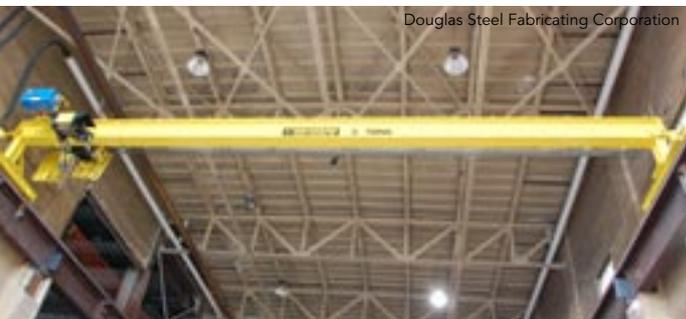
▲ To maneuver the steel in the turbine hall, the fabricator/erector installed a new crane for the duration of the project which allowed the use of the existing crane way.

In order to erect the steel in this area, Douglas Steel decided to take advantage of the existing crane way. The existing crane could not be used because it was a 70-year-old historical artifact and had not been operated for more than 25 years. Instead, Douglas Steel had a custom overhead crane constructed to run on the existing crane rails.

The new crane was sized to span the entire turbine hall and of sufficient capacity to hoist the new steel in this area. Because the crane would have to travel to the outdoor crane way to unload the steel from the trucks, it was equipped with a radio-controlled pendant.

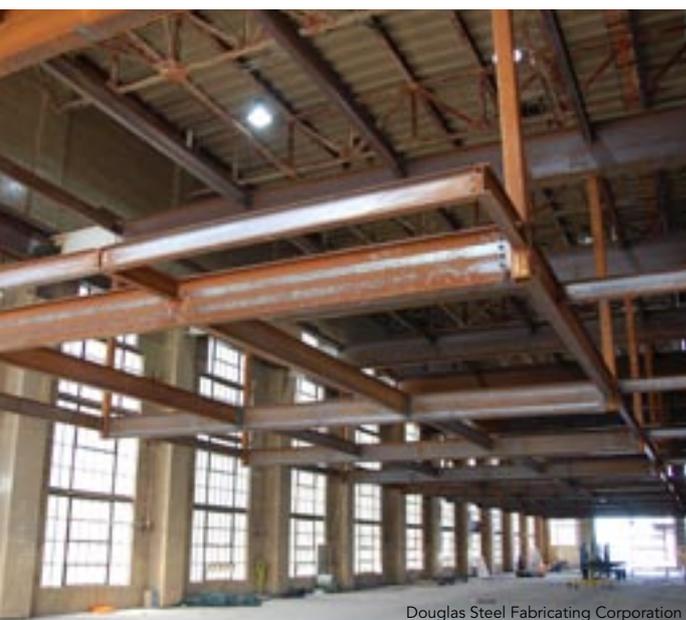
▲ In the turbine hall, new steel for the fourth floor was attached to the crane rail. The third floor steel was then hung from the bottom of the fourth floor steel.

Erection of the steel in the turbine hall area presented an additional challenge. The turbine hall was basically constructed as a lean-to type structure. It had a much lower roof than the balance of the building and only needed to have a third and fourth floor installed in this area. To complicate the matter, the existing turbine crane, crane rail and crane girder needed to remain in the structure for historical reasons. The final design required that the fourth floor steel be attached to the lower portion of the crane girder and the third floor steel be hung from the bottom of the fourth floor steel.

The method used to erect the steel was to unload the trucks at the north end of the building, hoist the fourth floor beam through the large door in that area, then travel to the south end of the building and set the member in place. The third floor beam that hung below the fourth floor beam was then set. That procedure was followed for each of the beams, working from south to north. After the last beam was placed, the custom crane was removed

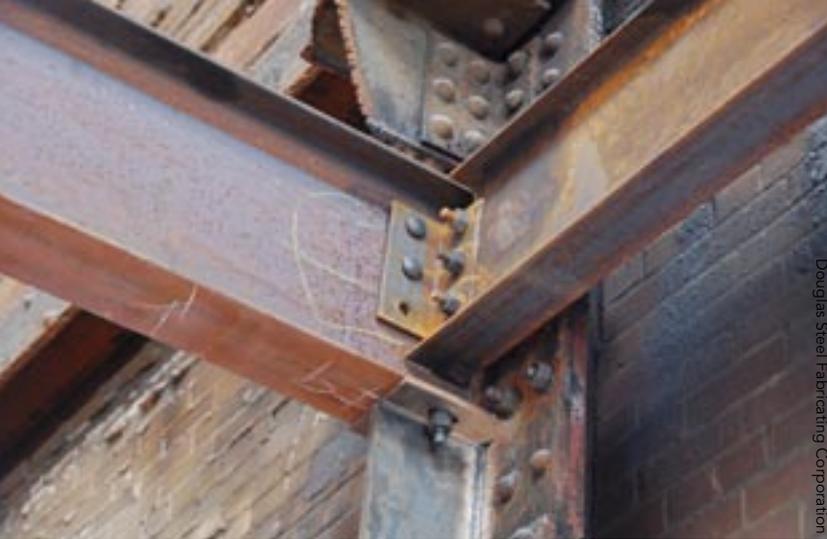
▲ In this connection carefully removed rivets were replaced by bolts as part of the new connection. Also note the slotted hole in the beam seat.

The existing member was removed by carefully removing the rivets in the web of the beam, then inserting a shear plate into the gap between the existing angles. The erection drawings indicated the dimension to be held from hole to hole in the new shear plate. The shear plate was then welded to the existing connection angle and the beam could be erected.

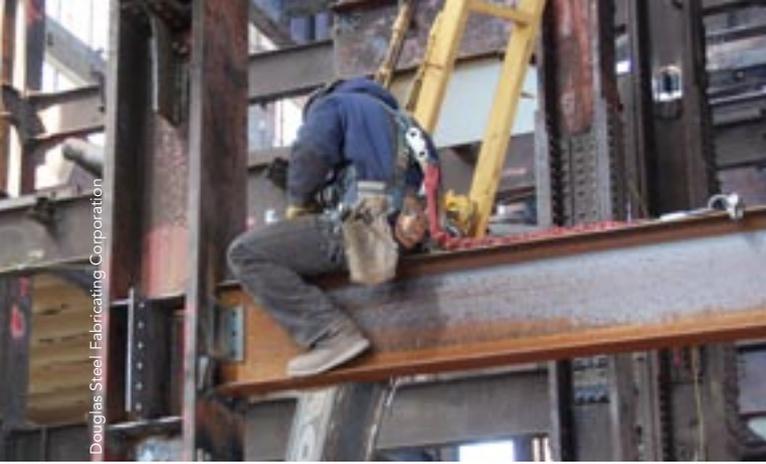
▲ Connection design often was complicated by the close proximity of existing steel and connections. Note the slotted holes in the shear plate attached to the column web. To see more photos of this project, visit www.modernsteel.com/photos.

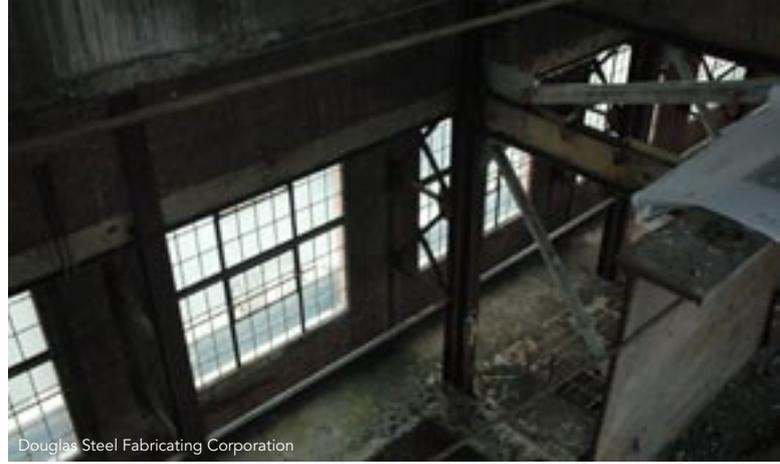
▲ The power station's steel framing and grate floors were designed to fit around generators, turbines and boilers, providing access for operations and maintenance. Much of the facility sat unused for a quarter century before the renovation began in 2008.
