The Brooklyn Bridge:

First Steel-Wire Suspension Bridge

BY JIM TALBOT

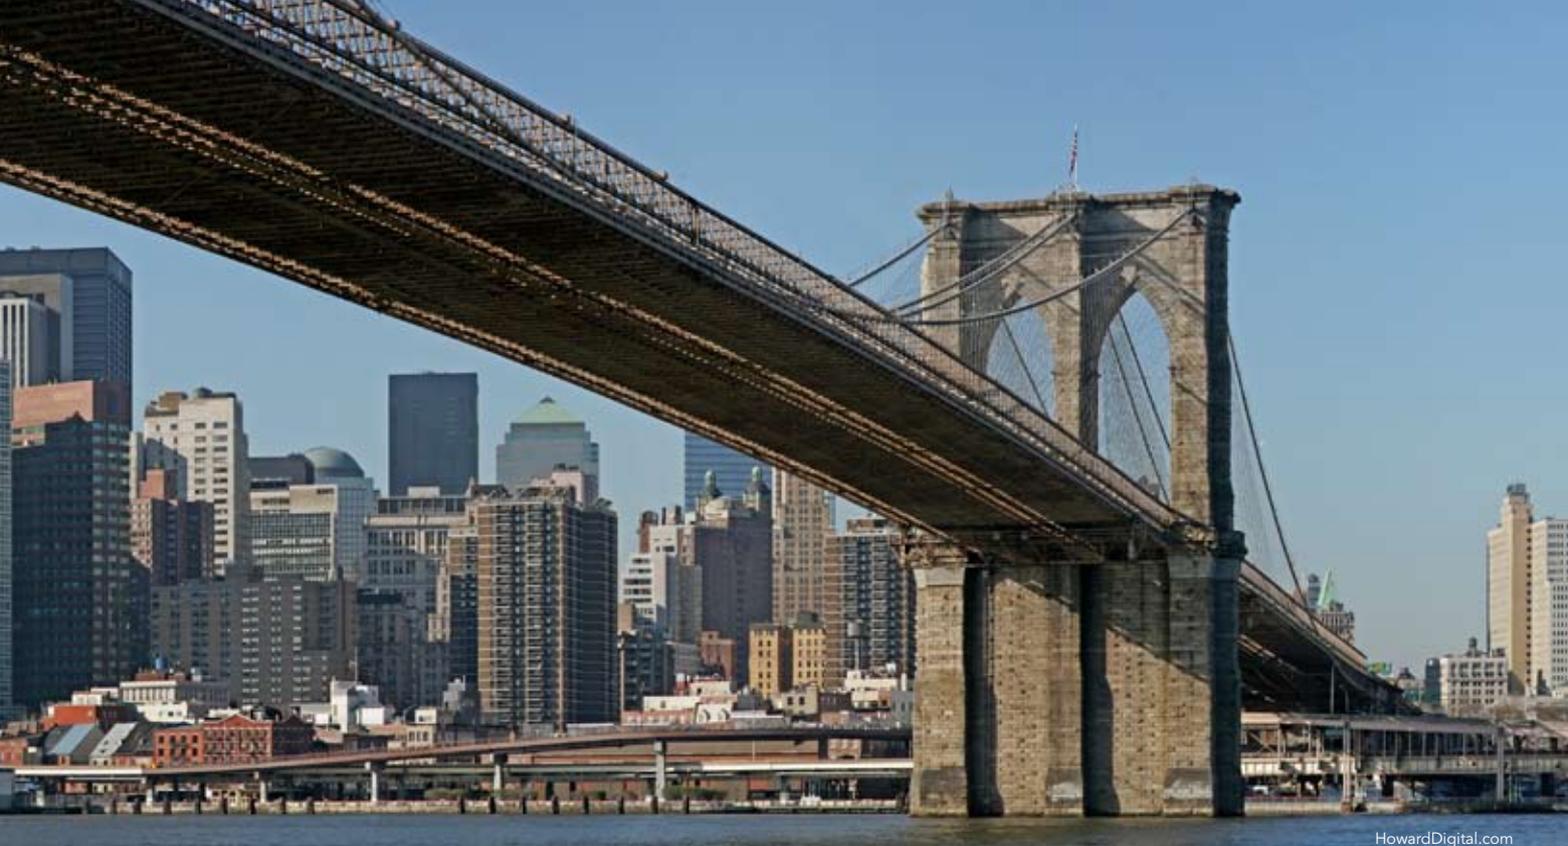
- ▲ The Brooklyn Bridge, which today carries an estimated 145,000 vehicles per day, was built at a time when the tallest building in New York was only 5 ft taller than the bridge's 276.5-ft towers.
- ▶ The 85-ft-wide main deck of the Brooklyn Bridge had a pair of rail tracks for passenger trains down the center flanked by lanes for coaches and a pedestrian promenade. Pedestrians paid a 1 cent toll on opening day and 3 cents thereafter. The vehicle toll was 5 cents. By 1884, a year after the bridge opened, 37,000 people a day were using the Brooklyn Bridge to cross the East River.
