Adding steel cross braces to stiffen tall concrete piers made isolation bearings an effective seismic solution.

# Seismic Retrofit of the Antioch **Toll Bridge**

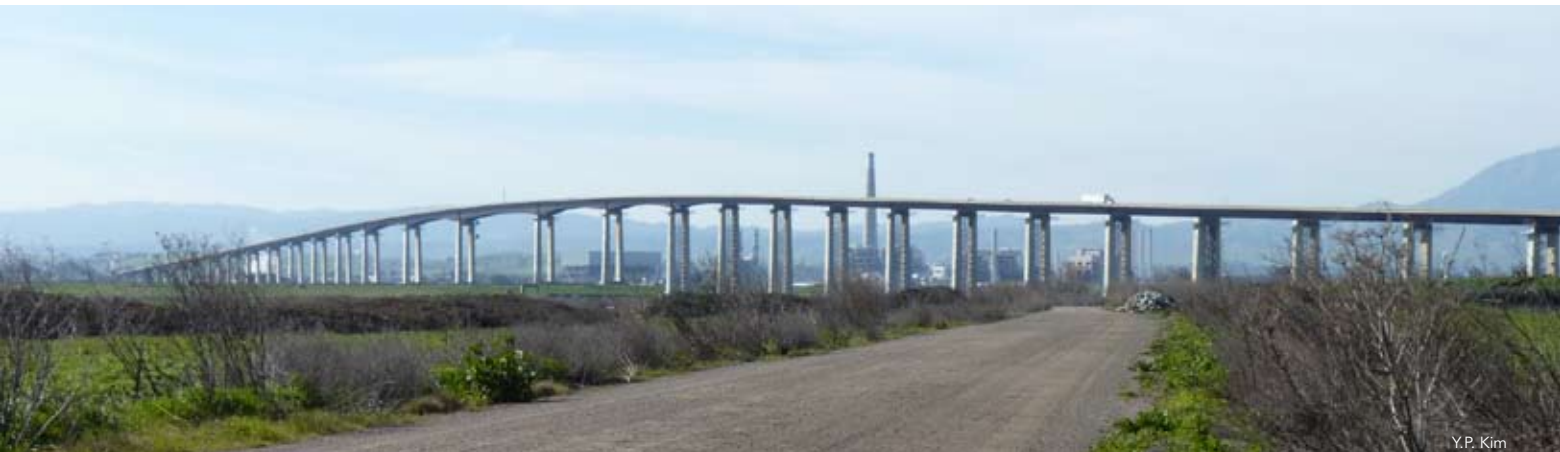
▲ Steel braces were added to stiffen the columns of the 20 tallest piers as part of a seismic retrofit on the Antioch Toll Bridge over the San Joaquin River in Northern California.

Steel braces were added between the columns for 20 of the tallest piers in the mid-portion of the bridge, which range in height from 82 ft to 147 ft. The piers consist of portal frames with two hollow concrete columns linked by a hollow concrete bent cap. Because the original, unbraced frames were flexible under lateral loading, it was necessary to make them stiffer for the isolation bearings to be effective. Accomplishing this through the use of bracing also reduced the seismic loading in the columns. Steel braces were the obvious solution, because of their

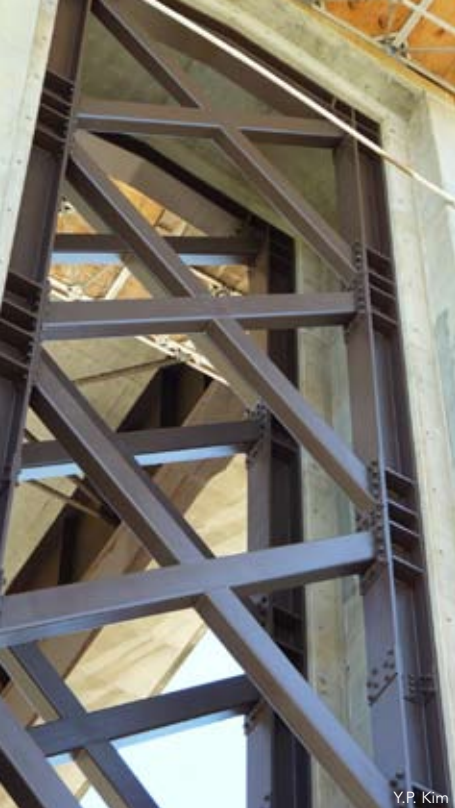
- ◀ **Far left:** The main diagonal cross braces are rectangular HSS welded at the cross joints.
- ◀ **Left:** All frames were trial fit in the Brooklyn Iron Works shop.

The main diagonal cross braces consist of HSS 12x8<sup>3</sup>/<sub>8</sub> welded at the cross joints. There are two sets of bracing per pier. Each set of braces aligns with the webs of the hollow columns in the transverse direction to make the concrete and steel bracing work integrally in resisting shear. The cross braces are connected on each side to vertical W14x211 wide-flange beams, ASTM A709, Grade 50W, which in turn are connected to the columns through a

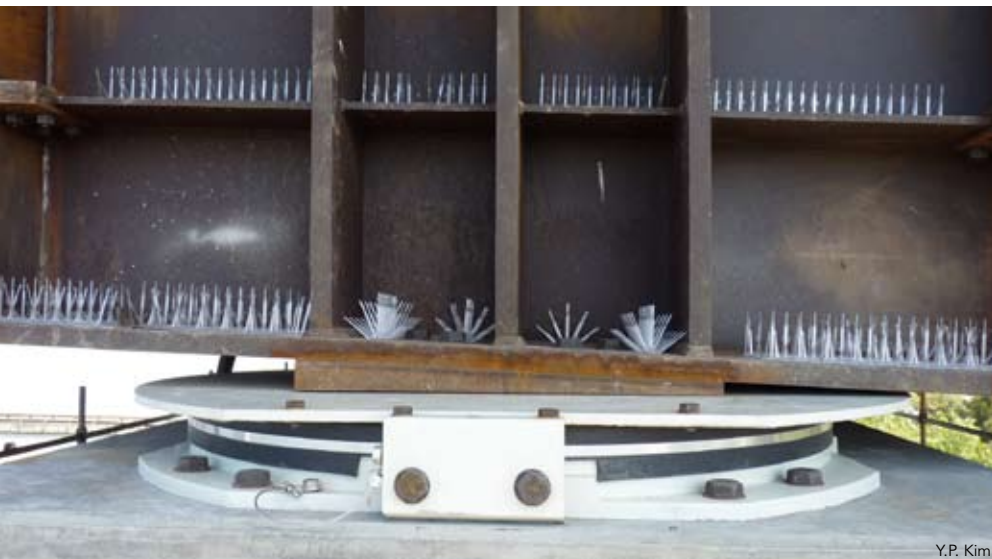
- ▲ Allowance had to be made for the bevel plate above the isolation bearing in addition to the thickness of the bearing itself.

Even though relatively thin bearings were selected it was still necessary to remove some existing concrete at the top of the bent cap to accommodate the bevel plate over the bearing and the grout pad underneath and still keep the same vertical profile of the existing bridge deck. This was accomplished by using a cable saw to cut and remove as much as 4.5 in. of the top of the existing concrete bent caps. Because this process either cuts through the exiting top transverse bent cap reinforcements or weakens their bonding, additional post-tensioning was installed in transversely cored holes and lightly stressed. This will preserve the moment capacity of the bent cap. Even though some of the bent caps were up to 32-ft wide, coring through them could be achieved fairly accurately.

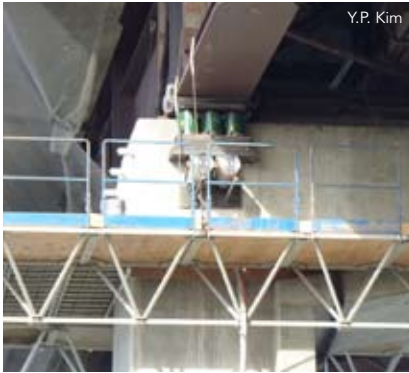
▲ Steel cylinders inserted through holes cored in the pier cap provided a base for hydraulic jacks, which lifted the girders to allow replacement of the original bearings with isolation bearings.

Jacking of the girders was carried out with live traffic on the bridge deck. Only temporary road closures were necessary when lowering the bearings from the deck. A maximum of 1/2 in. of lifting of the girders was necessary to release the existing bearings. On many of the piers the jacking system was supported on two solid steel cylinders that were inserted into holes cored in the concrete bent cap. Simultaneous jacking was carried out at four points on each pier to unload the existing bearings.
