conference preview

RETROFIT MEASURES FOR DISTORTION-INDUCED FATIGUE

BY TEMPLE RICHARDSON, FATIH ALEMDAR, CAROLINE BENNETT, PH.D., ADOLFO MATAMOROS, PH.D., AND STAN ROLFE, P.E., PH.D.

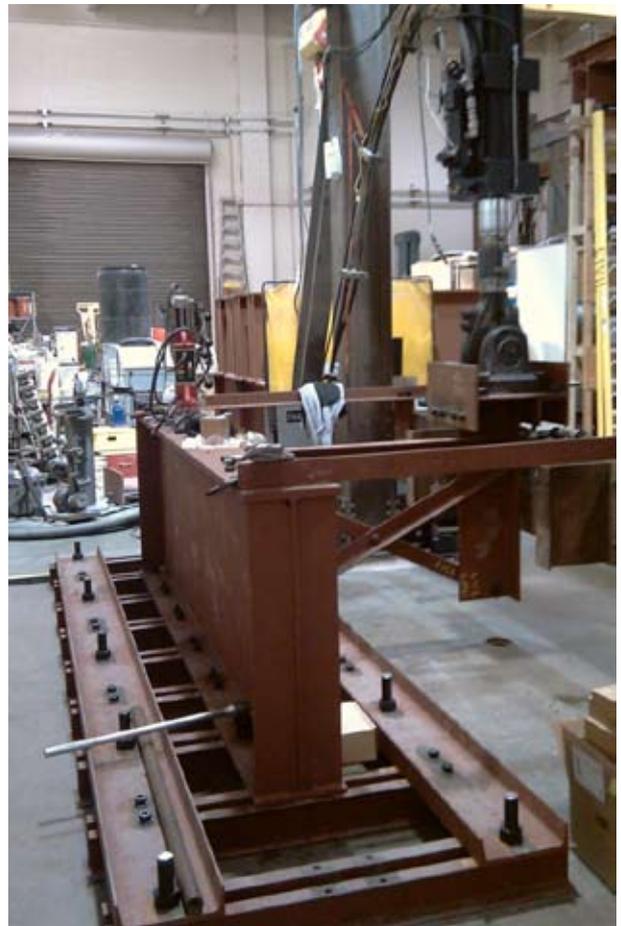
► Fig. 1: View of physical test setup.

restrained from lateral motion as it occurs in the top flange of a bridge girder made composite with a concrete deck (see Figure 1). Specimens were tested cyclically using load control, with loads applied by an actuator connected to a cross-frame assembly with a maximum load of 4.6 kips (tension) and a minimum of 0.8 kips (tension). The specimen and loading apparatus were modeled closely using the finite element analysis (FEA) software ABAQUS v6.10 (the model is shown in Figure 2). Cracks were explicitly simulated in some of the finite element models. The hot spot stress technique was used to quantify the stress demand near welds. The two fatigue-vulnerable details of particular interest were the connection stiffener-to-web weld and the web-to-bottom flange weld.
