A Bridge in Building's Clothing

A community college conceives a creative crossing to connect its campus.

Onondaga Community College decided to do both—but in one structure—and is in the process of completing an \$18.9 million, 45,000-sq.-ft “bridge building” across the foliage-filled Furnace Brook Gorge, a 60-ft-deep fissure that divides its campus in Syracuse, N.Y. The gorge was, in fact, previously spanned by a bridge, but one that was open to wind, rain and snow. The new building will provide a protected crossing over the gorge—particularly enticing during the area’s harsh winters. In addition, the two-story structure makes use of otherwise unusable land. And by avoiding underground rerouting of elements such as sewer lines and electrical conduits, which would have been required with the original proposed building location, it was achievable within the college’s original budget.

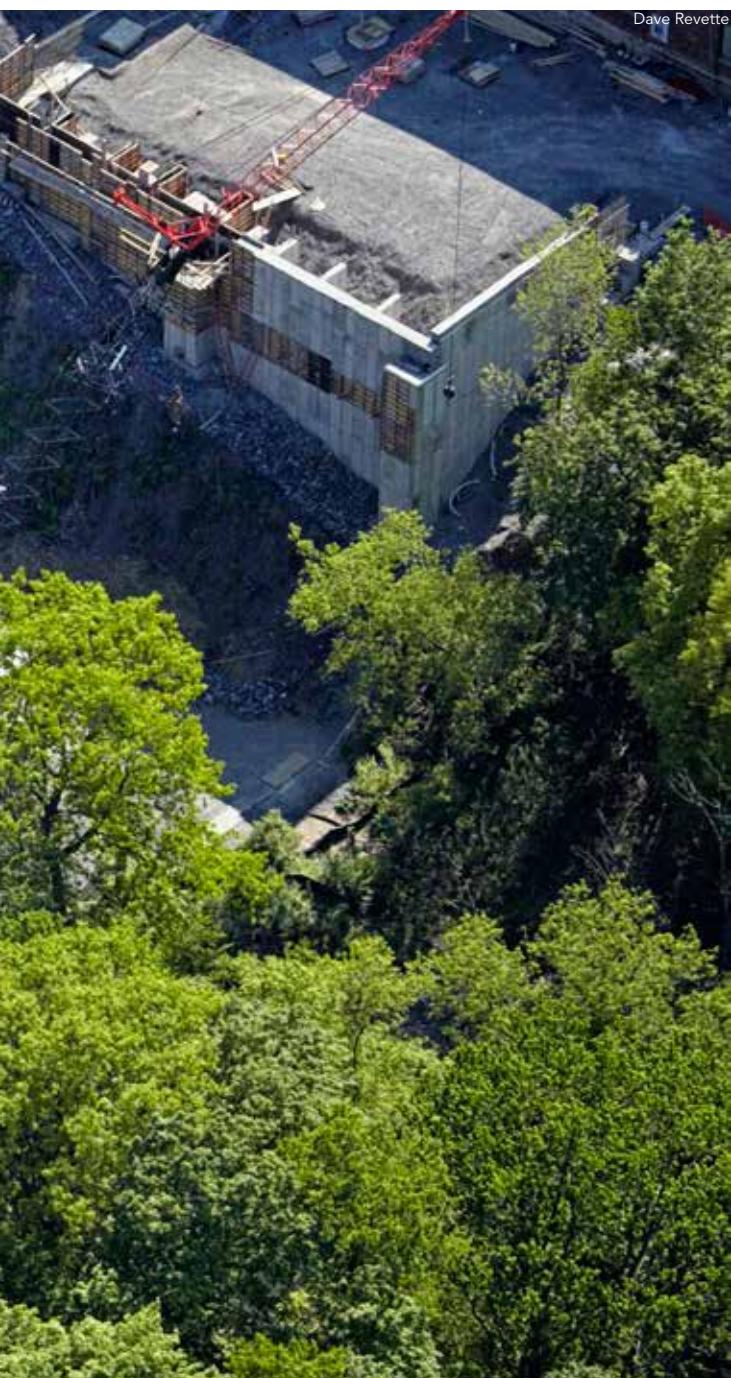
- ▲ Lift and installation of truss 1.
- ◀ The construction team built a temporary single-support steel tower in the middle of the gorge, allowing the trusses to be erected in two halves and spliced in the middle.
- ▼ A top truss cord gusset connection.

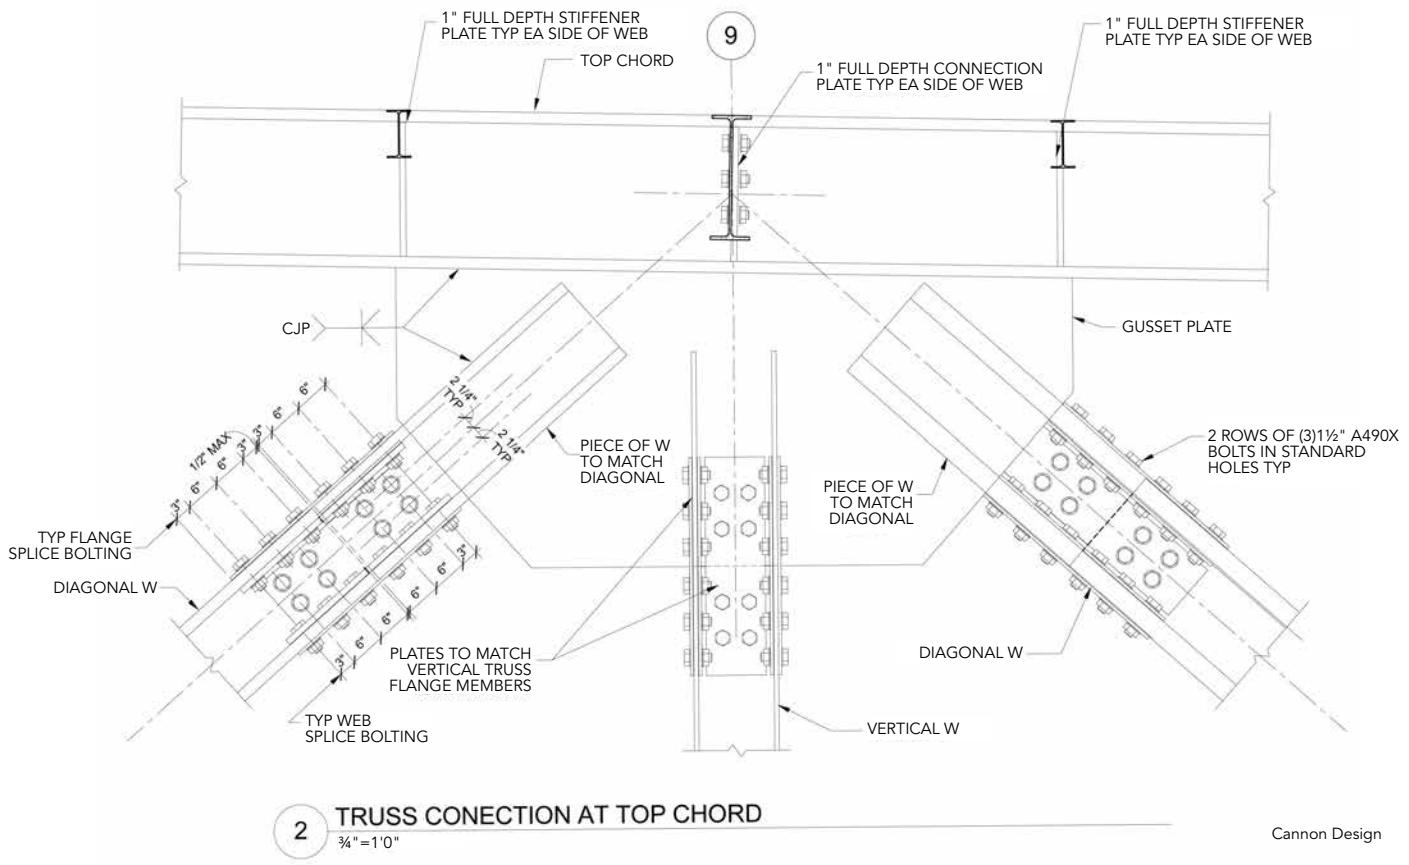
▲ A detail of a top truss chord connection.

Besides the unique construction area and balance issues, bolting also posed a challenge. During steel fabrication, the team learned that the 1½-in. A490 bolts specified in the design had a tendency to fail if they were installed by turning the head end of the bolt rather than the nut end. In the building's design, however, the bolts were an architectural feature specifically designed to be installed in one direction—via rotation of the bolt head. And because the bolts

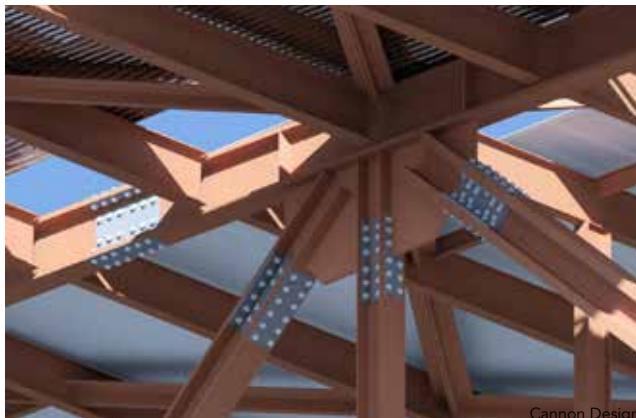
▼ A truss connection as a Revit model...

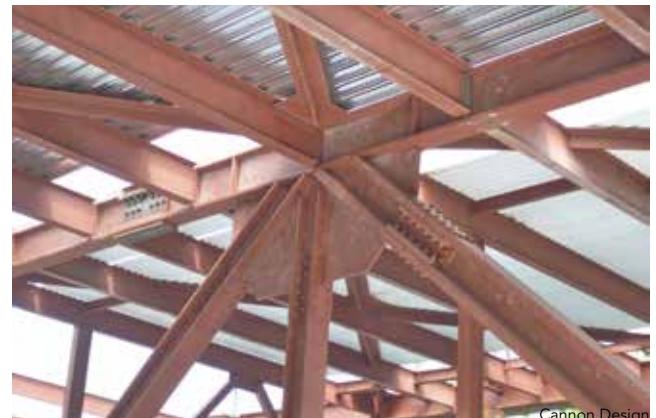
▼ ... and as-built.

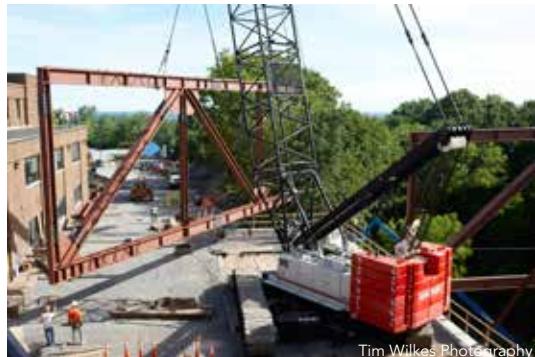
▼ Lift and installation of truss 2.
