A new arch span replaces a historic Iowa bridge and serves as a pilot for a statewide bridge performance-monitoring program.

# Pilot Program

In the case of the Iowa Falls Bridge, which crosses the Iowa River on U.S. Highway 65 in Iowa Falls, Iowa, it had to happen. The bridge, a 235-ft-long reinforced concrete open spandrel deck arch structure (with a 24-ft-wide roadway and 5-ft-wide sidewalks on each side), was built in 1928 and was considered a local landmark. The existing bridge had undergone rehabilitation on seven different occasions, including major ones in 1976 and 2000. However, by 2007, the bridge had become structurally deficient and the costs of repairs and strengthening were deemed high enough to warrant replacing it rather than rehabilitating it yet again.

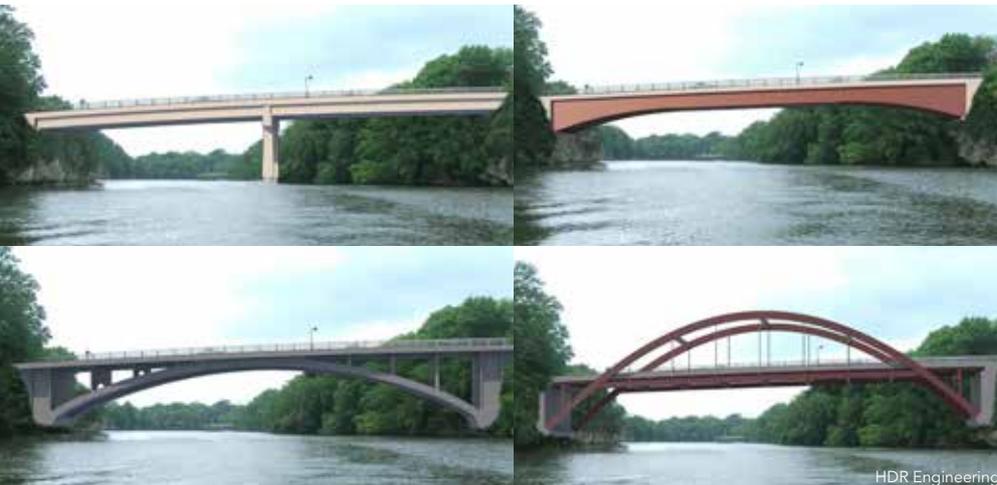
▲ The four bridge alternatives that were considered. Clockwise from upper-left: a prestressed concrete girder, a haunched steel girder, a partial through steel arch (the selected design) and a concrete deck arch.

Iowa Falls prides itself as a scenic town with the Iowa River at the center of its beauty, and is committed to historical preservation; any replacement option that did not fit the desired aesthetics and community expectations would have faced strong opposition. Through a brainstorming session between Iowa DOT and HDR, it was decided that replacement options would be limited to girder and arch type bridges. Four different bridge alternatives were considered and evaluated for cost, timeline for construction, aesthetic value, constructability and impact on the community. The bridge options evaluated were: a prestressed concrete girder, a haunched steel girder, a concrete deck arch and a partial through steel arch.

In an effort to engage the community and solicit opinions on the type of bridge to replace the existing arch bridge, the Iowa DOT held a public information meeting to showcase each of the options considered. The attendees favored the partial through steel arch bridge, and this ended up being the chosen design.

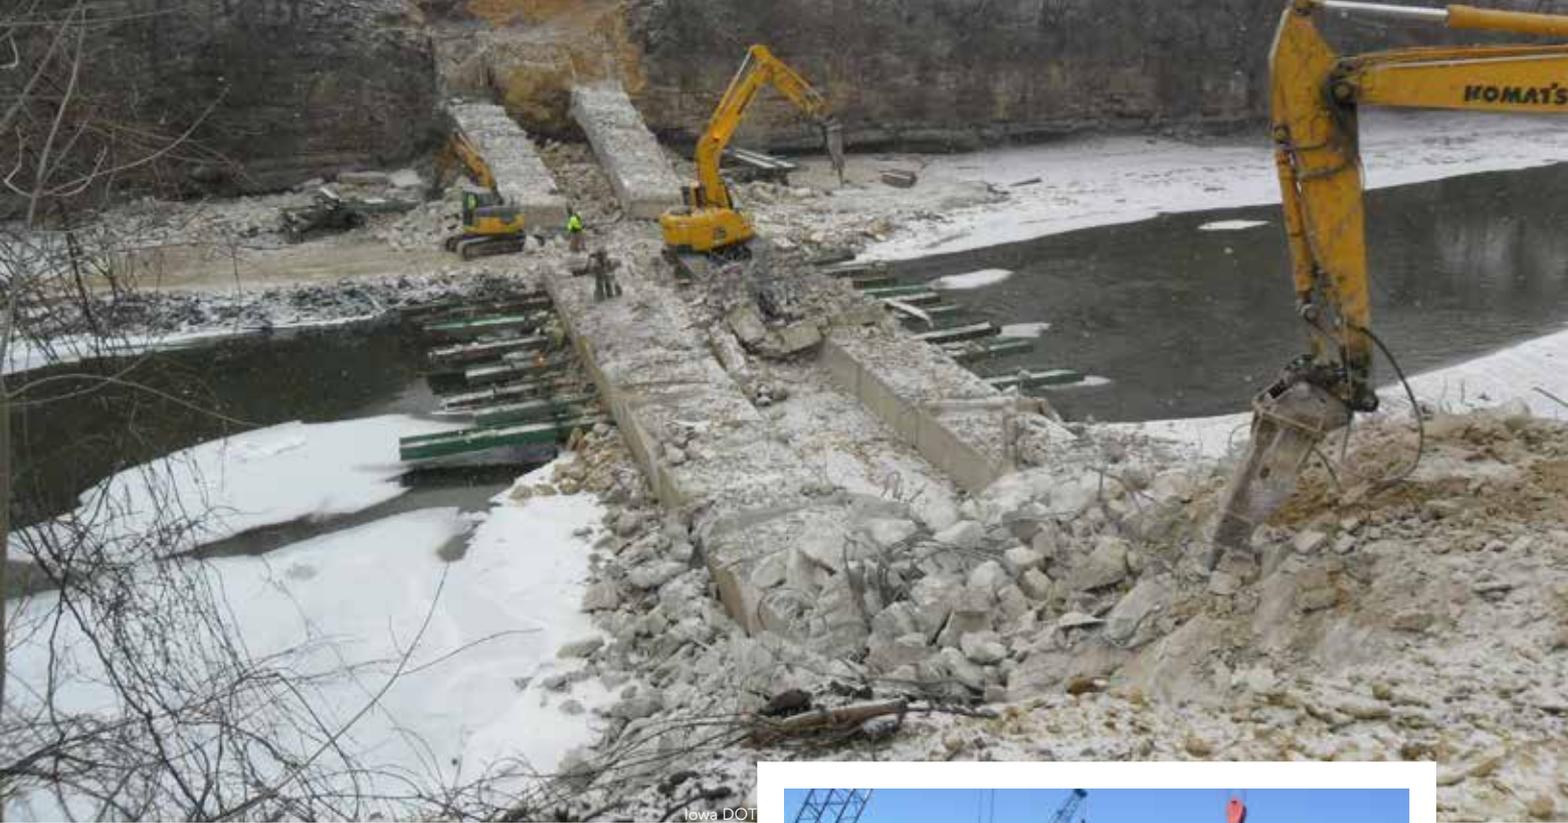
- ▲ Demolition of the existing concrete bridge.
- ▶ Erection of the new steel bridge.

The steel erection began with the placement of the south bearings. Using falsework towers in the river, the first two segments of the arch were erected from both sides of the river. The falsework towers were designed to allow the segments of the arch to be adjusted vertically to facilitate the setting of the crown section. After both arch ribs were erected along with the end floor beams, lower cross bracing and the cross struts, the contractor started erecting the floor system. The floor system was erected in a panel-by-panel method from south to north. The new bridge used 835 tons of structural steel in all.
