A structural rehabilitation keeps the heart of Elmira College beating.

CAMPUS Revival

COWLES HALL is at the center of Elmira College's campus. But at one point it was the entire campus.

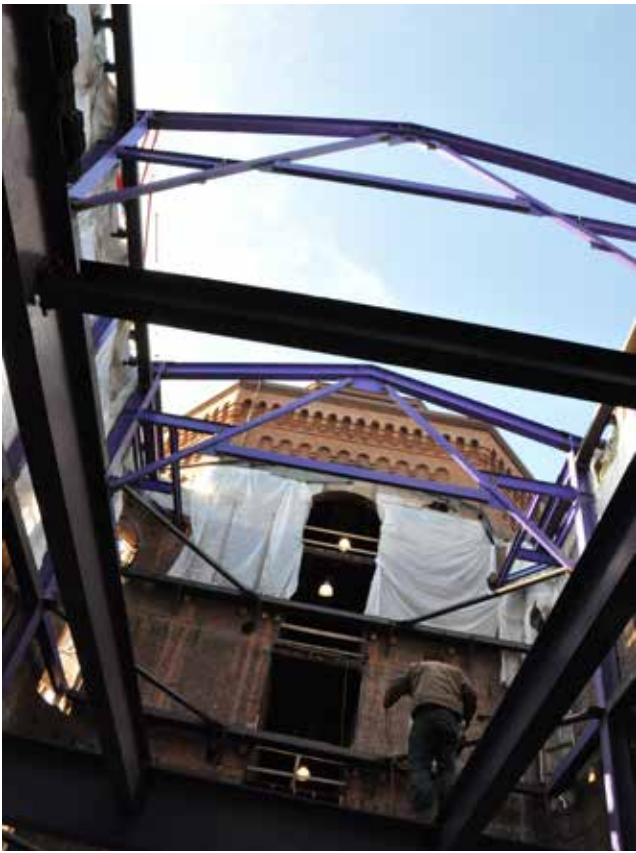
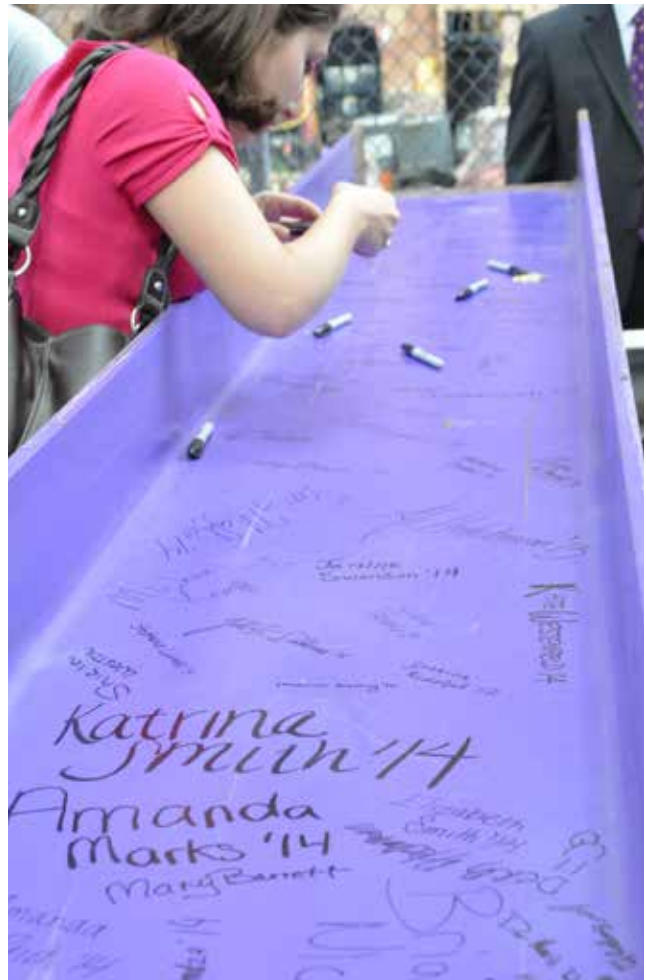
- ▲ Reinforcing old with new.
- ◀ Framing for the central Remembrance Hall.
- ▼ The four-story, 3,345-sq.-ft chapel.

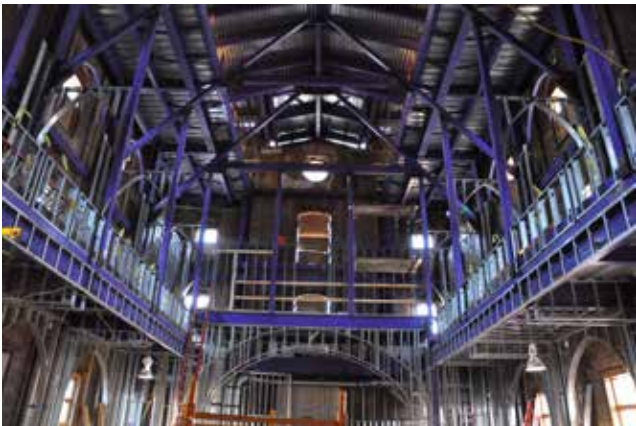
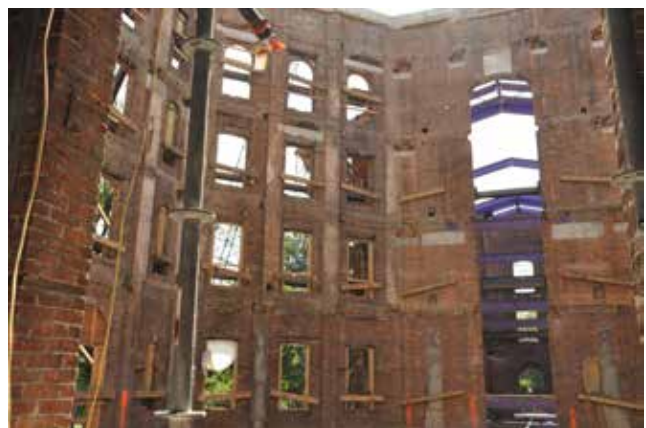
- ▲ Signed steel painted Elmira College purple.
- ▼ Cowles Hall, hollowed out.

At no extra cost to the owner, the steel was primed purple, the college's principal color. Intumescent paints were used on the ground-floor interior columns to provide an efficient fire-resistant barrier to enable the columns to be wrapped in oak while maintaining a minimal size. New steel beams installed to support the new elevated concrete floors ranged from W12×35, W14×26 and W14×30 to W18×60, W18×76 and W18×86.

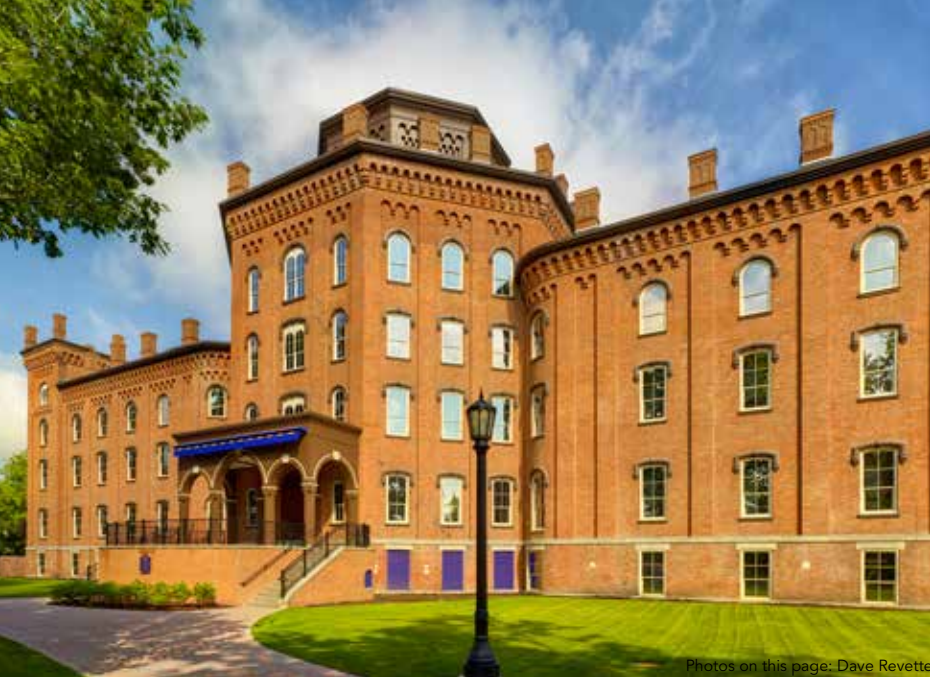
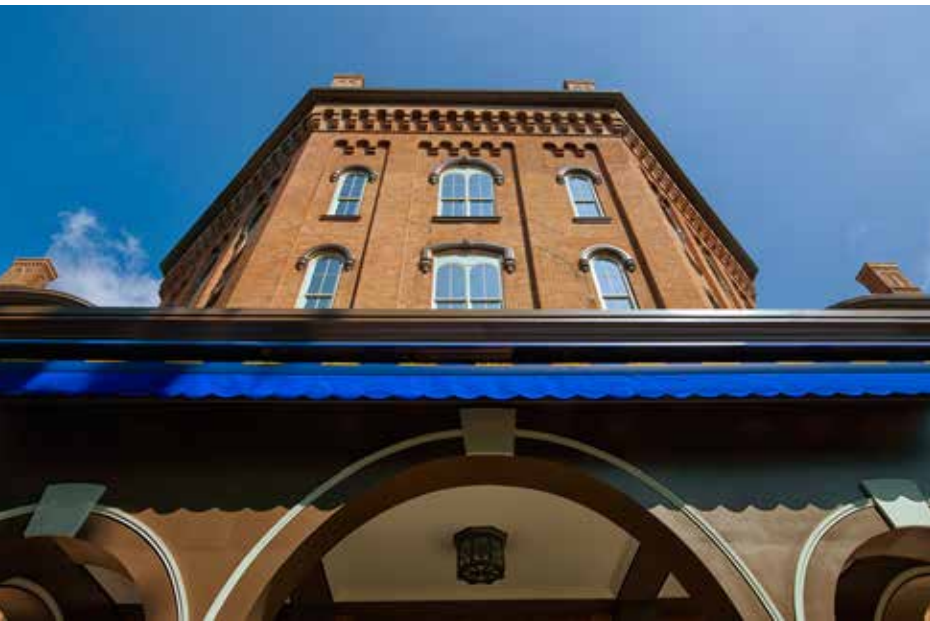
▲ ▼ A temporary interior structural wall stabilization system was coupled with a temporary exterior structural wall stabilization system on the five-story octagon. Once stabilized, teams were free to build the elevated deck back up from the ground level.

A temporary interior structural wall stabilization system was used and coupled with a temporary exterior structural wall stabilization system on the five-story octagon. Once securely stabilized, teams were then free to build the steel-framed elevated deck back up from the ground level. After the completion of each level, the bracing steel from the elevation below was removed and modified for reuse on the next level. Once the interior steel framing and concrete were completed, the outside of the existing field stone foundation wall was excavated and encapsulated with a new concrete foundation wall and post-tensioned steel rods to ensure that it would maintain its bearing. Today, the brick walls carry only their own weight, and the rest of the building relies on the new steel structure built within.

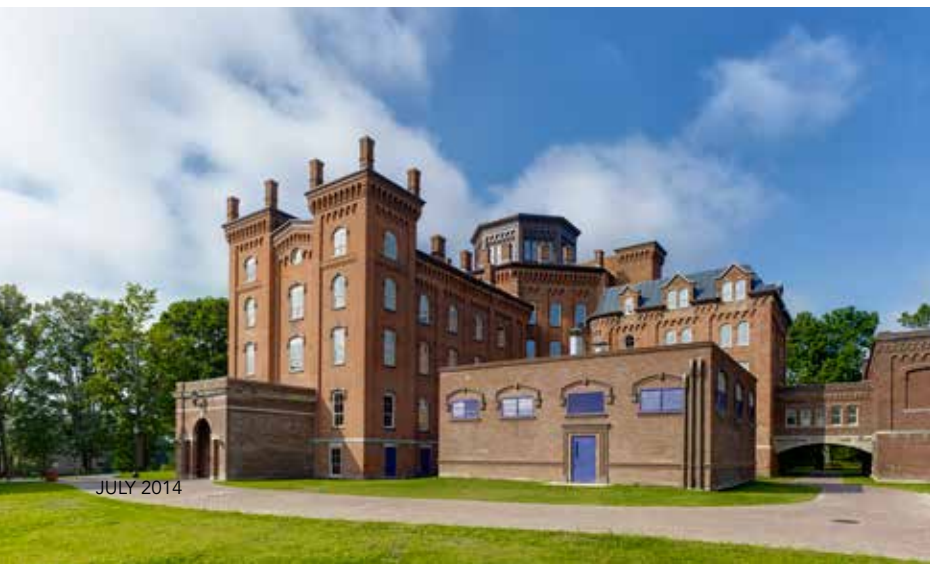
▼ Today, the brick walls carry only their own weight, and the rest of the building relies on the new steel structure built within.
