# Improved and NEW

A suburban Chicago high school improves its swimming facility with a mixture of new framing and spot reinforcement of existing framing.

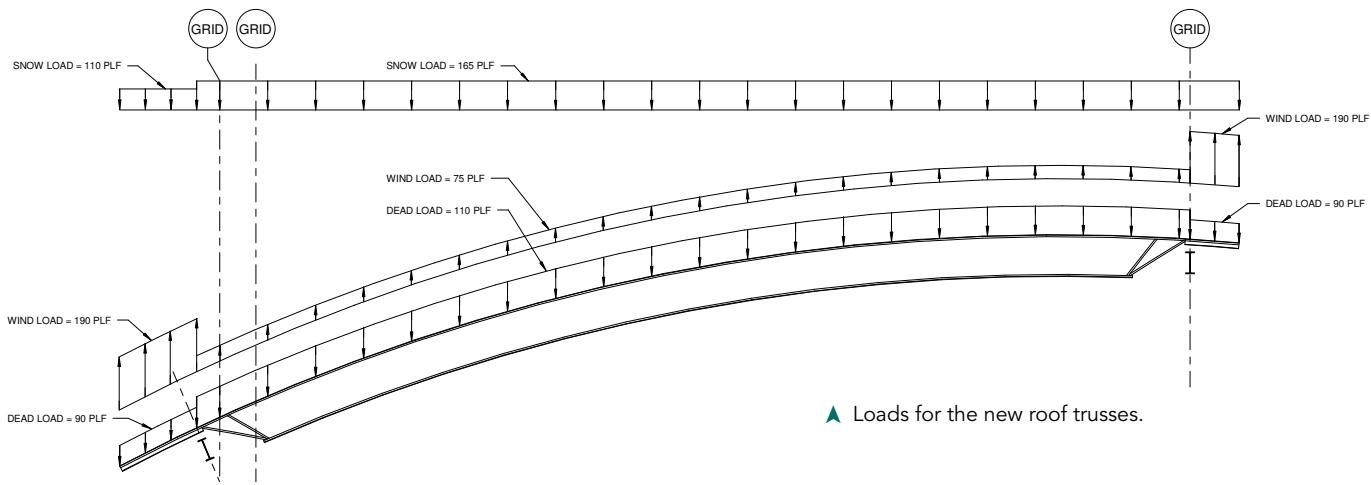
- ▲ The new roof joists are 52 in. deep and 101 ft long.  
◀ Joists being attached to joist seats.

Steel joists (52 in. deep and 101 ft long) were chosen to support the curved roof as they economically provided the light and airy feeling that the architect was trying to achieve and were easy to fabricate in the curved shape. However, the curved shape also dictated that the joists needed to be designed as pinned on one side and as a roller on the other side. This was due to horizontal deflection of the arched chords under dead and snow load, which was calculated to be around 1¼ in.

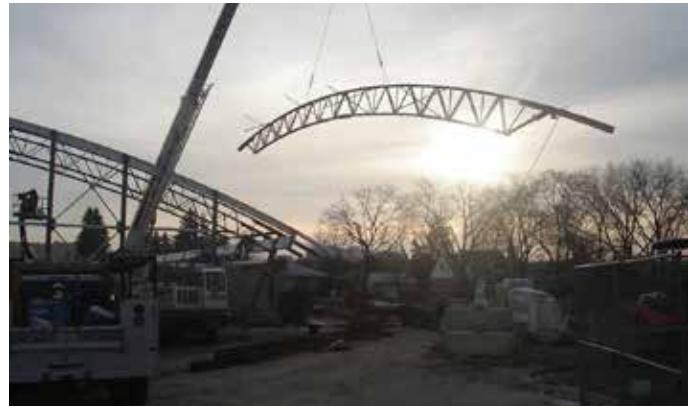
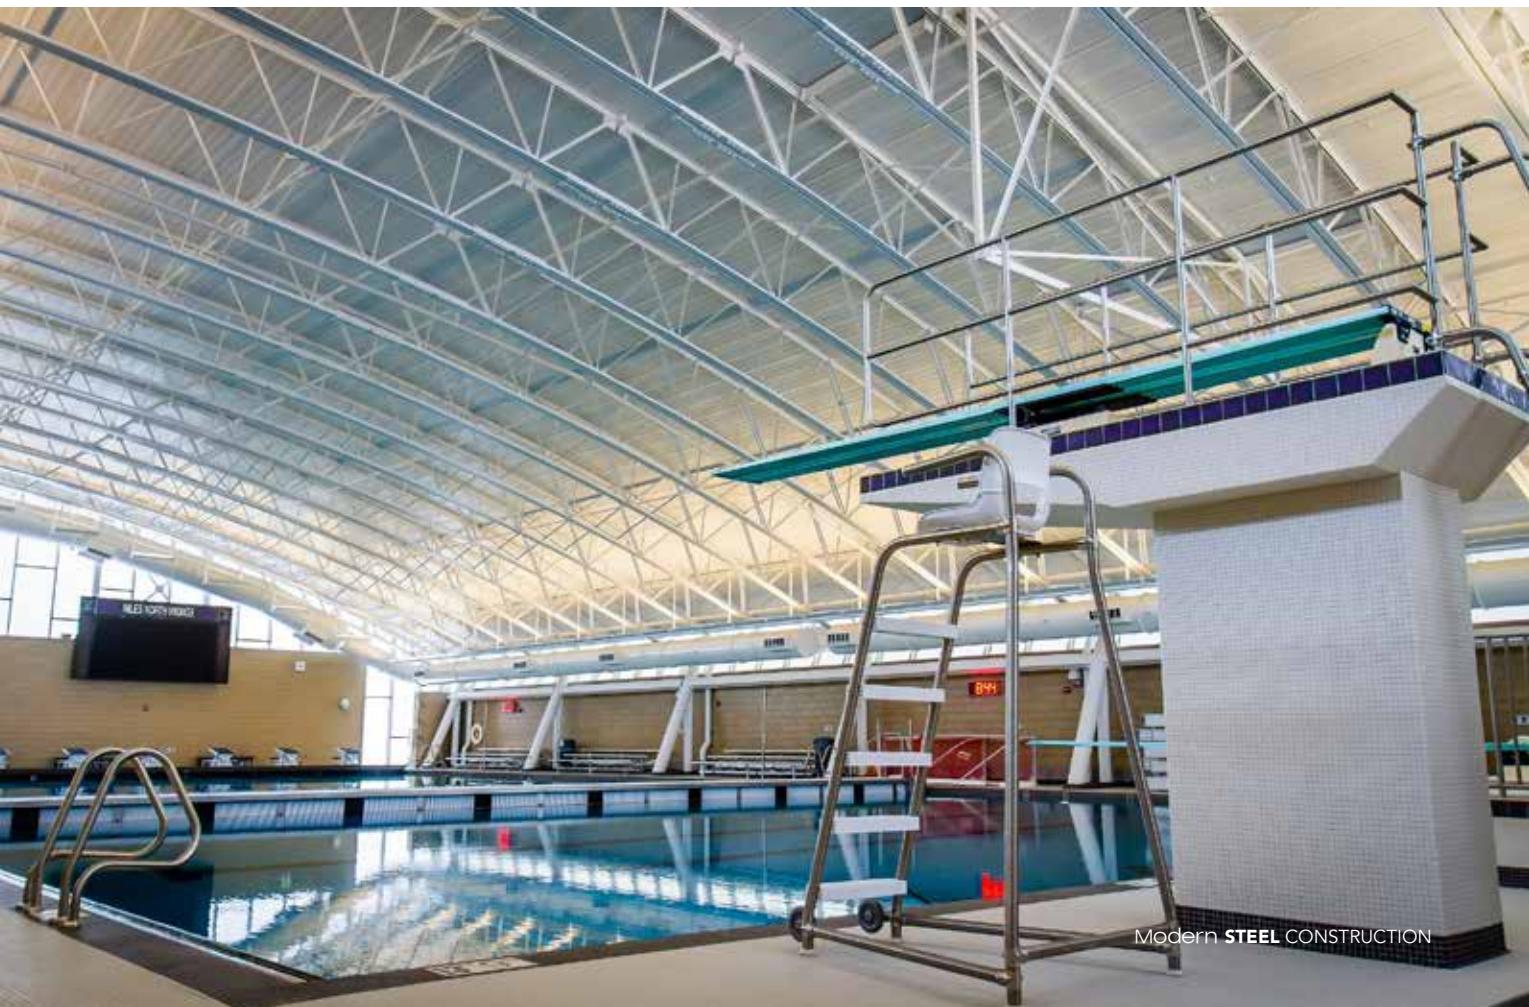
- ▲ ▼ The new pool addition is distinguished by its curved ceiling—one story high at one end and two stories high at the other to accommodate seating and capture natural daylight.

The new pool addition is distinguished by its curved ceiling—one story high at one end and two stories high at the other to accommodate seating and capture natural daylight (the sloped roof also reduces the volume of the addition to decrease demands on the mechanical system). Legat Architects was able to achieve the height needed to accommodate the spectator seating and three-meter diving board along the north side of the addition, while reducing the height (where it is not needed) for the athletic seating along the south pool deck. On the south side of the building at the low end of the curved joist, the roof also overhangs the sidewalk on the exterior to provide shading and canopy coverage for students and staff on the sidewalk.
