A simple skylight retrofit in a Manhattan high-rise becomes a complete roof overhaul.

TOP Heavy

BY MARCO SHMERYKOWSKY, P.E.,
AND ANDREW STEINKUEHLER

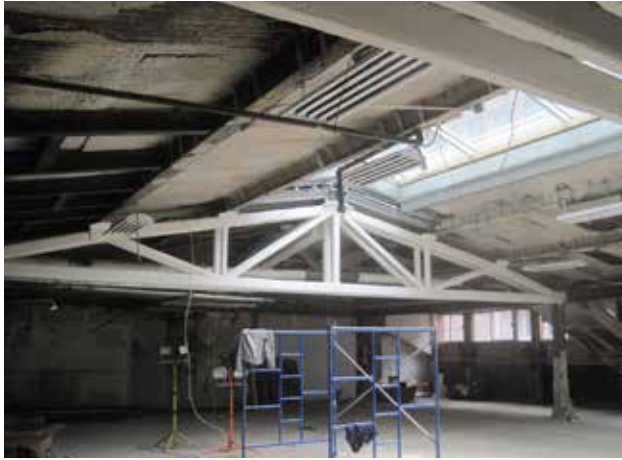
< ▲ The central roof structure consists of a standard pitched roof with the main ridge spanning in the east-west direction, and the “hips” of the roof are located on the east and west ends of the main ridge. The structure consists of a metal roof deck spanning between W8 purlins, and the purlins for the main roof span between two roughly 39-ft-long trusses supported on building columns; the original trusses had a depth of 6 ft at mid-span.

The project took place on the building's 18th floor, below the roof level. The central roof structure consists of a standard pitched roof with the main ridge spanning in the east-west direction, and the "hips" of the roof are located on the east and west ends of the main ridge. The structure consists of a metal roof deck spanning between W8 purlins, and the purlins for the main roof span between two roughly 39-ft-long trusses supported on building columns; the original trusses had a depth of 6 ft at mid-span. The roof hips connect to the main ridge purlins approximately 7 ft away from the main trusses, and the support for this connection point is created by the cantilevering of the ridge beam past trusses.

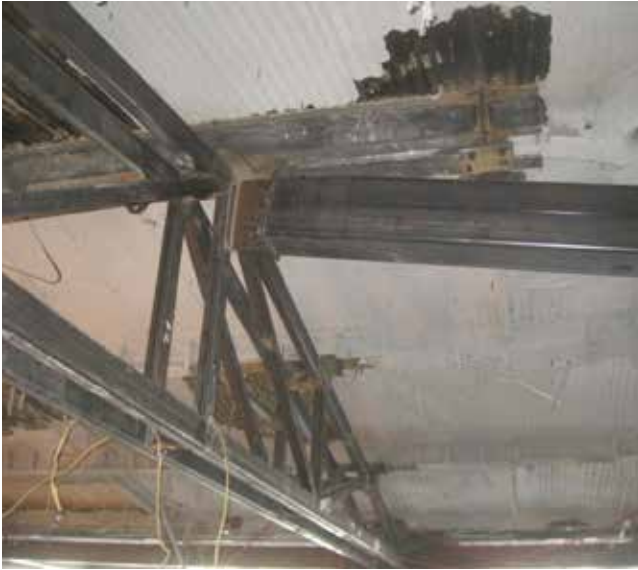
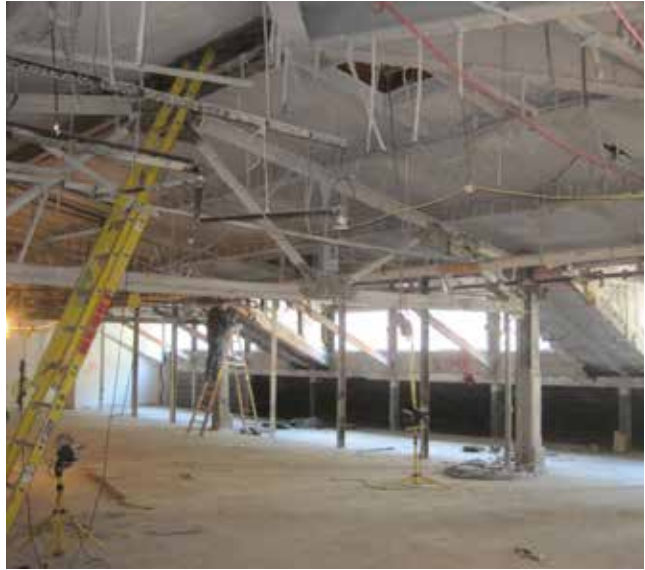
▲ ▼ At some point during the life of the building, three dormers were added to the original sloped roof area. The original structure consisted of cinder-crete slabs, shallow beams and posts down to the floor below, and the main framing bay between building columns was approximately 26 ft wide. Within each of these bays, the original purlins were located 8 ft, 9 in. on center.

At some point during the life of the building, three dormers were added to the original sloped roof area. The original structure consisted of cinder-crete slabs, shallow beams and posts down to the floor below, and the main framing bay between building columns was approximately 26 ft wide. Within each of these bays, the original purlins were located 8 ft, 9 in. on center.

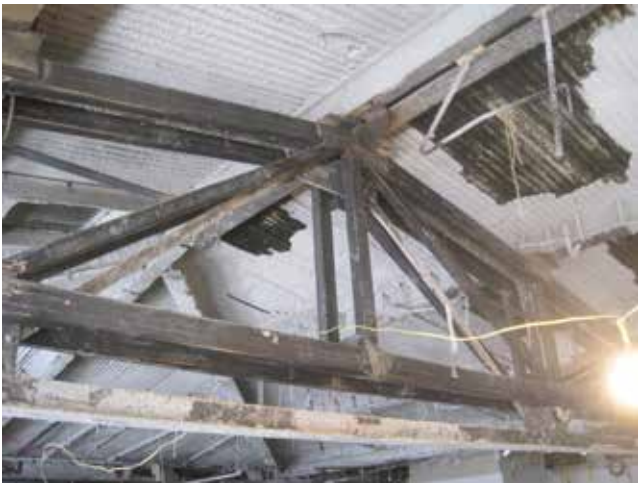
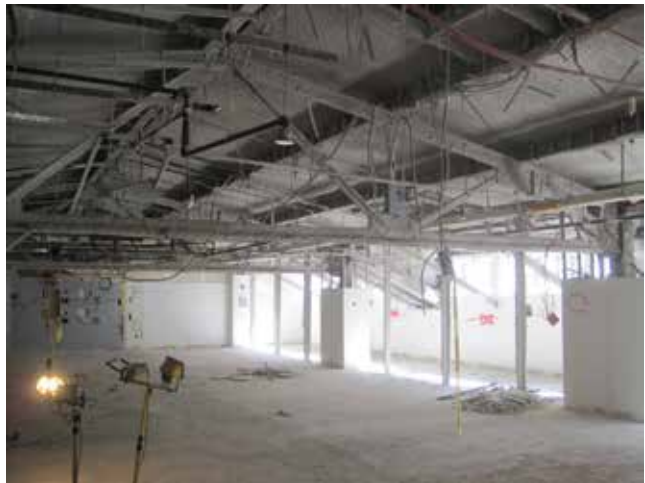
▲ ▼ The skylight also required an additional support structure that would work as an independent framing system and would be located above the roof deck surface. A box frame constructed of HSS12x8 and HSS12x4 members was developed by the engineers and arranged so that the new frame would bear on a total of eight support posts, which were coordinated with the roof purlins below.

The skylight also required an additional support structure that would work as an independent framing system and would be located above the roof deck surface. A box frame constructed of HSS12×8 and HSS12×4 members was developed by the engineers and arranged so that the new frame would bear on a total of eight support posts, which were coordinated with the roof purlins below. Small spans of deck there originally spanned to the ridge purlins were re-supported by ledge angles as required.

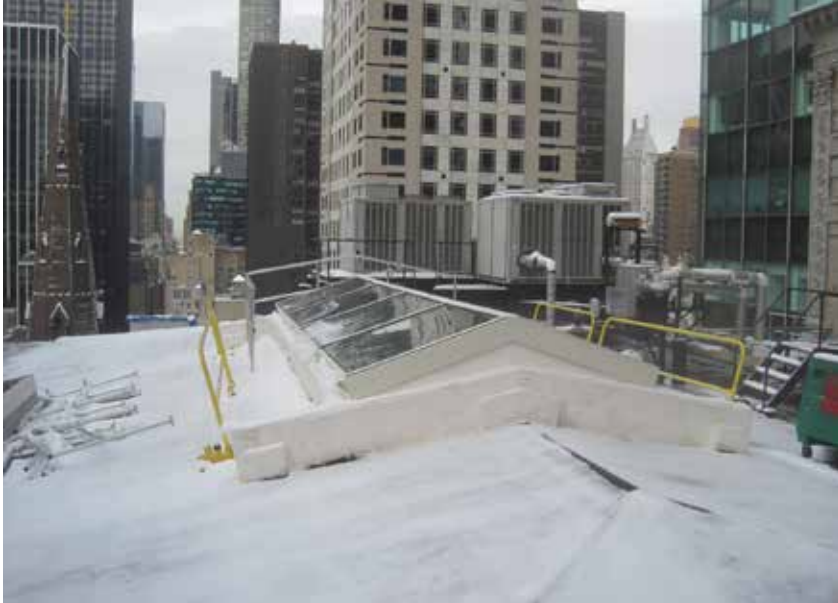
◀ An exterior view of the 25-ft by 8-ft skylight.

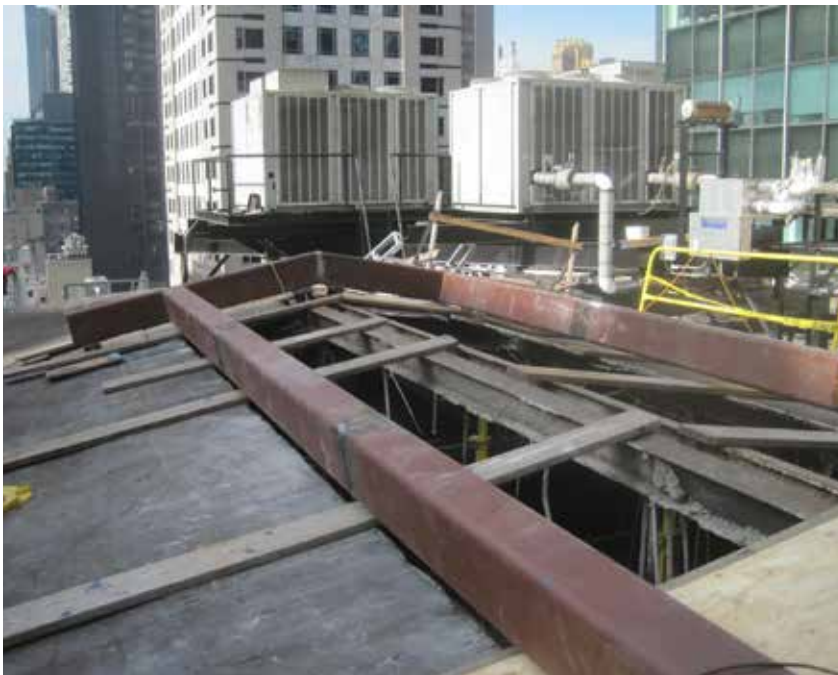
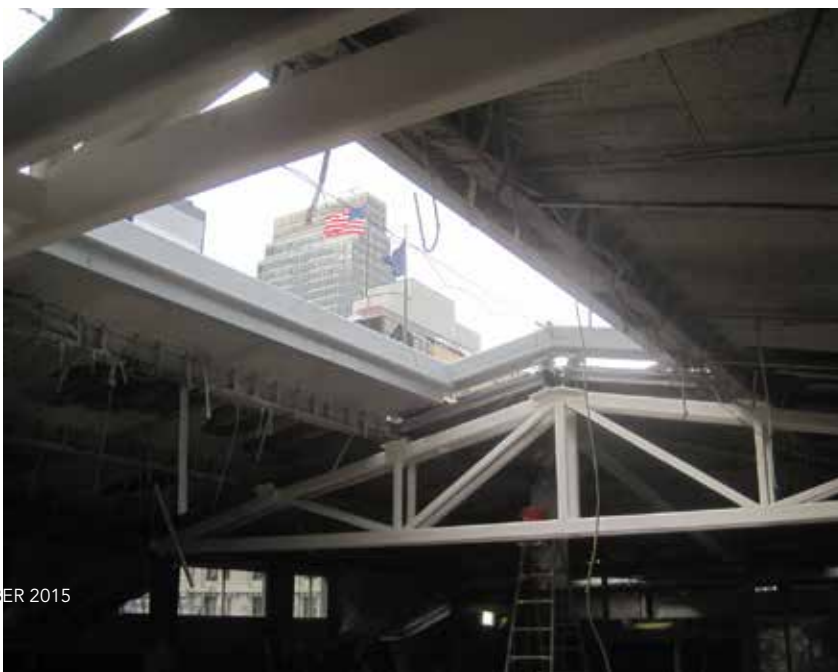
▲ ▼ The structural team decided to support the roof hips with new ridge beams that would span between existing building columns, which were conveniently located at the center of each roof hip's base as well as at the center of each exterior truss.

After careful consideration, the structural team decided to support the roof hips with new ridge beams. These ridge beams would span between existing building columns that were conveniently located at the center of each roof hip's base as well as at the center of each exterior truss; the new beams were simply supported.
