# On the Fast TRACK

How to plan and prepare for what-ifs when constructing a rapid-replacement rail bridge.

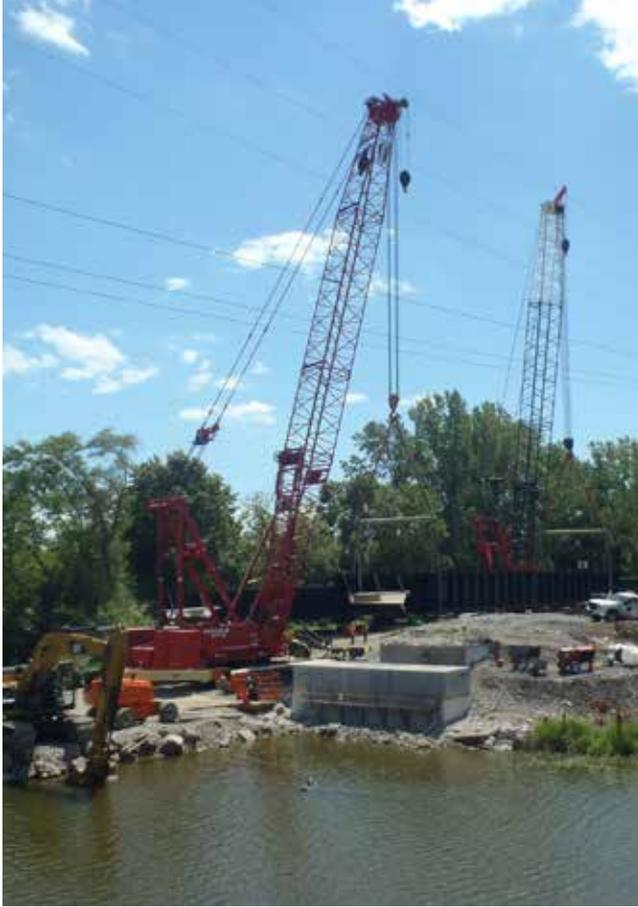
- ▲ Picking the new span up from the lay-down yard.
- ◀ Removing an existing span.

Once demolition was completed, bearings were placed on the newly built piers and precast concrete abutment pieces were placed to allow for span erection. The new spans were then rigged and walked into place with a tandem pick by 300-ton Manitowoc 2250 crawler cranes. Each pick was approximately 200 tons and carefully choreographed so that weight remained balanced and the operators of each crane stayed in sync throughout the movement. The spans were carried approximately 1,000 ft across the lay-down area and through the river before being swung into their final positions on the newly

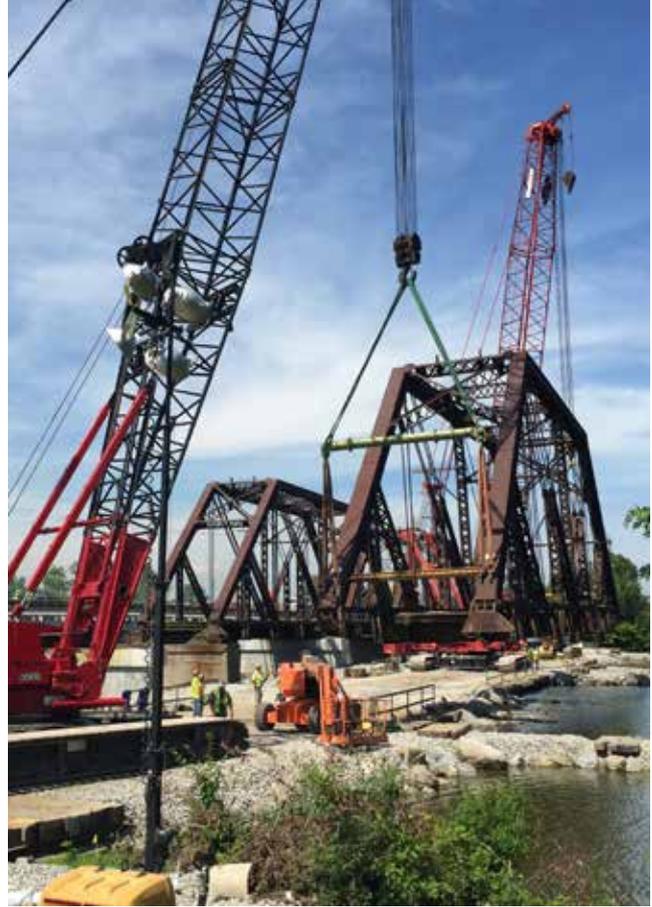
- ▲ Placing an old span on an island downstream to make way for the new spans.

During the outage, the existing bridge was dismantled, via torch-cutting, enough to lighten each span for removal. The three existing spans were then picked and placed on temporary stone islands downriver to make way for the new spans. Two existing sandstone and concrete piers and the top 4 ft to 5 ft of the existing bridge abutments were also removed during demolition. The removed spans produced 750 tons of steel to be recycled.

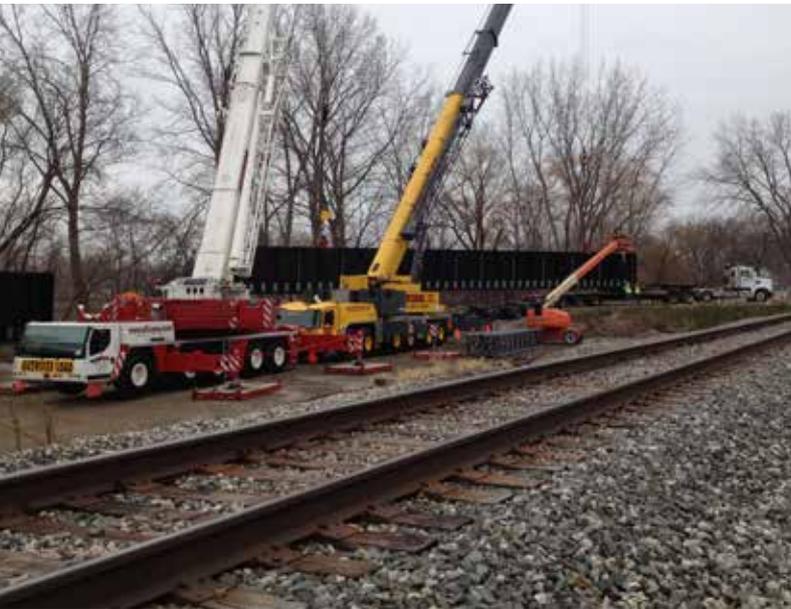
- ▲ Unloading steel in the lay-down yard.
- ▼ An elevation view of the new bridge.

In preparation for on-site construction, the team created a lay-down yard on the southeast corner of the structure while a temporary causeway was constructed across the river. The causeway was constructed using 15,000 tons of stone, 120 tons of temporary steel beams and 160 crane mats. The temporary beams and crane mats were used to create bridges to maintain the flow of the river and allowed for quick removal in times of high water to eliminate the potential for flooding upriver. These temporary bridges had to be designed to withstand the

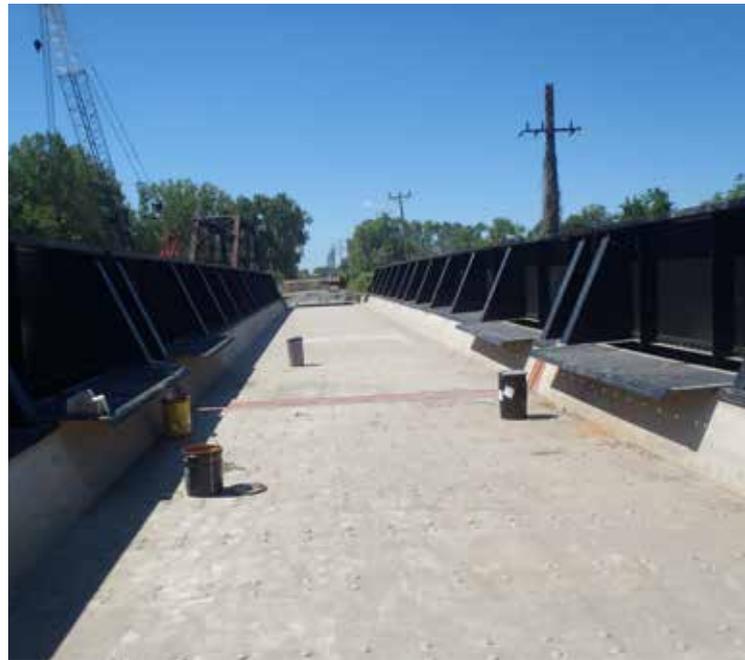
- ▲ A view, from the deck, of two new spans set onto new piers.
