HANGING OUT in Salt Lake City

BY PATRICK M. HASSETT, SE, AND JORIEN BAZA, PE

An elaborate erection and jacking scheme involving an innovative roof-top truss helps pull together the Utah capital's newest Class A high-rise.

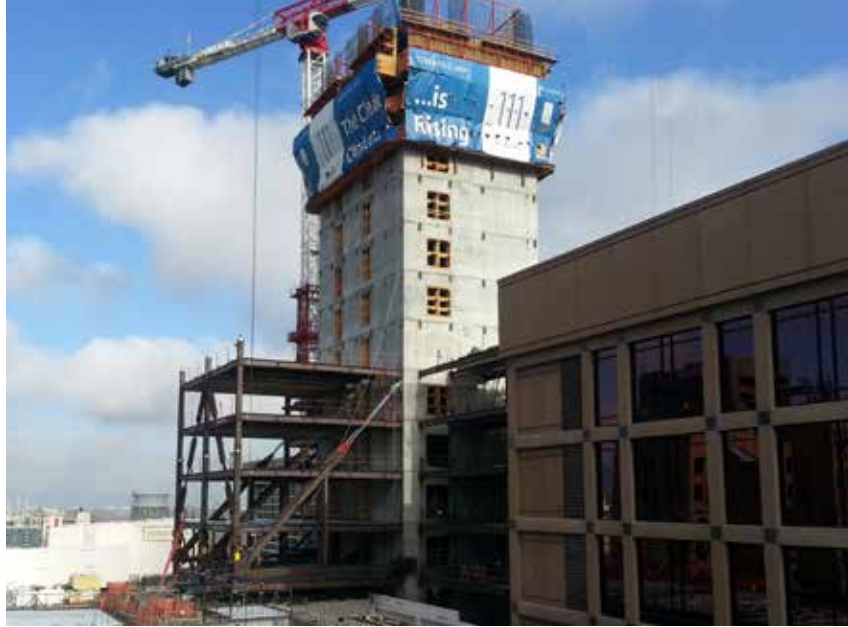
- The cable jacking frames and building core.

the behavior in the ETABS model, the team determined that some load transfer (by plate action of the slabs) was occurring between jacking lines 3, 4 and 5 and braced frame lines 1 and 7. Connections for the jacking trusses and the bracing for lines 1 and 7 were reinforced to accommodate the additional loading, and the jacking magnitude at each adjustment was minimized to keep the floor elevations within acceptable tolerances while ensuring that the jacking frames would not be overstressed.

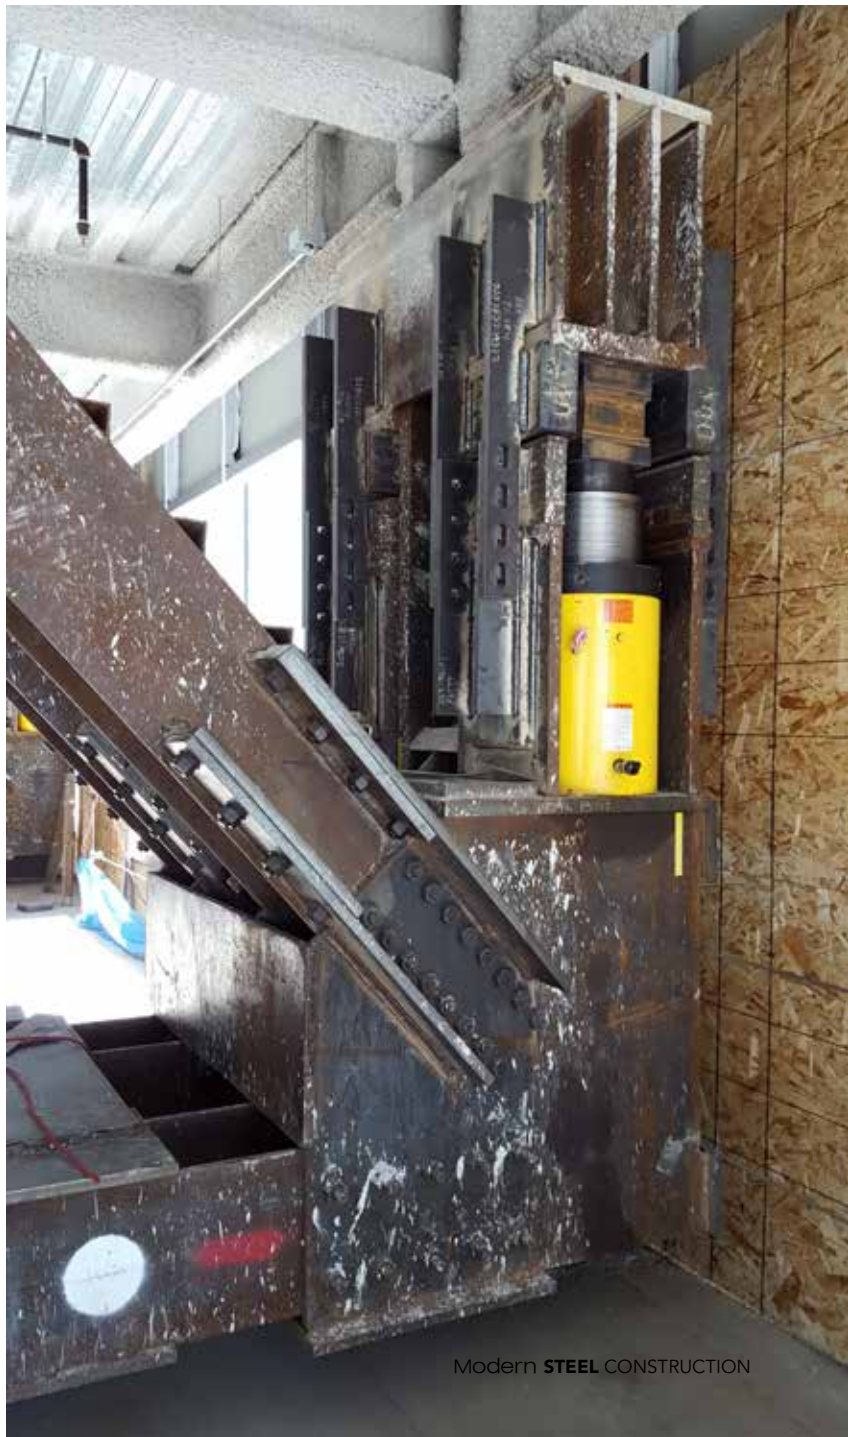
- A jacking frame and column bracket.

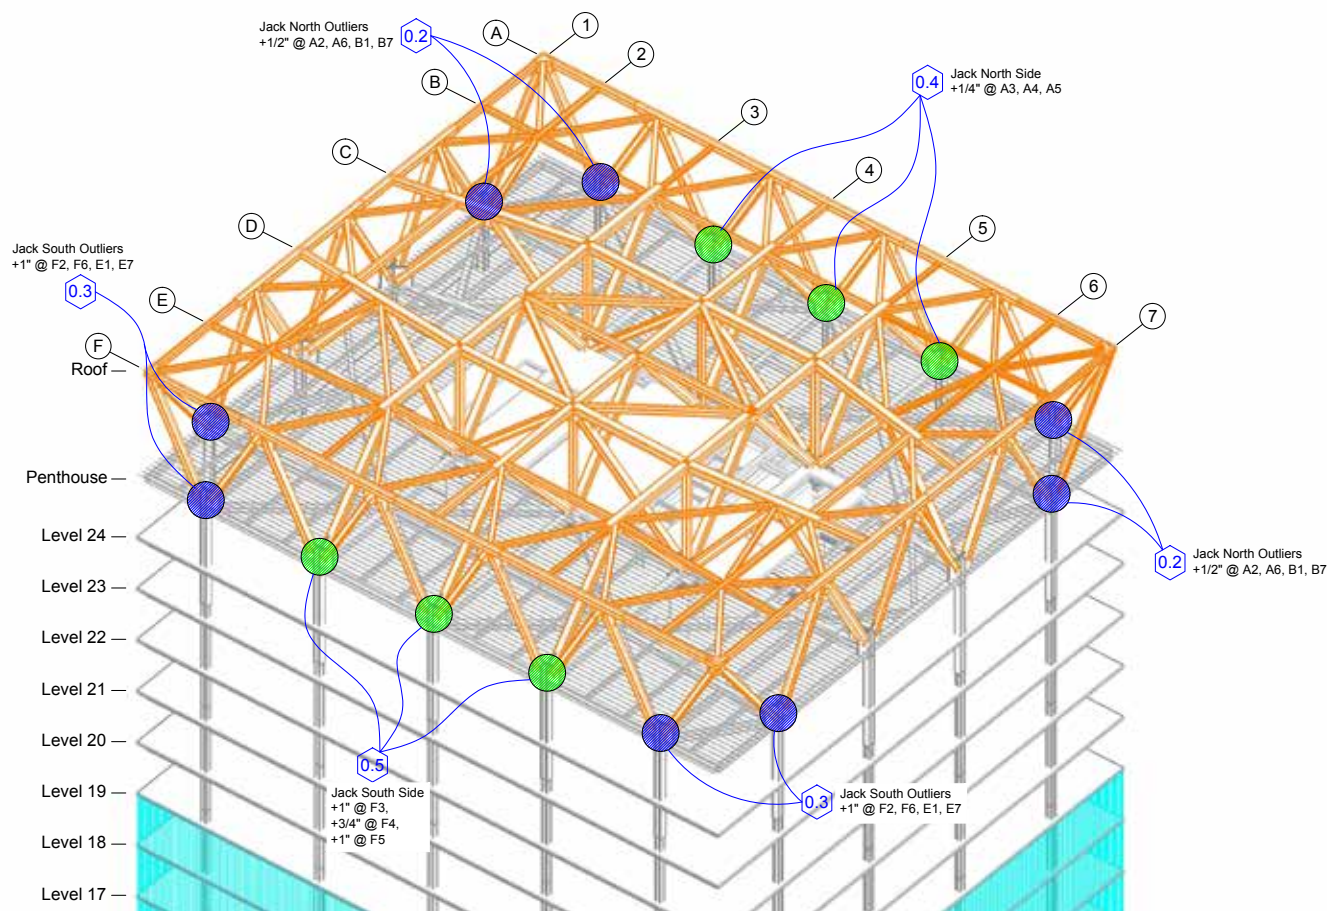
▲ Pre-jacking adjustments to the hat truss.

Relying on the carefully developed survey data provided by Okand Construction, and correlations made with ETABS erection sequence modeling, adjustments at the roof were done in four phases:

1. The four outliers on the north were jacked $\frac{1}{2}$ in.; these column grids then could provide some pretension for the supporting hat truss, acting as an abutment
2. The four outliers on the south were jacked 1 in.
3. The columns on line A at 3, 4 and 5 were jacked $\frac{1}{4}$ in. to provide further pretension for the next jacking.
4. The columns on line F at 3, 4 and 5 were jacked 1 in., $\frac{3}{4}$ in. and 1 in., respectively. By making these small final adjustments at the roof level, the roof trusses were effectively preloaded and the erection team was able to set the geometry closer to the theoretical elevations prior to jacking down the building

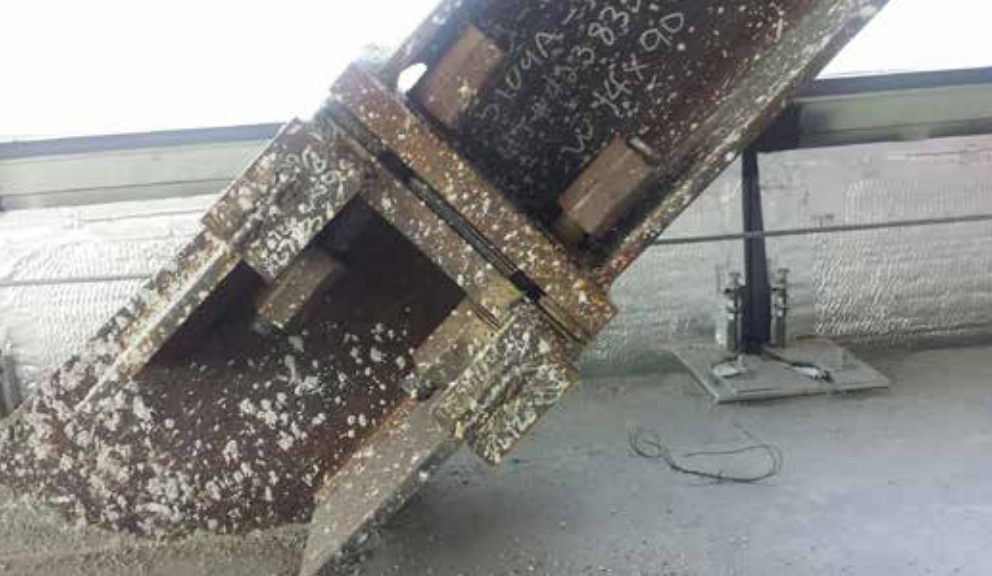
◀ A tension release at a braced end-plate connection.

much residual tension load. This was done by loosening the tension rod nuts in the end-plate connections of the braces, with a resulting gap spread of between $\frac{1}{16}$ in. and $\frac{3}{16}$ in. between end plates.

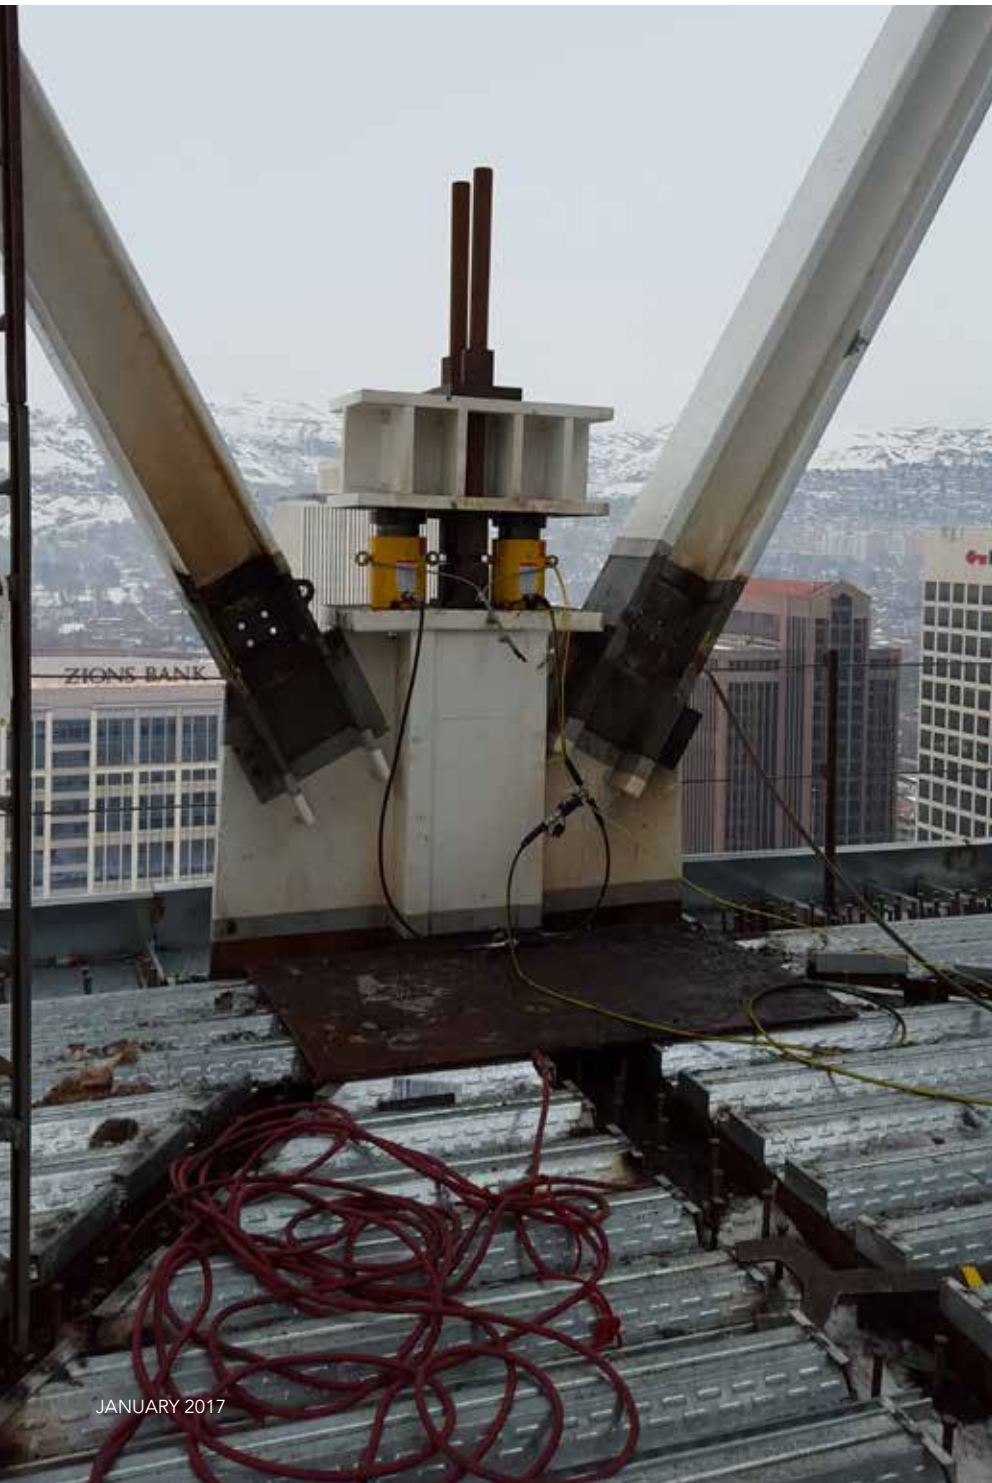
◀ Jacking adjustments at the roof node.

Jacking rods were installed on the bottom chord of the roof truss as a backup plan to make further elevation adjustments, which would involve pulling up the columns and pulling down the trusses. This backup scheme proved to be very useful in adjusting the floor elevations, as the floor elevations at the south side and outlier columns were lower relative to the other grid lines. These “outlier columns” were columns outside of the main truss lines and were supported by perimeter trusses off the main trusses at the roof. Because the measured loads during jacking indicated that more jacking would stress the saddle cables beyond their intended design loads, the decision was made to leave those three columns relatively low.
