Orthotropic steel deck
is a viable option for
rehabbing movable
bridges working on tight
schedules.

ORTHOTROPIC Deck Delivers

BY MARK TORRIE, MENG, PENG, AND ÉRIC LÉVESQUE, MSc, PENG

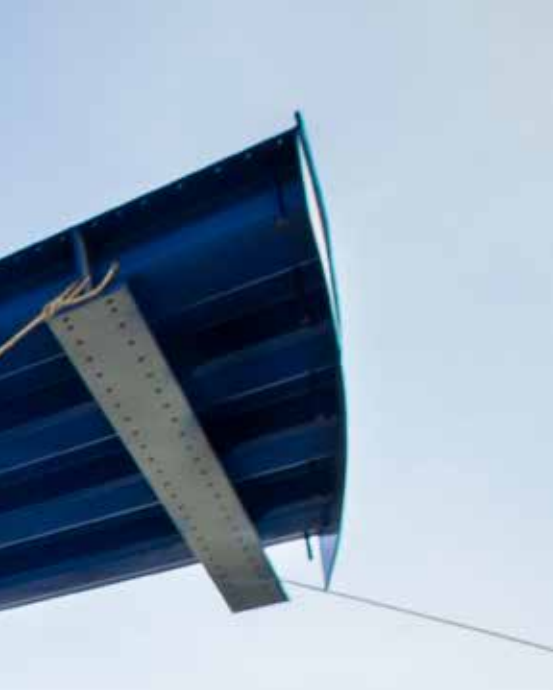
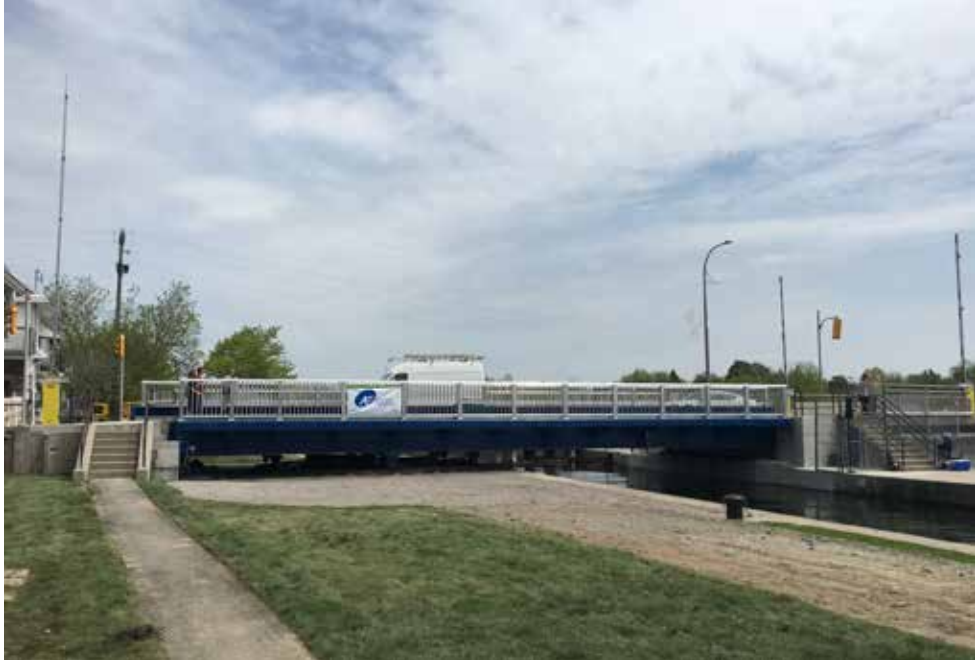
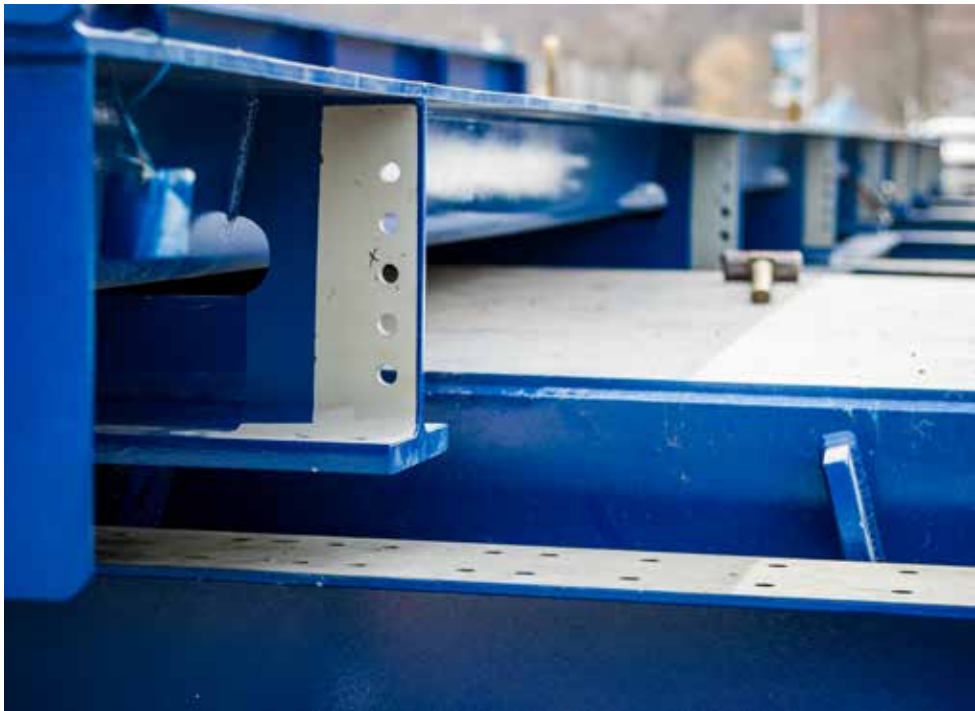
- ▲ The new bridge in full-service condition.
- ◀ The underside of an OSD panel during installation.
- ▼ The OSD panel is positioned in place prior to bolting the bottom flange of the transverse floor beam to the steel superstructure.

The OSD layout and design were chosen with shop fabrication, shipping and erection issues in mind. With input from the fabricator, this OSD design completely eliminated on-site welding of the deck plate by incorporating a longitudinal bolted joint splice. By bolting this splice instead of welding it, the contractor saved valuable time by limiting delays related to winter conditions that would prevent welding.

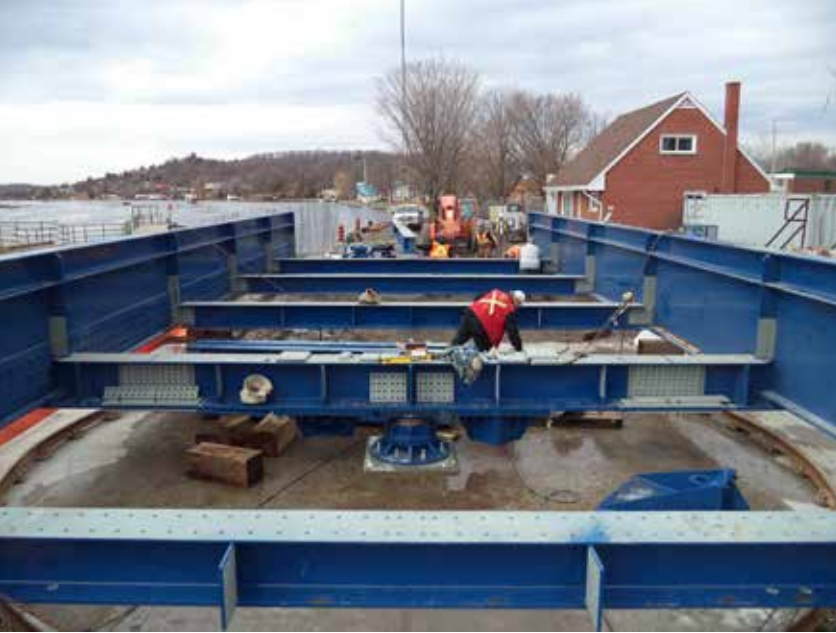
◀ A view of the steel superstructure prior to installing the OSD. The transverse floor beams of the OSD were used as a template to drill matching holes in the superstructure above.

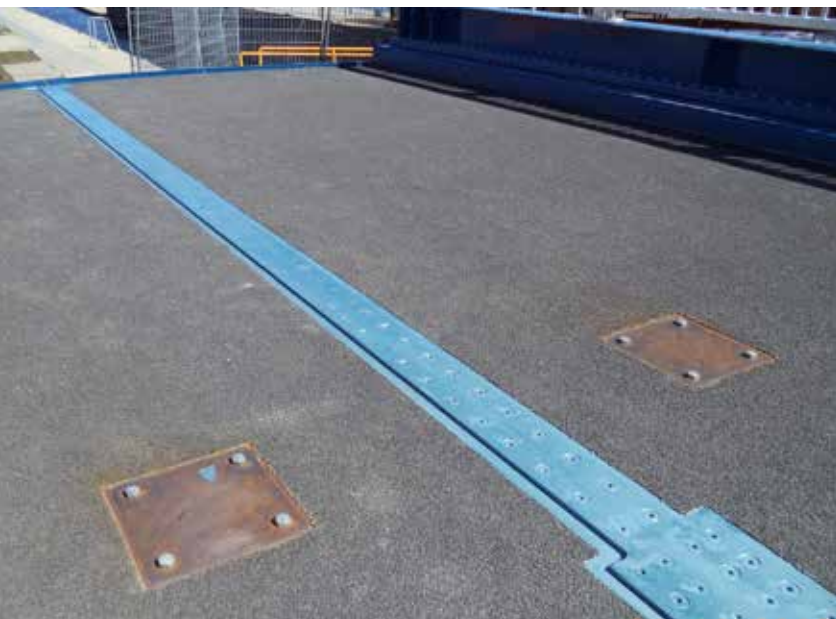
▲ A view of the longitudinal bolted splice between the orthotropic steel deck panels before asphalt was added. The panels were delivered with an anti-skid waterproofing membrane that was preinstalled by the fabricator for durability and worker safety during the wet winter months.
