A seemingly small structural retrofit at the bottom of a prominent Manhattan high-rise brings big gains to occupants and visitors.

# Playing to THE BASE

**75 ROCKEFELLER PLAZA LOOKS** down on one of the most famous public spaces in a city of famous public spaces.

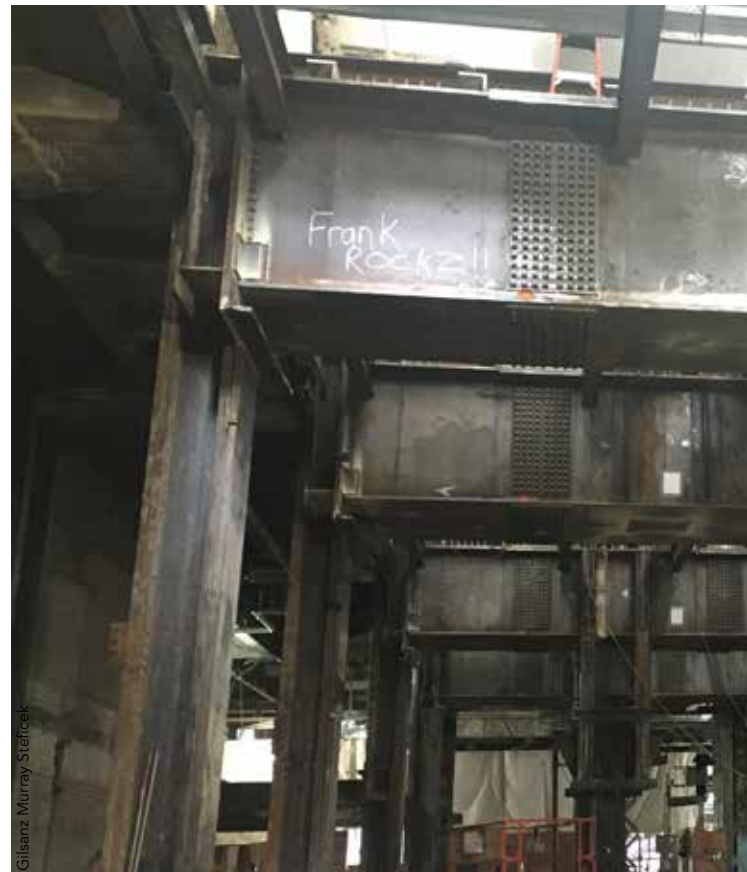
above and between the scalloped architectural finishes of the new lobby ceiling. To meet these requirements, composite box girders were used for the cross section of each new transfer. The box shape could be kept tight to the existing transfer girders and within the envelope of the new ceiling. Engaging the slab to develop composite behavior helped minimize the depth and tonnage of each member. The elastic section of the steel shape was designed for the dead load, reduced live

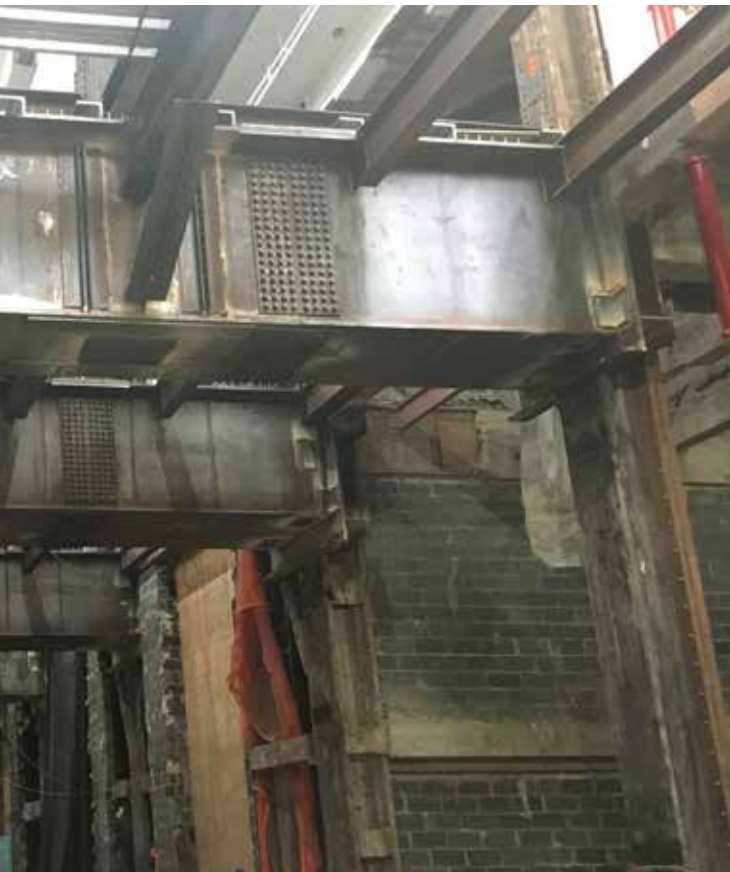
- ▲ The new lobby space features white walls and terrazzo floors.
- ◀ The box girders were jacked at the four columns to be removed.

The girders were preloaded to minimize deflection of the existing column above, as well as to minimize any load that would be induced into the existing moment frame as a result of this deflection. Each girder was loaded using two temporary steel yolks that were connected to the webs of the new girder at the location of the existing column to be removed. Jacks were installed between the yolks and the existing column to be removed. The new girders were then pulled down against the column to be removed, which was pushed up. Effects encountered during the preloading, such as axial shortening and resistance from the steel moment frame above, were considered in the structural design and loading procedure. The process was monitored from the initial loading through the final connection and column removal. This was critical for a successful transfer, as the magnitude of the load and the extent of the existing column elongation meant a visual separation was not achieved prior to cutting the existing column.

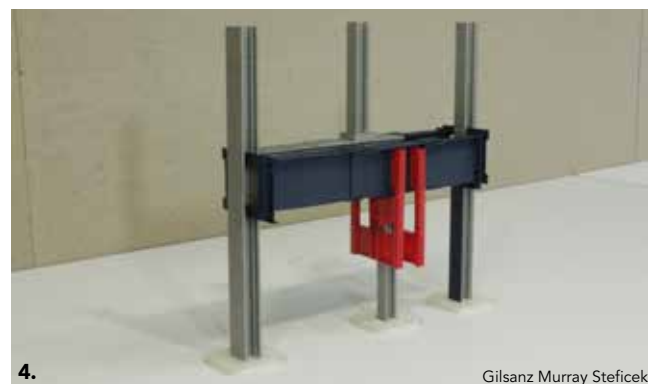
plates from the second floor down to the existing grillage foundations. The plates were widened where they meet the webs of each new transfer girder to allow for the new shear connections to be made. *Strength and Ductility Requirements for Simple Shear Connections Under Shear and Axial Load* by William Thornton was referenced when analyzing moment transfer through the new girder connections. As box girders are more common to bridges than buildings, the American

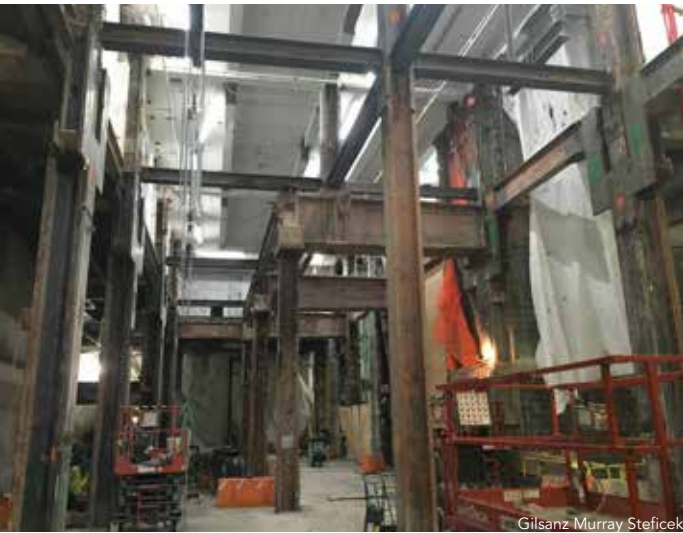
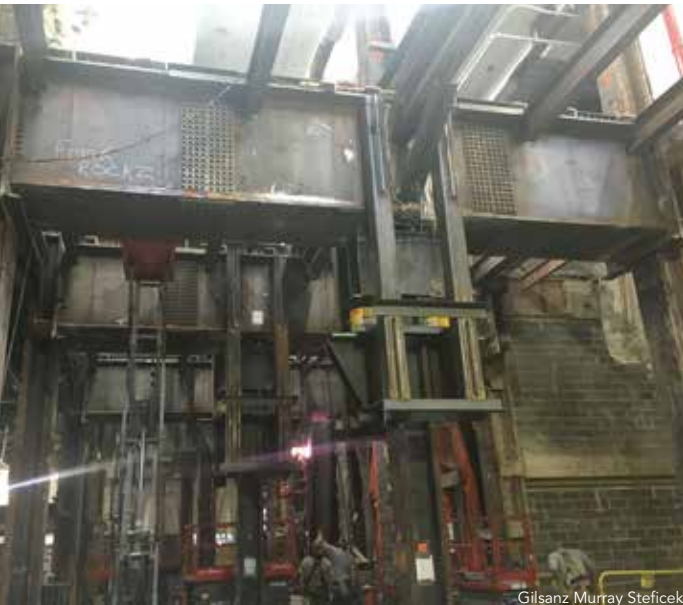
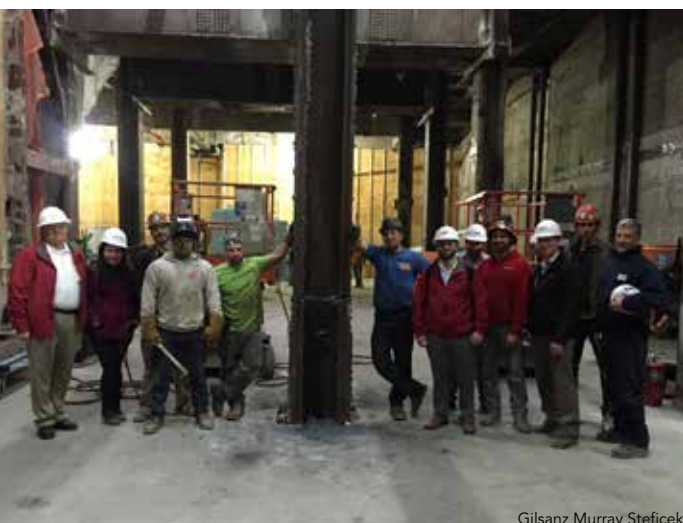
- ▲ ▼ ▶ The composite box girder scheme coordinated well with the planned sculpted lobby ceiling, which required the transfers to be as narrow as possible.

- ▼ Box girders, in place.

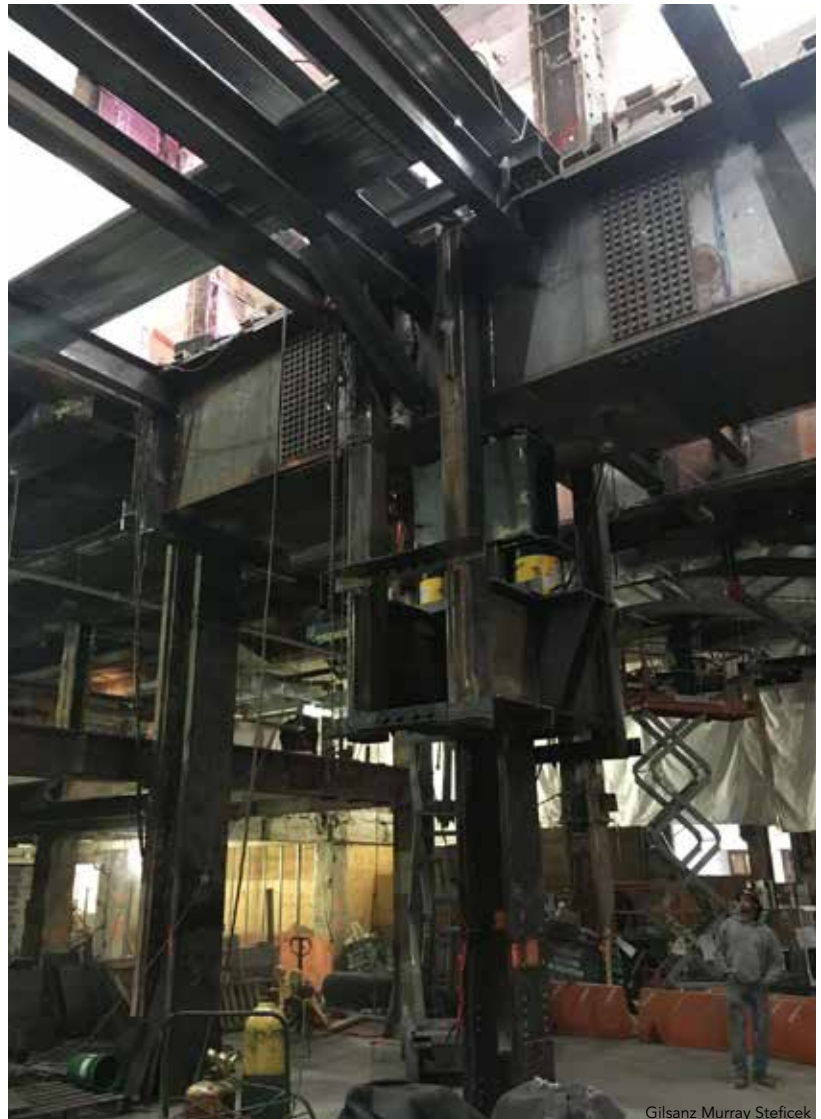
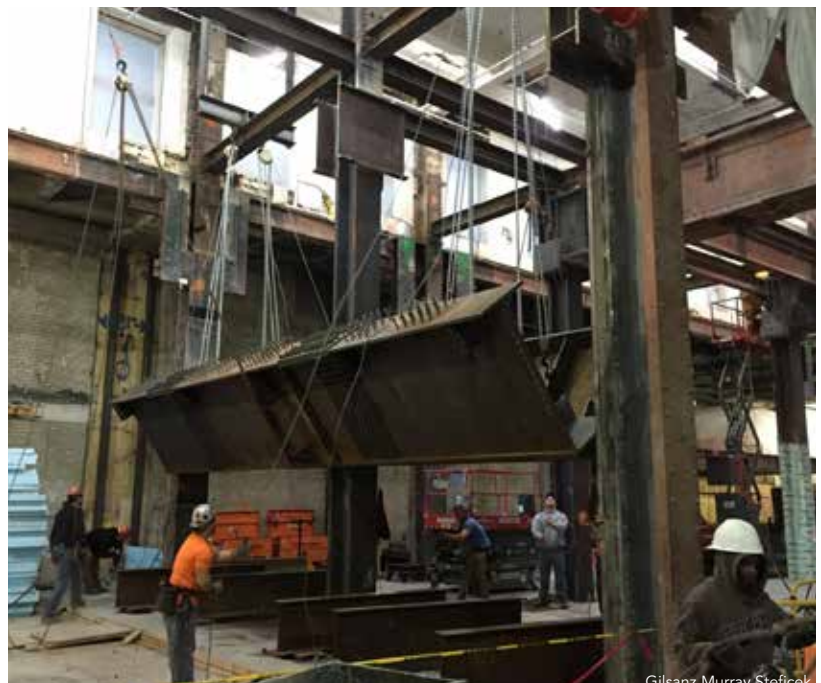
- ▼ Hoisting a new girder in two segments to surround the existing framing.

nicate the design concept to the team and the owner. Each girder was fabricated and transported in six pieces that were spliced together in the field and erected into place.
