A report on construction activity in Christchurch, New Zealand, following a devastating earthquake offers insights on how other cities might recover after potential similar events in the future—and why steel has become the material of choice for much of the city’s repaired, rebuilt and new buildings.

Rebuilding a City in Steel

BY MICHEL BRUNEAU, PEng, PhD, AND GREGORY A. MACRAE, PhD

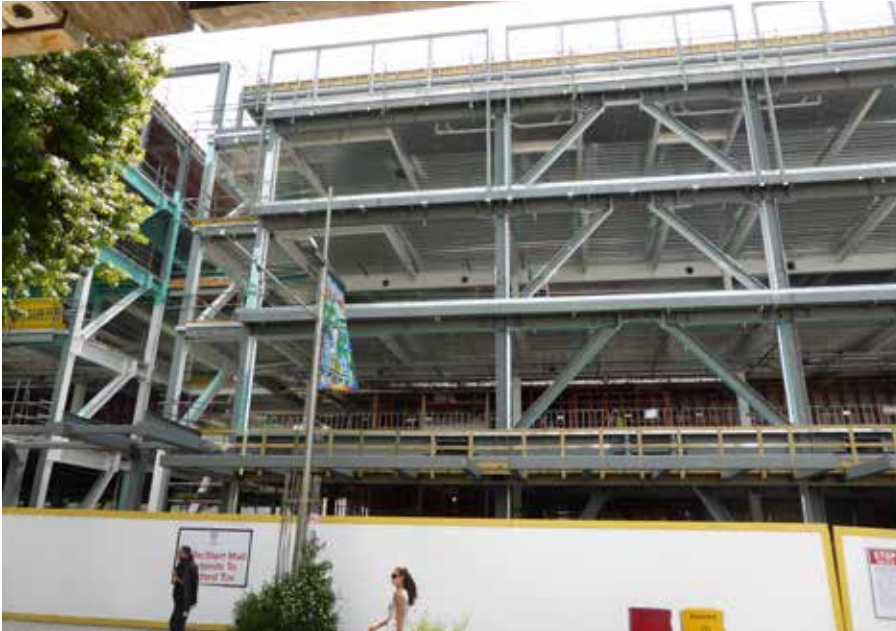
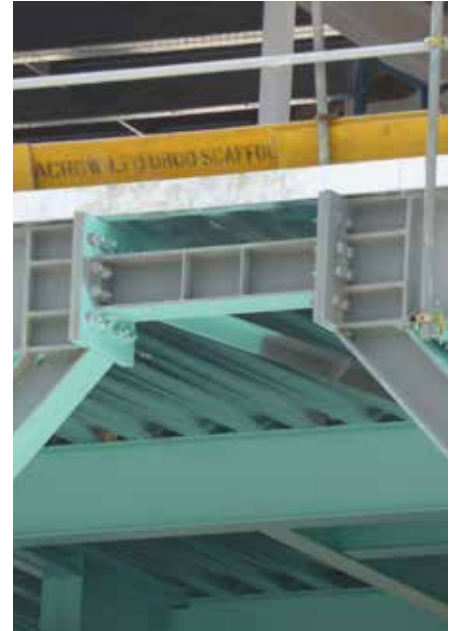
An EBF with replaceable links (left) and a close-up of a link in an inverted-V braced frame (right).

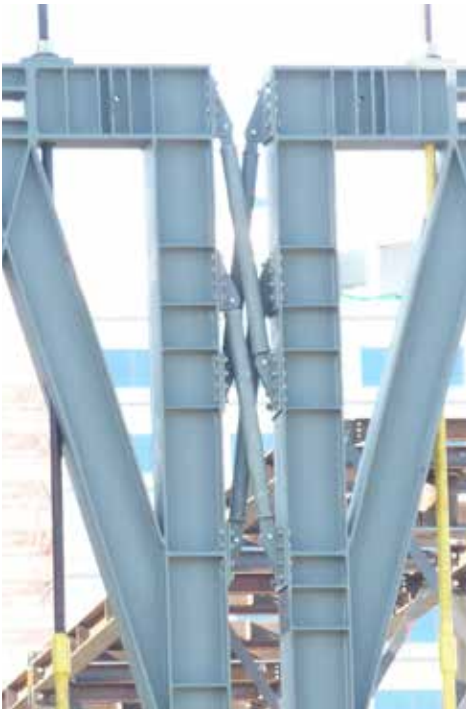
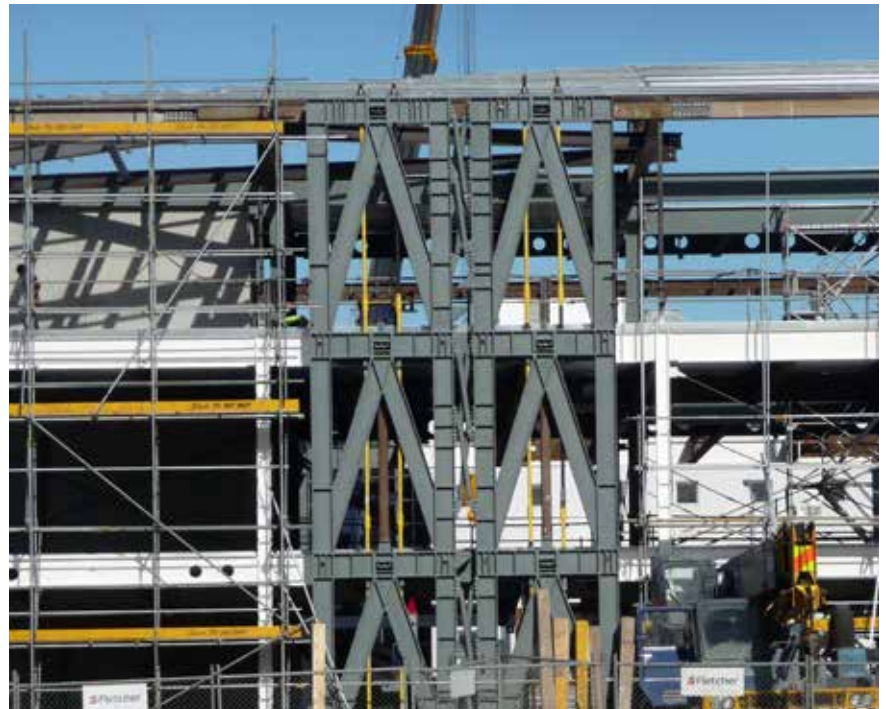
A rocking frame system with energy-dissipating couplers between the frames.

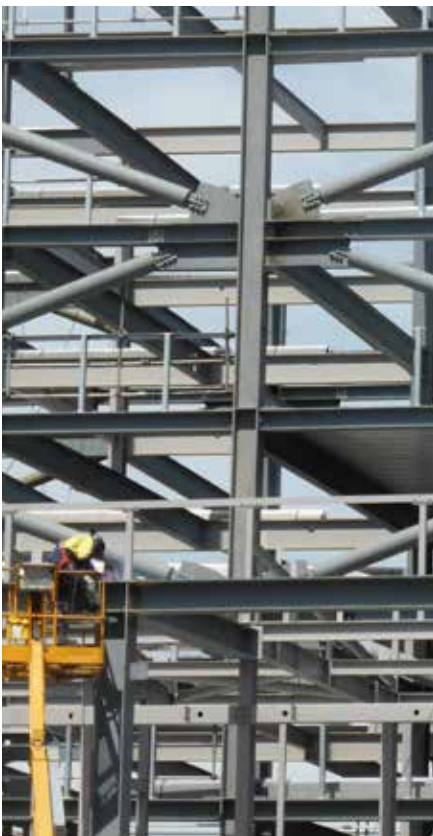
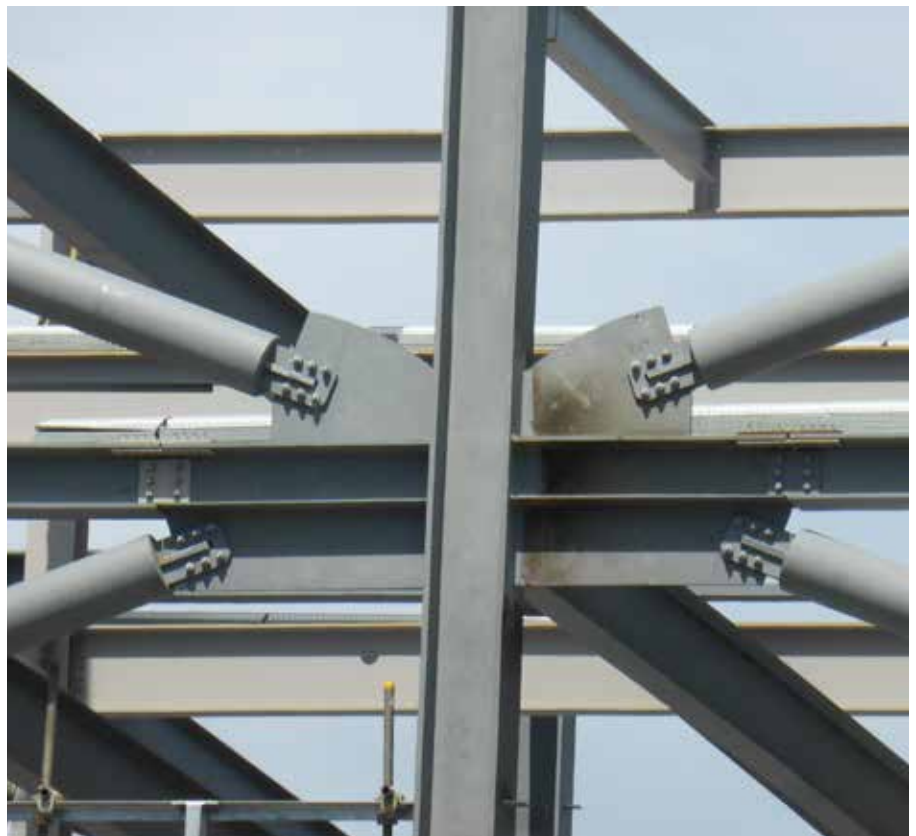
A BRB frame (left) and a column connection at mid-bay of the frame (right).

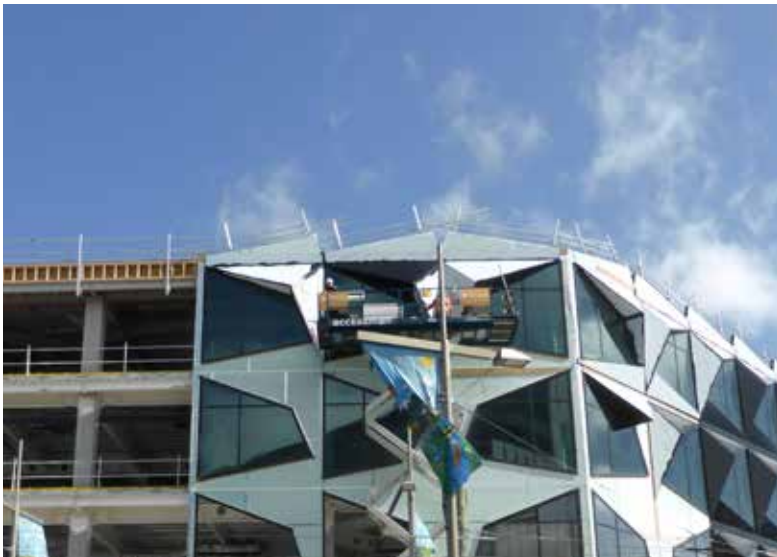
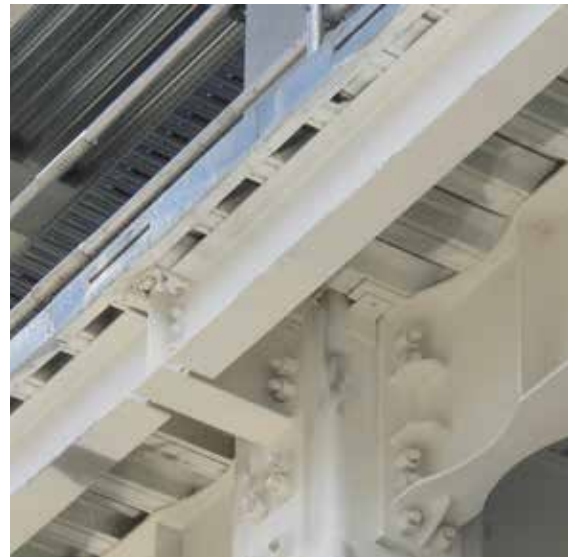
A space moment frame (left) and a close-up of an RBS connection in the form of a bolted end-plate to moment-resisting connection to a square steel section (right).

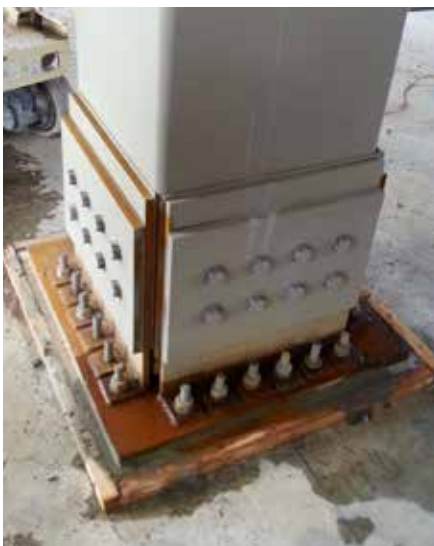
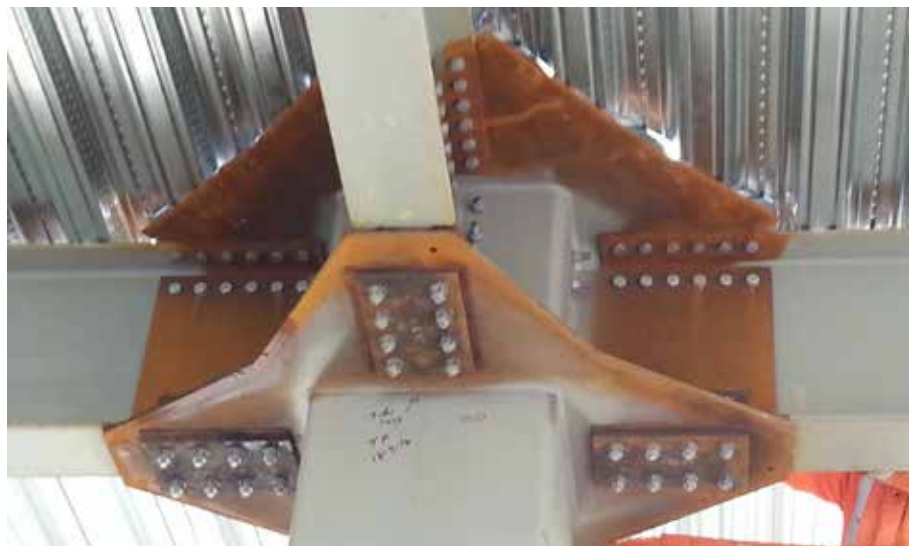
A base friction connection (left) and a completed bidirectional moment friction connection (right).
