National "Truss" for Historic Preservation

A new truss brings structural modernization to a century-old Washington apartment building.

BY JASON MYERS, SE, PE, SHANE MAXEMOW, SE, PE, AND TIMON HAZELL

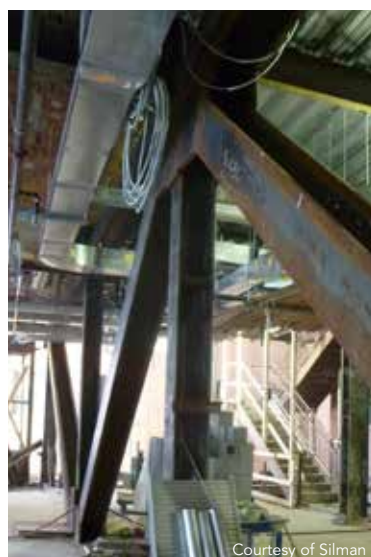
The new truss incorporates existing historic steel columns as truss verticals and support columns.

An advantage of steel construction is this ability to implement connections that accommodate varying existing steel construction. The 72-ft-long, 14-ft-deep, 20-ton truss incorporates existing historic steel columns as truss verticals and support columns. The existing columns were 10H and 12H sections, oriented in different directions. Therefore, 12-in. wide-flange sections were chosen for the top chord, oriented web-horizontal and nested underneath the existing third floor beams. This allowed the connection plates to sandwich the existing columns and align with the chord flanges for a simple full-penetration weld. The floor beams at the bottom chord were removed and replaced with 12-in. wide-flange sections, oriented web-horizontal and connected through the columns like the top chord. Truss diagonals were also chosen to be 12-in. wide-flange web-horizontal sections, thus allowing the connecting gusset plates to align with top and bottom chord flanges and top and bottom chord sandwich plates.

The existing support column to the east was reinforced for the additional load by boxing the column with steel plates. This allowed the gusset plate for the chord and diagonal to sandwich the existing column and bear directly on the reinforcement plates. The existing support column to the west had a plan offset of 1 ft to the north, which allowed a new steel column to be nested adjacent to the existing and take the entire load of the new truss.

An additional challenge was ensuring that the existing column splices were stable for the truss verticals with compression and could transfer tension when needed. To accomplish this, the gusset plate connections were extended up and a sequence was devised to remove existing cap and splice plates that protruded from the face of the columns while attaching the new gusset plates.
