# **RECONSTRUCTION OF NEW YORK CITY'S WILLIAMSBURG BRIDGE**

# RECONSTRUCTION OF THE WILLIAMSBURG BRIDGE

By  
Roger Haight, P.E.  
Jay Patel, P.E.

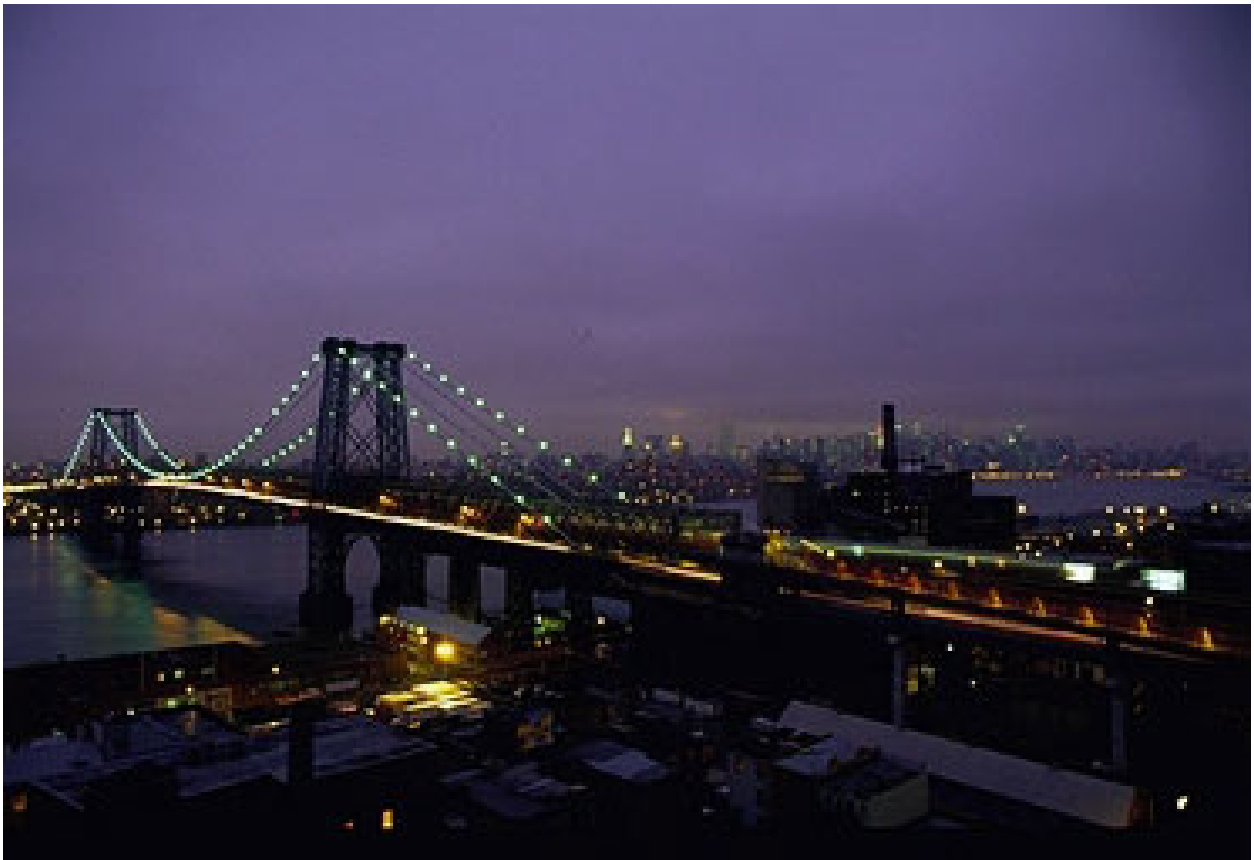
Figure 1. The Williamsburg Bridge in New York City.

The Williamsburg suspension bridge spanning over the East River in New York City, shown today in Figure 1, opened to traffic in 1903. It is one of many suspended, fixed, and movable spans over the East River that form New York City Department of Transportation's (NYCDOT's) infrastructure connecting Manhattan with the boroughs of Brooklyn, Queens, and the Bronx. It was designed by Leffert Lefferts Buck as one of the last major suspension bridges for the horse and carriage. Following the Brooklyn Bridge, which captured the imagination of engineers, poets, and artists after it opened in 1883, the Williamsburg Bridge was considered an "ugly duckling" by comparison. L.L. Buck countered the aesthetic criticism of the bridge with the words "but it is strong". This first major suspension bridge to use steel towers to support the main cable, over 100 years later, is still strong. With a wooden carriageway replaced previously by concrete deck and currently by orthotropic steel deck, and its pedestrian footwalk replaced with a new footwalk/bikeway system that is barrier-free, the bridge has, through the vicissitudes of over 100 service years, worked its way into the hearts of New Yorkers. Like the subway system that travels over it, the bridge seems complex until you get to know it; the huge stiffening truss is full of connection angles, lacing bars, and thousands of details. Yet like New Yorkers themselves, the bridge is get-the-job-done functional, and the overall structure on the skyline is raw and simple.

The main suspended span is 1,600 feet long, with side spans each 596.5 feet. The main span is suspended, while the side spans are each supported by three intermediate towers as well as at the anchorages and main towers. The anchorages are each 114.25 feet long. The Manhattan Approach viaduct is the longer of the two approach viaducts at 2,090.25 feet; the Brooklyn Approach viaduct is approximately 1,557 feet long. Four cables suspend the stiffening truss approximately 135 feet above mean high water level in the East River. The stiffening truss is 67 feet wide and approximately 40 feet deep and is pinned at each main tower.

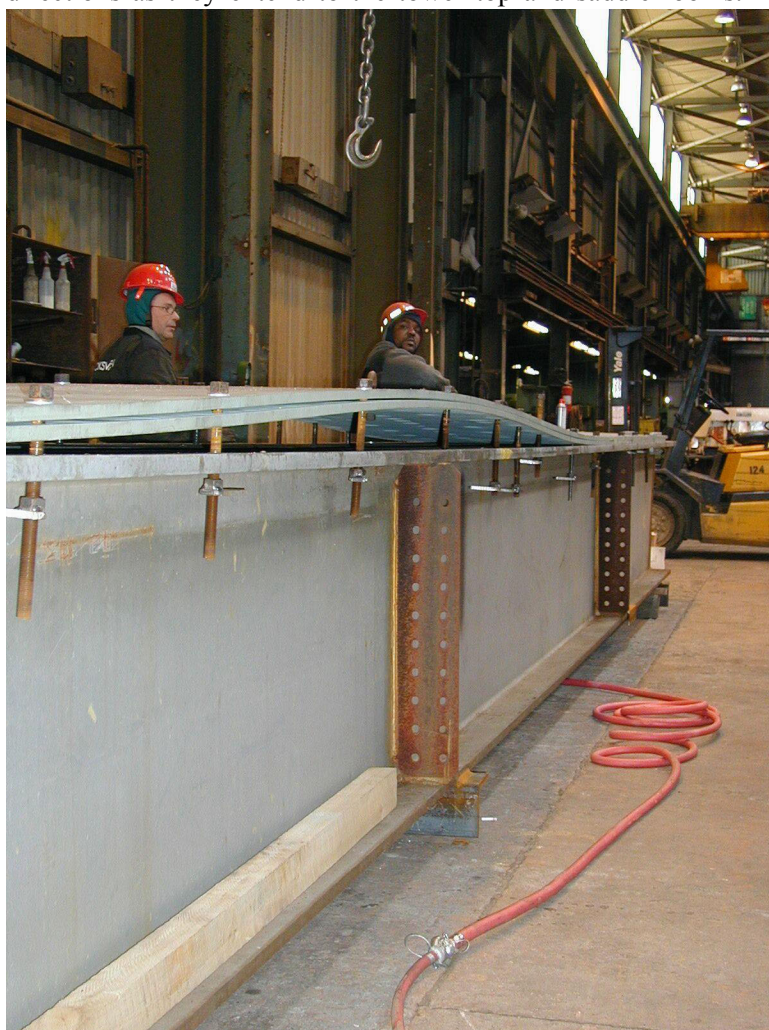
**Figure 4. Steel erector's shop test of reinforcing plate tightening procedure, before performing the operation on the bridge.**

The reinforcing procedure consisted of first building a temporary scaffold with decking over the operating roadways and subway track areas. A temporary roller and guide angle system with a motorized winch at the tower top was used to pull plates up the tower faces and into position. This system was used successively on each tower face and was designed by the steel erector to be used on all dihedral faces. The reinforcing system consisted of two plates, a fill plate and an exterior reinforcing plate. The first two top plate packs in succession were placed in position at the tower top and bolted at their top ends. A block of suitable thickness was placed against the tower column at the midpoint of the upper plate pack, and the plate pack was then drawn down at its lower end and the reinforcing splice plate was then installed, locking the upper plate pack in position. The block was then removed, and the rest of the upper plate pack was drawn down using temporary undersized extra-long bolts. The plate pack was then secured by field-drilling and installing the final high-strength bolts. The procedure was then

repeated down the face of each tower column. Approximately 815,000 pounds of steel reinforcement was added to the main towers. The procedure was first tested in the steel erector's shop, as shown in Figure 4.

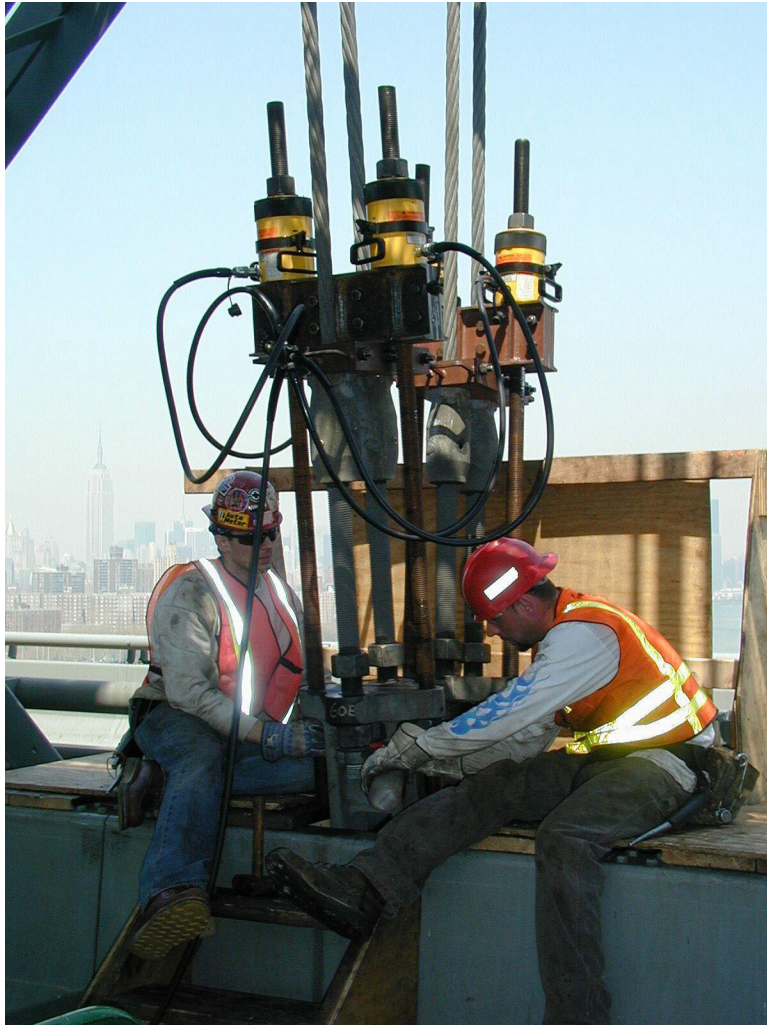
**Figure 5. Suspender adjustment showing the two cable suspenders with tension rods being jacked.**

The profile of the main span was raised to match its profile at the time of original construction. This would alleviate two problems: stiffening truss chord stresses and track profile discontinuities. All suspenders from the main towers to midspan were adjusted to raise the bridge profile. The maximum suspender adjustment was 21 inches at midspan, tapering to a 1-13/16 inch adjustment at the first suspender. Each suspender socket was foreseen with a threaded tension rod attached to a suspender adjustment link and equalizer when it was replaced as part of an earlier contract in the rehabilitation. Temporary rods were threaded into the suspender adjustment links, and a jacking yoke was attached to the temporary rods and to the suspender above the

socket. In this way, the suspender sockets were jacked against the adjustment link, and the tension rod loosened so that its adjustment nuts were retightened, shortening the length of the tension rod. The tension rods were saw-cut as they grew too long for working access.

adjustments were maximized at 2 inches. This maximum increment of adjustment allowed subway trains to continue operating on the bridge without interruption, because NYCT specifies that the maximum curvature in a 31-foot chord (the centerline-to-centerline distance of the wheel trucks) is  $\pm 1/4$  inch. Each adjustment during the sequence was checked for this tolerance on the computer. With each suspender adjustment link and equalizer engaging two cables, an adjustment at one location raised two of the four cables at a time. The steel erector was required to adjust all four cables simultaneously (North and South) at the analogous East and West panel points to ensure symmetry and adherence to the tolerance. Ten passes, for a total of 1,116 adjustments, were required to raise the profile 21 inches at midspan. A typical suspender adjustment jacking system is shown in Figure 5.
