EVALUATION OF THE PERFORMANCE OF RETROFIT MEASURES FOR DISTORTION INDUCED FATIGUE USING FINITE ELEMENT ANALYSIS

Abstract

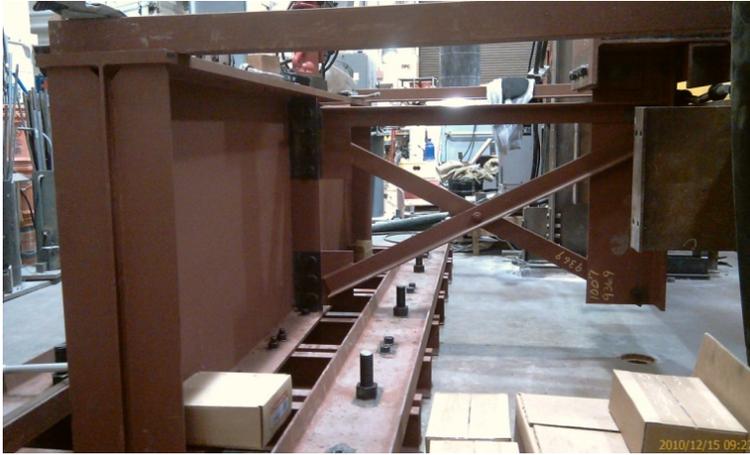
Figure 1. View of of girder specimen

The test specimens were proportioned such that they were each 2,845-mm (112-in.) long with web dimensions of 876×10 mm ($34.5 \times 3/8$ in.). The width of the top and bottom flanges was 279 mm (11 in.), with the top flange having a thickness of 25 mm (1.0 in.) and the bottom flange width being 16 mm ($5/8$ in.). In the physical model, the girder specimen was connected to the laboratory floor through a series of channels post-tensioned to the concrete floor, as shown in Figures 1 and 2. The girder was tested upside-down, with the laboratory floor simulating the restraint offered by a concrete bridge deck. The top flange in the laboratory model (*top flange_{test}*) reflected behavior for a discretely braced bottom flange in a bridge girder (*bottom flange_{bridge}*). The top flange_{test} was restrained at both ends in the out-of-plane direction by angles connected back to a stiff anchorage (a channel member on the load frame), to simulate the restraint effects provided by intermediate cross-frames and lateral flange bending resistance of the bottom flange_(bridge). Full-depth stiffeners were provided at the girder ends to ensure web stability in those regions.

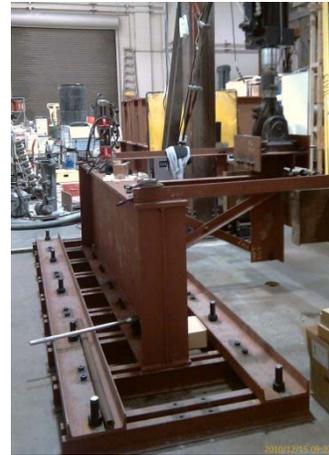
Figure 2. View of fascia side of girder specimen

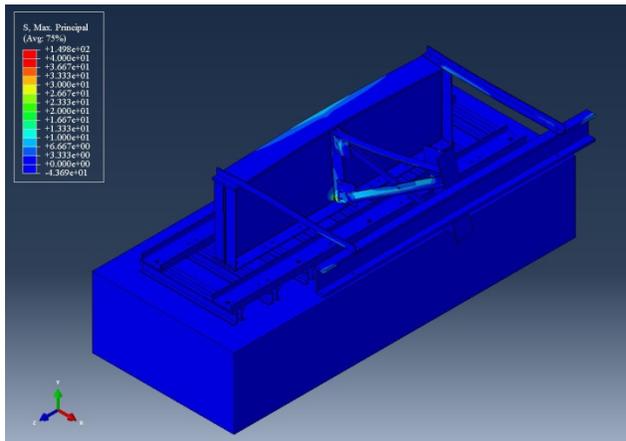
Figure 3. Overall view of girder FE model

The specimen and loading apparatus were modeled closely, as shown in Figures 3 and 4, using the commercially-available FEA software ABAQUS v6.10. The concrete laboratory floor and the girder tie-down system were simulated in the models. Movement of the actuator in the lateral or longitudinal direction of the girder was prevented. In the simulation, the loading step was divided into five increments, with a static load of 5 kips.

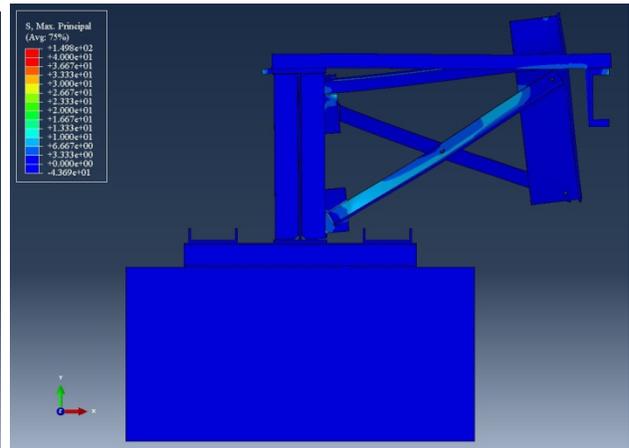
Figure 4. Cross-section view of girder FE model

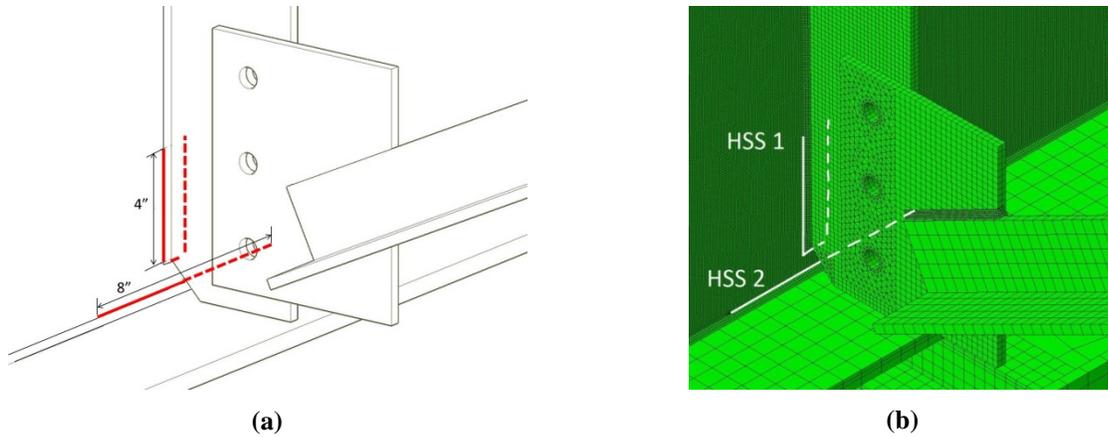
Figure 5. (a) Diagram of modeled 4-in. long horseshoe-shaped crack and 8-in. long horizontal crack geometry at weld toes; redlines represent modeled cracks.; (b) Location of HSS extraction paths, HSS1 and HSS2, in the bottom web gap_(test)

Finally, cracks were also simulated and analyzed using contour integrals. This technique was implemented to calculate contour integrals in the area surrounding the tip of the cracks, such as the J -integral, to be used as a measure of the potential for crack re-initiation in models with retrofit measures. When this method was used, the web was partitioned to have a small circle at each crack tip. The diameter of the circle was 5.1 mm (0.2 in.). The direction of crack growth was specified by the q -vector, defined in terms of the starting point of the crack and the crack tip. For cracks below the connection plate two q -vectors were specified, allowing both crack tips to grow. After the q -vector was defined, a seam was placed in the web which functioned as the crack. The q -vector was defined to act in the direction of the cracking paths noted in Figure 5a.

Figure 5a presents the location of the cracks modeled, and Figure 5b shows the two HSS paths considered in the bottom web gap_(test). In scenarios where crack length was varied, cracks were symmetric about mid-thickness of the stiffener. When comparing retrofits with varying crack lengths, the HSS path lengths were always kept constant. Therefore, the length of HSS2 was maintained at 203 mm (8 in.) and the height of HSS1 maintained at 102 mm (4 in.), regardless of the crack length examined. This approach allowed for the maximum principal stresses to be extracted for every element along the two paths in the various models; the reported HSS value for each path always corresponded to the greatest value of maximum principal stress along that path for the model being examined.

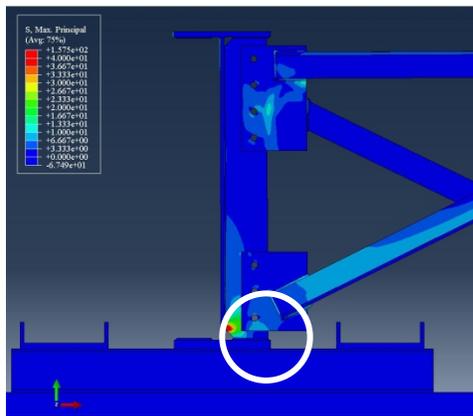
Figure 6. Overall view of specimen, with bottom web gap_(test) shown by the circle.

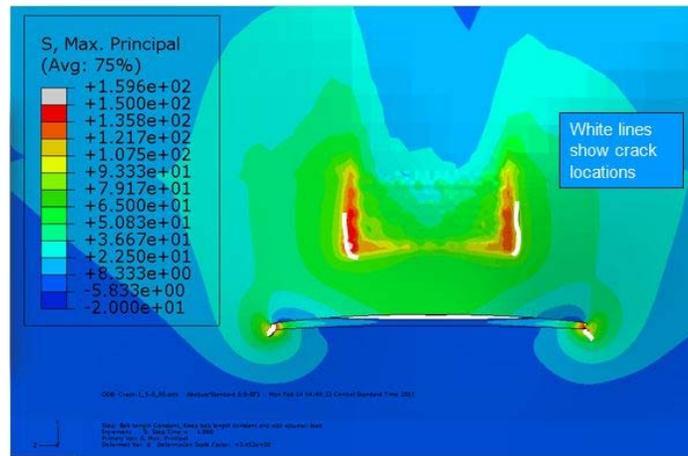
Figure 7. View of maximum principal stress contours in the cracked web gap region in the finite element model of Specimen 1. Superimposed white lines represent experimentally-observed cracks locations.

In the first specimen (Specimen 1), a 38-mm (1.5-in.) long crack was fabricated 20 mm (0.8 in.) below the connection stiffener-to-web weld. The intent of fabricating a crack prior to loading was to control the location and length of cracks at the start of the tests. Contrary to what was expected, the crack tips grew down towards the web-to-flange weld at the bottom flange_(test), and a second crack quickly initiated at the connection stiffener-to-web weld. Figures 6 and 7 present the simulation results for Specimen 1, with the experimentally-observed cracking superimposed. It can be readily observed that excellent agreement was observed between the maximum principal stresses calculated with the finite element model and the experimentally observed crack locations. It should be noted that the connection stiffener was removed from view in Figure 7.

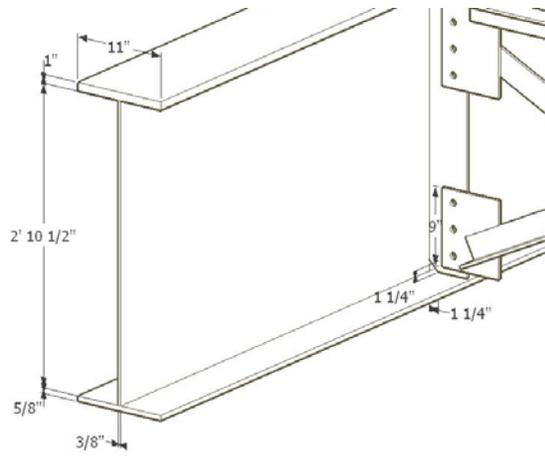
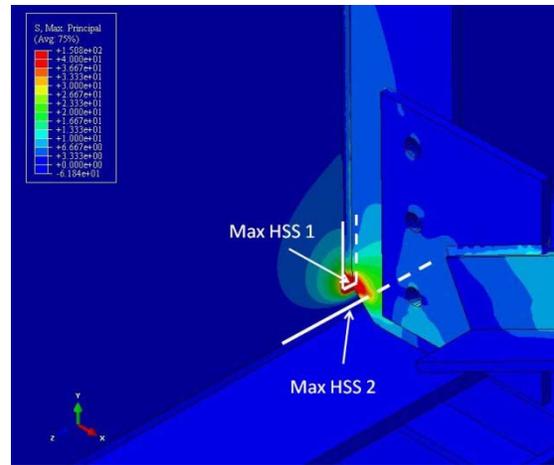
Figure 8. (a) Schematic of unretrofitted web gap region; (b) Maximum principal stress contour plot for unretrofitted web gap region (no cracks modeled); arrows point to point of highest maximum principal stress along HSS Paths 1 and 2.

In simulations of unretrofitted, uncracked models very high stresses were found at the toe of the weld between the web and the connection plate (Figures 8a and 8b). On the fascia side of the girder, in the bottom web gap of the specimen, an area of high stress was found at the web-to-bottom flange_(test) weld. Cracks formed in both of these areas in the bottom web gap during the experiment. In Specimen 2, horseshoe-shaped cracks first formed at the toe of the connection stiffener-to-web weld, followed by cracks at the web-to-bottom flange_(test) weld. The experimentally-observed crack pattern was in close agreement with locations of peak maximum principal stress calculated with the FE models. In Specimen 2, the horseshoe-shaped and horizontal cracks were allowed to grow to 102 mm (4 in.) and 203 mm (8 in.), respectively. This particular crack configuration was modeled, and increases of 4.5× and 25× were calculated for the magnitudes of HSS1 and HSS2, respectively, when compared with computed values from the uncracked configuration.

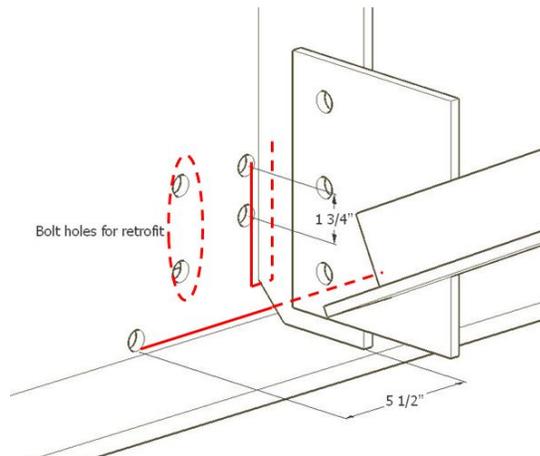
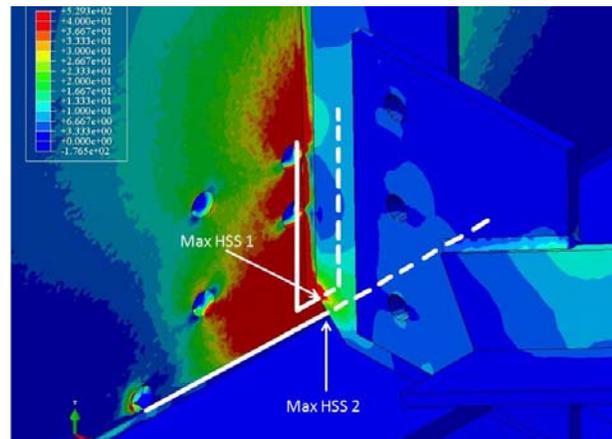
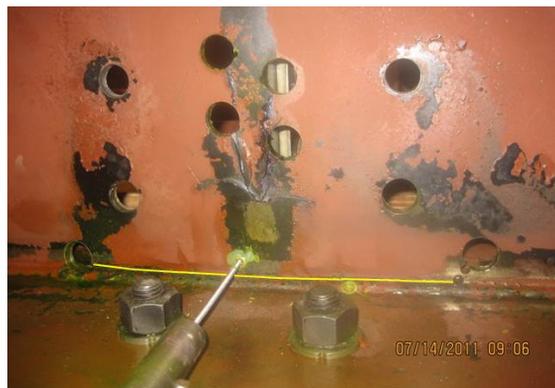
Figure 9: Retrofit measure 1: drilled crack-stop holes (a) Schematic of drilled crack-stop holes, where redlines represent hot spot paths; (b) Maximum principal stress contour plot (cracks modeled explicitly); arrows point to point of highest maximum principal stress along HSS Paths 1 and 2; (c) Photograph of cracking pattern on fascia side of girder. Horseshoe-shaped cracking is visible, horizontal crack has been

highlighted in yellow.

This retrofit measure was modeled in the simulations, and is shown in Figures 9a and 9b. Cracks were modeled explicitly with a thickness equal to one element width, which was set to 2.54 mm (0.1 in.). The stress distribution in Figure 9b shows that there were very high stresses in the immediate vicinity of the crack stop holes, along the connection stiffener weld. The calculated value of HSS1 decreased by 38% after the holes were drilled. Although the reduction in the stress was meaningful for HSS 1, the calculated stress in the model without the crack stop holes was so high that the reduction in stress was not expected to prevent cracks from re-initiating.

In Specimen 2, cracks indeed re-initiated a relatively small number of cycles after the holes were drilled, which was in agreement with results from the computer simulations. The length of the horseshoe-shaped crack before the crack-stop holes were drilled was 102 mm (4 in.), and after the holes were drilled, the horseshoe-shaped crack grew to 70 mm (2.75 in.) in 39,700 cycles. A photograph depicting the crack pattern and crack-stop hole placement is provided in Figure 9c.

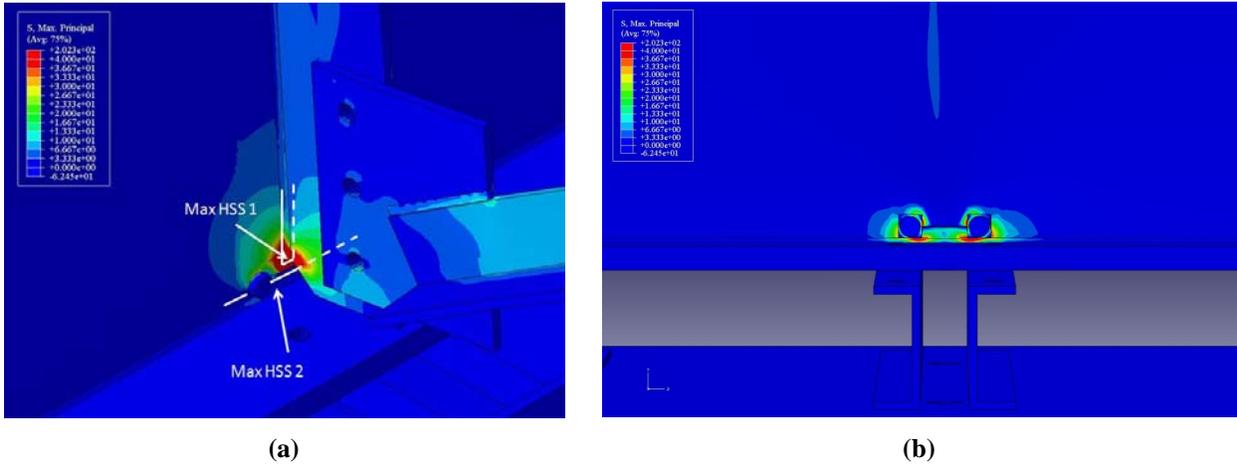
Figure 10. Retrofit measure 2: Tensioned bolts (a) view of stress contour plot for interior face of girder; (b) view of maximum principal stress contour plot for fascia side of girder; cracks modeled explicitly; arrows point to point of highest maximum principal stress along HSS Paths 1 and 2.

Retrofit measure 2 was studied analytically. In this case 19-mm (³/₄in.) diameter tensioned bolts were inserted into the crack-stop holes with the intent of applying a compressive stress to the crack tip. A view of this retrofit on the fascia and interior of the web is shown in Figure 10. In addition to tensioned bolts, 25 × 25-mm (1 × 1-in.) square washers were added to the fascia side of the web to investigate if the compressive stress could be distributed over a larger area. It was found that neither method significantly reduced the stress at the connection stiffener-to-web weld. Also, it should be noted that this type of retrofit is not possible to construct for all crack configurations because a bolt cannot always fit in geometrically constrained areas. In these simulations, this retrofit was possible only when the crack was at least 38 mm (1.5 in.) below the weld toe.

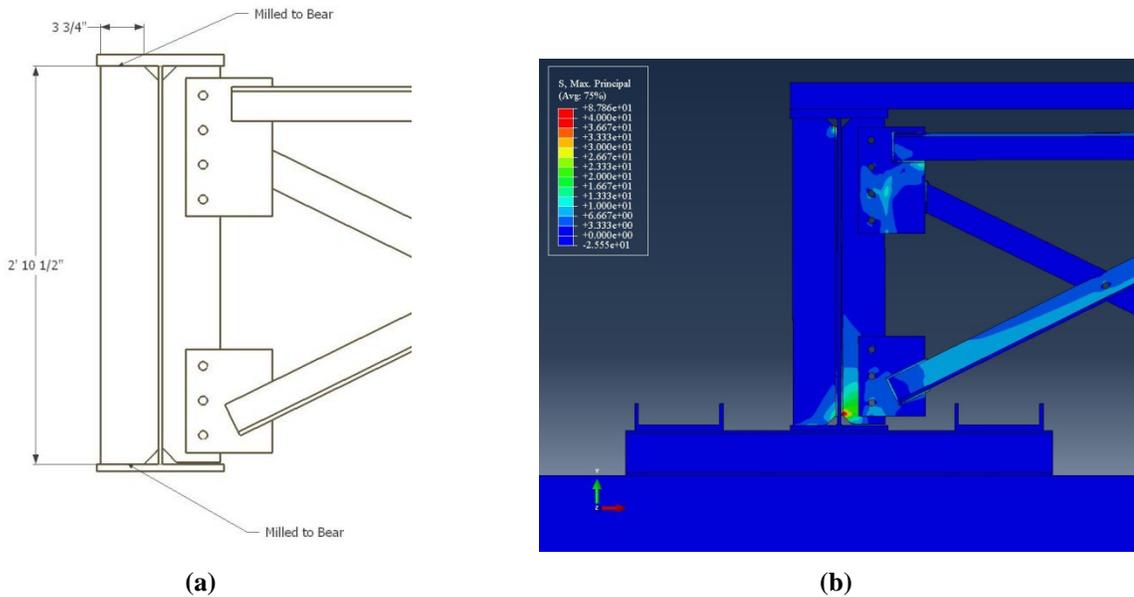
Figure 11. Retrofit measure 3a: (a) Schematic of full-depth transverse back-up stiffener; (b) Maximum principal stress contour plot for full-depth transverse back-up stiffener; cracks modeled using XFEM

Retrofit 3 was studied analytically, and two different back-up stiffener geometries were considered. The first was a full-depth back-up stiffener welded to the web, with bearing interaction between the stiffener and the top and bottom flanges_(test), which is shown in Figure 11. In the simulations, bearing was achieved by placing a hard contact interaction between the flanges_(test) and the stiffener. When comparing models that are unretrofitted with a 102-mm (4-in.) horseshoe-shaped crack and an 203-mm (8-in.) horizontal crack versus models that have the same crack configuration and are retrofitted with a full back-up stiffener, it was found that HSS1 decreased by 85% and HSS2 decreased by 60% after the retrofit. It is interesting, too, that if the stiffener was added before cracks formed (i.e., used as a preventative measure), HSS1 values decreased by 13%, but HSS2 increased by a factor of 11.

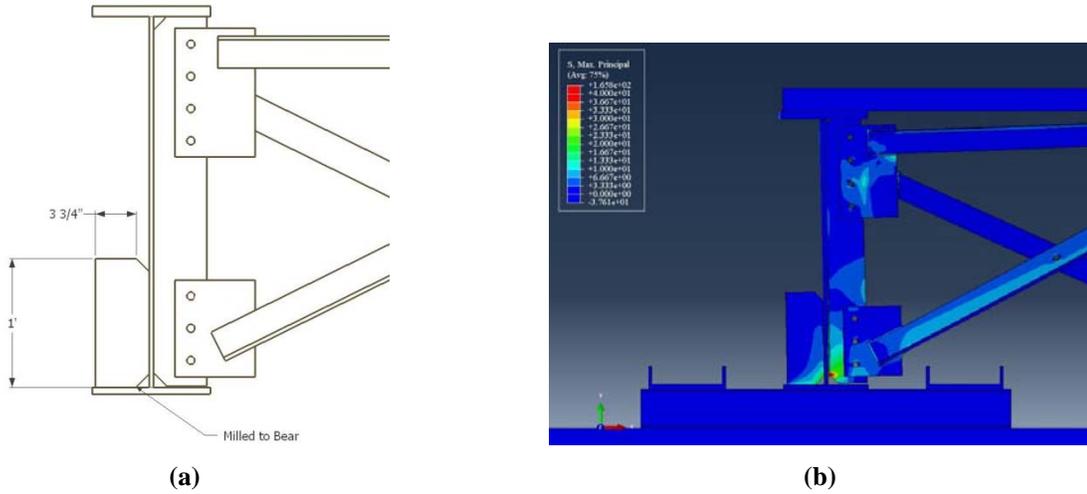
Figure 12. Retrofit measure 3b: (a) Schematic of partial-depth transverse back-up stiffener; (b) Maximum principal stress contour plot for 305-mm (12-in.) partial-depth transverse back-up stiffener; cracks modeled using XFEM

The second back-up stiffener considered was partial depth [305 mm (12 in.)] and was welded to the web with a hard contact placed between the bottom flange_(test) and the transverse stiffener. This second configuration can be seen in Figure 12. Comparing a cracked, unretrofitted simulation to a cracked, retrofitted simulation with a partial depth stiffener, it was found that HSS1 and HSS2 decreased by 76% and 36%, respectively, after the retrofit.

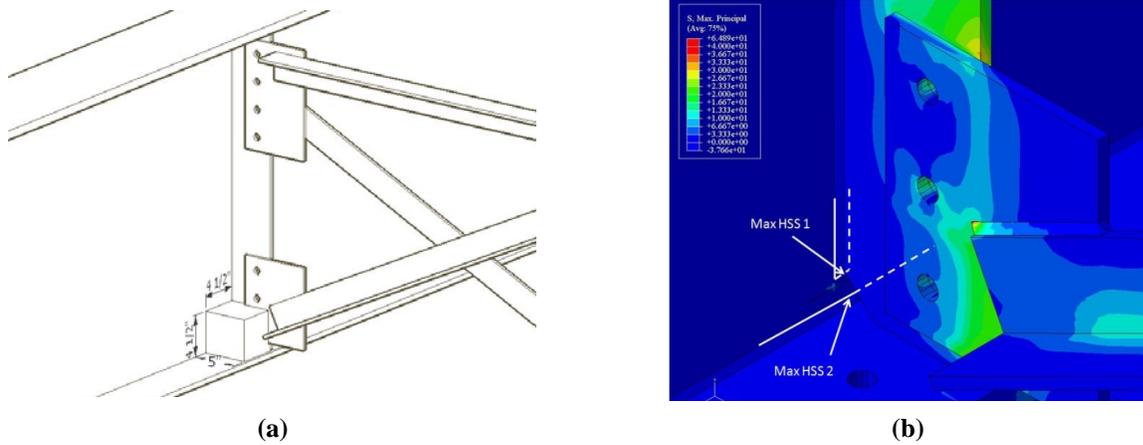
Figure 13. Retrofit measure 4: (a) Schematic of modeled geometry for the CFRP block (b) Maximum principal stress contour plot for steel beneath composite block; Cracks modeled explicitly. Arrows point to point of highest maximum principal stress along HSS Paths 1 and 2.

Retrofit 4 was studied analytically on a cracked model. The crack was modeled explicitly as having a length of 64 mm (2.5 in.), and was located 17 mm (0.65 in.) below the connection stiffener weld. A 127 × 114 × 114-mm (5×4.5×4.5-in.) composite block was designed to fill the entire web gap region, as shown in Figure 13. Tie constraints were used to attach the composite block to the surrounding steel members in the web gap region. The modulus of elasticity of the composite block was varied from 34,500 to 68,950 MPa (5,000 to 10,000 ksi) to evaluate which most effectively reduced the stress in the bottom web gap, and to test the sensitivity of the stress in the web gap region to the stiffness of the CFRP material. It was found that varying the modulus of elasticity changed the HSS values in the steel substrate by less than 0.5%.

Parts made out of composite materials can be manufactured to have different sizes and shapes, and tailored to suit a given geometric configuration. The stress field in Figure 13b shows that significant stresses remained in the steel substrate at the weld between the cross brace and the connection plate after the composite block was in place. This deficiency could be addressed by manufacturing the composite block to extend over the cross-brace-to-gusset weld. Despite the high stresses at the cross-brace-to-gusset weld, the maximum HSS1 in the region directly covered by the CFRP material was reduced by 93%.

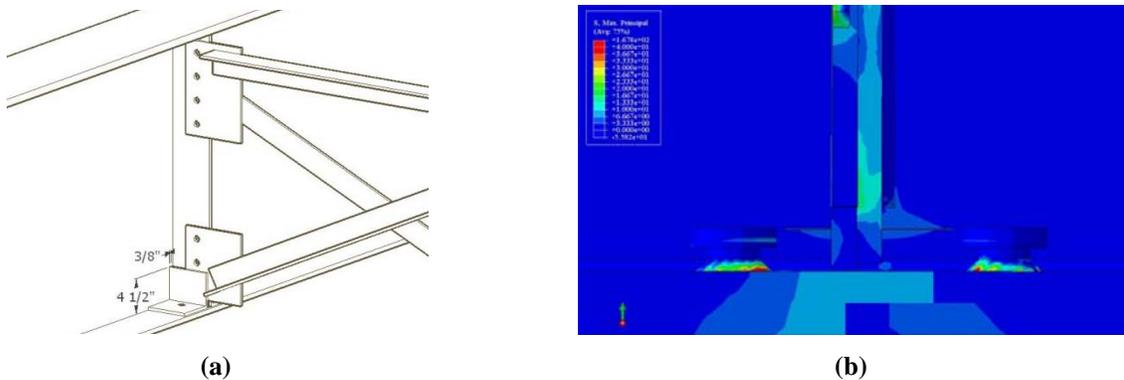
Figure 14. Retrofit measure 5: (a) Schematic of bolted stiffener-to-flange double angles modeled; (b) Maximum principal stress contour plot showing welded bolts at inside face of flange.

Retrofit measure 5, studied analytically, consisted of two angles bolted to the bottom flange_(test) and welded to the connection stiffener with geometry as shown in Figure 14a. This retrofit in an actual bridge would often require drilling through the concrete deck to install the bolts, which is not a simple solution. To avoid drilling through the deck, bolts or studs may instead be welded to the inside face of the top flange_(bridge). This retrofit was applied in a simulation with a 64-mm (2.5-in.) crack, modeled explicitly, which was placed 17 mm (0.7 in.) below the connection stiffener-to-web weld. It was found that HSS1 decreased by 95% in the web gap region after application of this retrofit, but a new fatigue prone detail was introduced at the stud weld. This phenomenon can be noted in Figure 14b.

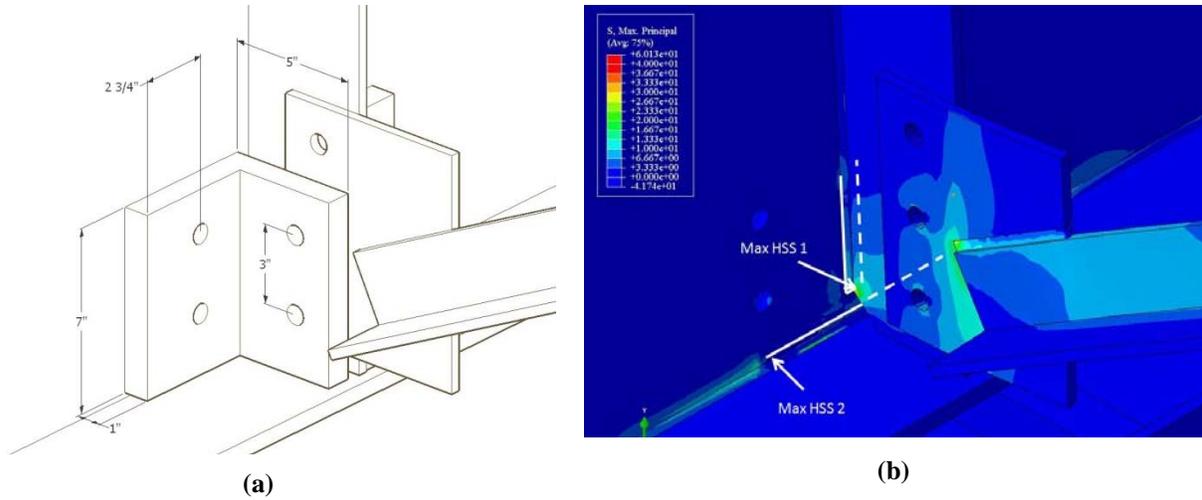
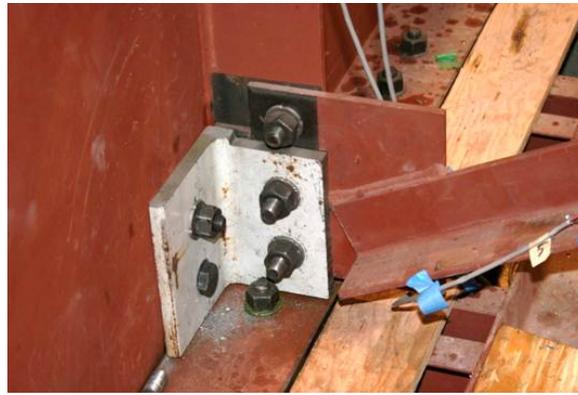
Figure 15. Retrofit measure 6: (a) Schematic of retrofit 6 (interior view); (b) Maximum principal stress contours in the web gap region with the angles removed from view; arrows point to point of highest maximum principal stress along HSS Paths 1 and 2. Cracks were modeled with XFEM and contour integrals. (c) Photograph of interior side of girder with stiffener-to-web angle and backing plate retrofit

L6×6×3/4 angles and a 457-mm×203-mm×19-mm (18-in.×8-in.×0.75-in.) backing plate were modeled to reflect the dimensions of the retrofit elements used in the physical simulations. In this model, there was a 102-mm (4-in.) horseshoe-shaped crack and a 203-mm (8-in.) horizontal crack in the bottom web gap_(test), dimensions that were consistent with the crack lengths achieved in the physical simulation of the specimen before it was retrofitted. Stresses in the web gap region decreased by 98% for HSS1 and 91% for HSS2 after application of retrofit method 6, compared with the unretrofitted case with a 102-mm (4-in.) horseshoe-shaped crack and a 203-mm (8-in.) horizontal crack. Maximum principal stress contours on the interior of the girder can be seen in Figure 15b, and maximum principal stresses in the web under the backing plate are presented in Figure 16b.

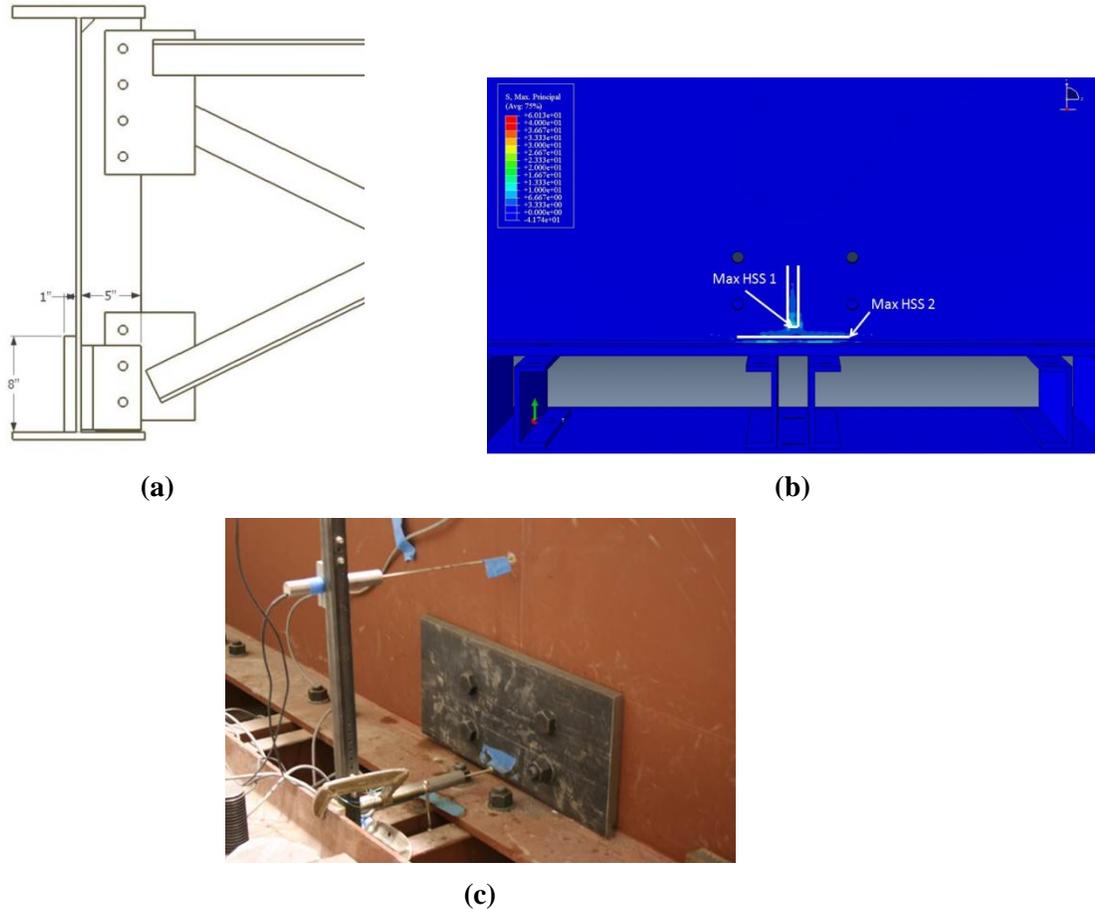
Figure 16. Retrofit measure 6: (a) 457-mm (18-in. long) backing plate on exterior side of web; (b) Maximum principal stress contours on the exterior side of web with the back plate removed from view; arrows point to point of highest maximum principal stress along HSS Paths 1 and 2. Cracks modeled using XFEM and analyzed with contour integrals. (c) Photograph of steel backing plate on fascia side of girder.

When comparing the HSS values for each model, it was found that if the backing plate thickness was kept constant at 25 mm (1.0 in.) (the greatest thickness within the range analyzed), the thickness of the angles had a negligible effect on stress. The opposite also held true; when the angle thickness was kept constant at 25 mm (1.0 in.), the calculated HSS was insensitive to the thickness of the backing plate. Therefore, it was found that choosing the stiffest option for the angle, the backing plate, or both would provide the greatest reduction in the computed stress.

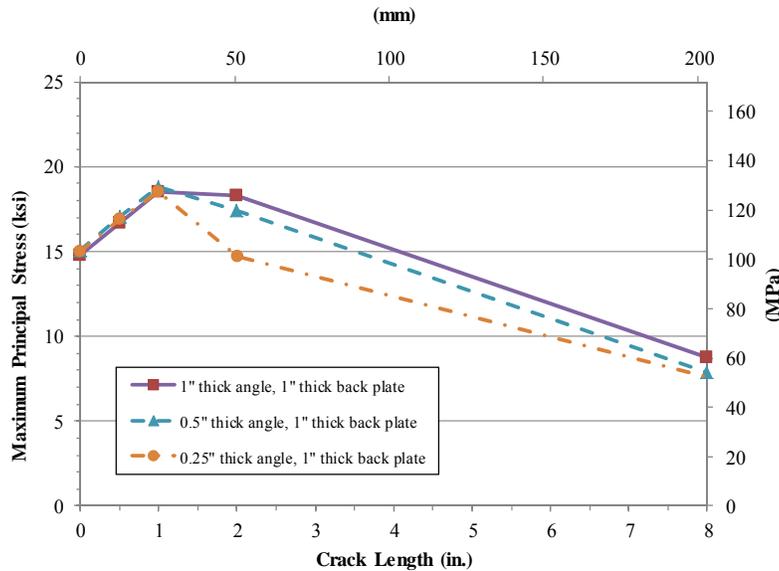
Figure 17. Change in maximum principal stress along HSS path 2 (horizontal web-to-flange weld) as crack length increased.

The effect of crack length on HSS was as follows. When stiff angles or a stiff back plate was used, the maximum HSS1 occurred when there were no cracks present. If both a stiff angle and plate were used, HSS1 values decreased slightly as the crack length increased, and eventually stabilized.

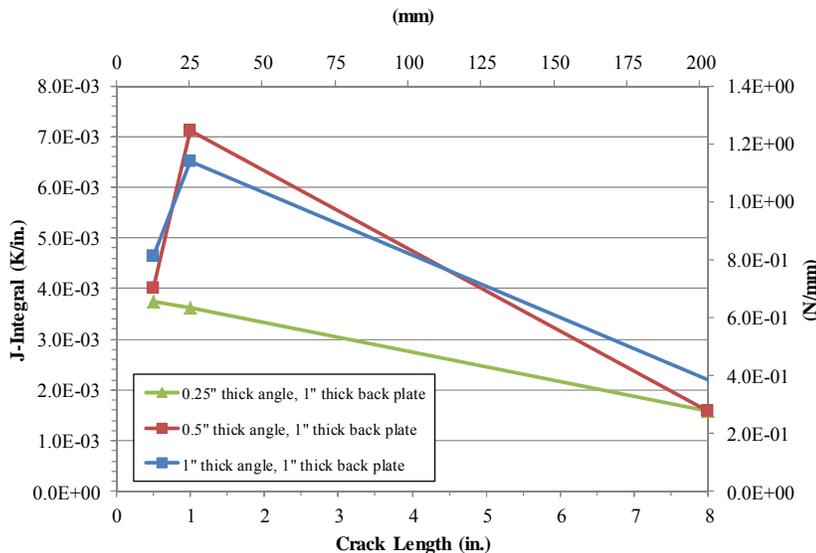
Figure 18. Change in J-Integral for horizontal web-to-flange weld crack as crack length increased.

Figure 18 and 19 show that HSS 2 and the J-Integral exhibited common trends as the horizontal crack lengthened. In both figures, a 25.4-mm (1-in.) thick back plate was applied, while the thickness of the angles was varied. HSS2 increased slightly as the crack lengthened, up to a crack length of 13 mm – 25 mm ($\frac{1}{2}$ in. – 1 in.), at which point stress in the horizontal crack decreased with further increase in crack length. These findings are important because they shed light on the effect of crack growth on stress when the retrofit is implemented. For the crack lengths studied, it was found that configurations with intermediate crack lengths of 25 mm (1.0 in.) at the web-to-bottom flange_(test) weld produced the greatest demands on the retrofit.

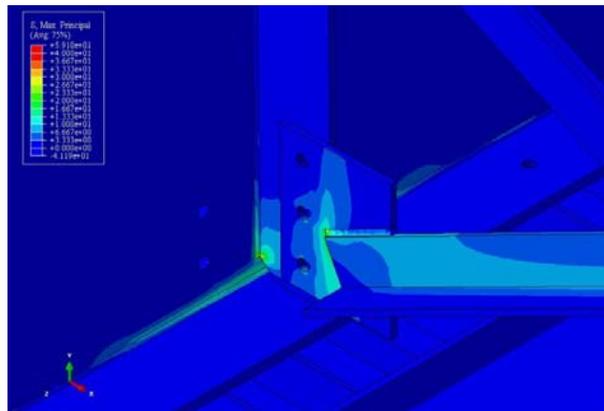
Figure 19. Maximum principal stress contours in an uncracked model with stiff web-to-stiffener angles and backing plate (Retrofit 6) applied.

As mentioned, the bolted web-to-stiffener angles with backing plate retrofit was modeled on cracked and uncracked specimen geometries to examine the effectiveness of the retrofit if used as a preventative

measure. It was seen that HSS 1 and 2 values were similar in magnitude when comparing retrofitted models with various crack lengths to a retrofitted, uncracked model. When 25 mm (1 in.) thick angles and backing plate were used, the uncracked configuration saw an HSS1 value of 60 MPa (8.7 ksi), while the model with a 102-mm (4-in.) crack had an HSS1 value of 38 MPa (5.5 ksi). Similar results were found for HSS2. The web-to-stiffener angles and backing plate retrofit exhibited a high level of stress reduction for both HSS1 and HSS2 in the web gap region for both the uncracked, retrofitted and the cracked, retrofitted scenarios. Therefore, this retrofit shows merit as a preemptive retrofit technique as well as a post-cracking retrofit technique.
