DESIGN FOR LAUNCHING AND OWNING A CURVED 2- GIRDER BRIDGE

DESIGN FOR LAUNCHING AND OWNING A CURVED 2-GIRDER BRIDGE

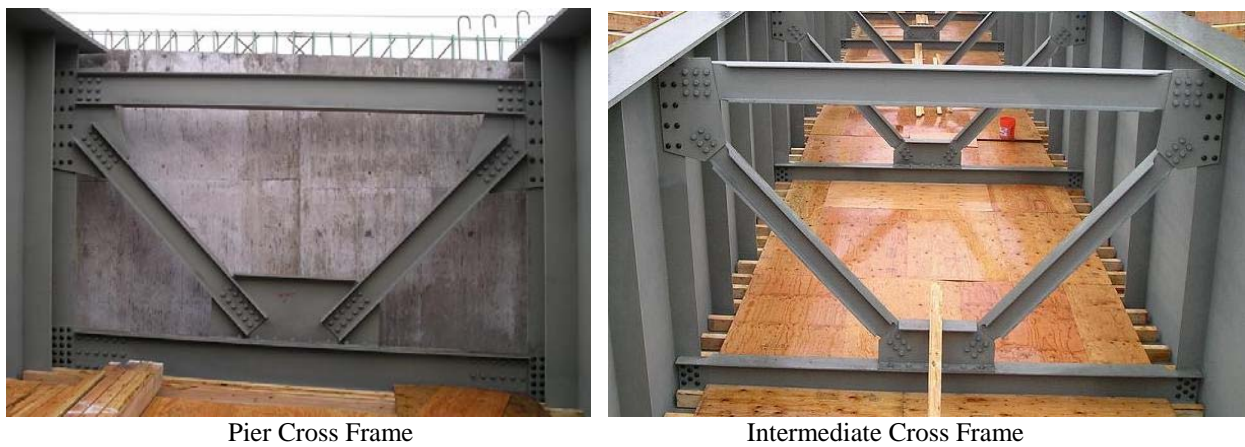
Figure 4 ~ Cross Frame Designs

AASHTO Article 6.13.1 (1) states that the cross frames need only be designed for the force effects determined in the structural model. This is what is typical at WSDOT. However, the designers considered the cross frames as part of the "primary load carrying system," so they felt it was worthwhile to design the cross frames for 75% of the member's capacity as suggested elsewhere in that AASHTO Article. The cross frames provide torsional stability of the entire system, and if they were to fail, the bridge could collapse or at least show some large deformations. What made the 75% rule interesting is that loads did not drive the cross frame design. The designers had to iterate between member sizes and connection designs to gain 75% of that member's capacity. By following the 75% rule, the cross frames had much more capacity than otherwise needed to support the design load. See Figure 4.

To fully understand the details of this project, a few structural details need to be understood. The on ramp, SE Line Bridge, spans 208'. The off ramp, NE Line Bridge, spans 248'. Both bridges consist of two steel plate girders, simply supported, each constructed with three steel segments. The SE Bridge has a constant web depth of 10'; the NE Bridge web is 10'-9" deep. The cross frames are steel K-Frames with moment connections at the ends of all the members, see Figure 4 further ahead in this paper. The

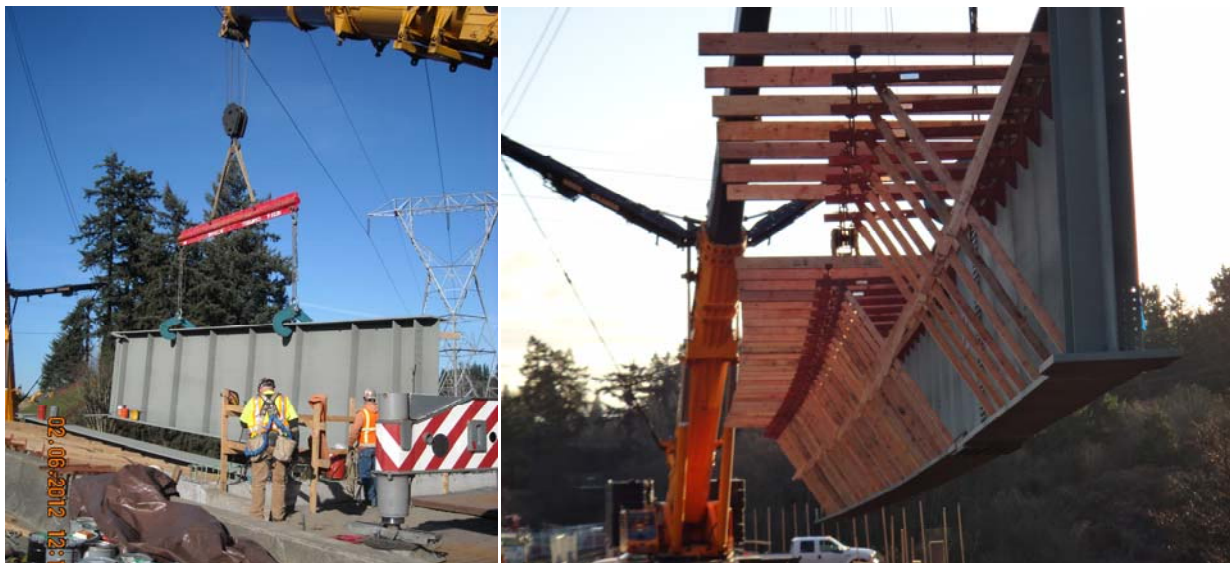
Figure 5 ~ Girder Erection

The bridge contractor and their erection subcontractor decided not to pursue launching. They chose to pick the pieces from a delivery truck and place them on shoring towers, see Figure 5. For the area closest to the power lines, they chose to use a high capacity extension crane with flat picks and a short boom length. They decided not to place the crane on the adjacent bridge because they did not want to pay for the cost of the engineering to determine where to place the crane.
