# DESIGN, CONSTRUCTION AND STRUCTURAL HEALTH MONITORING OF A STEEL ARCH BRIDGE

Under a contract with the Iowa DOT, HDR Engineering, Inc. performed a bridge replacement Type Study and final design services for the replacement of the existing concrete arch bridge on US 65 crossing the Iowa River in Iowa Falls, Iowa. The existing bridge was structurally deficient and functionally obsolete, leading the Iowa DOT to opt to demolish the existing bridge and build a new bridge on the existing alignment. The replacement option consisted of a Partial Thru Steel Arch Bridge.

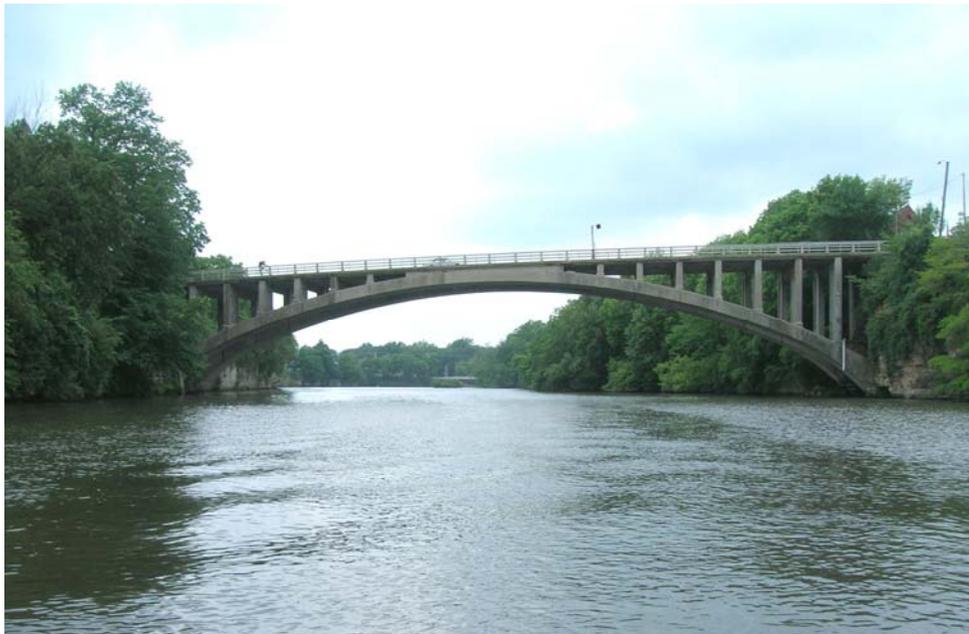
Figure 1

This bridge is located in Iowa Falls, Iowa and was built in 1928. It is a 235-foot reinforced concrete open spandrel deck arch structure with a 24-foot-wide roadway and 5-foot-wide sidewalks on each side of the roadway.

Elevation of Existing Bridge, Looking West

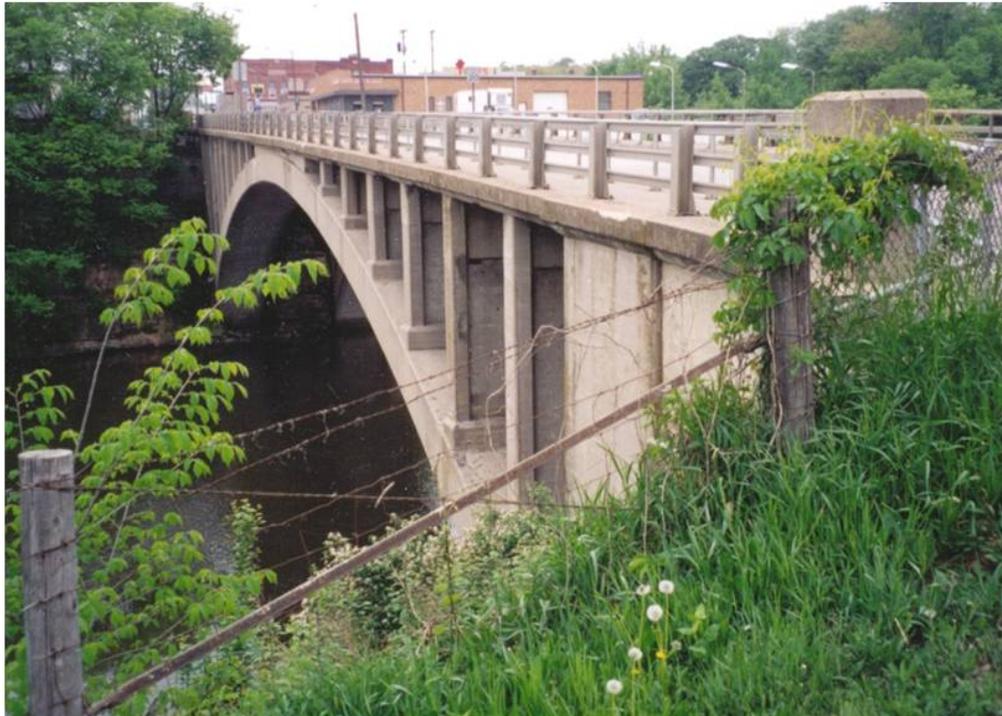
Figure 2

The reinforced concrete deck is supported by reinforced concrete floor beams, which are a part of the spandrel bents. The spandrel bents frame into the reinforced concrete arches and the arches are supported by reinforced concrete abutments (thrust blocks). The abutments are founded in the native rock outcropping. The existing bridge had undergone rehabilitation on seven different occasions with the major rehabilitation in 1976 and 2000. Original construction expansion joints were placed transverse to the deck at the ends of the deck and at 6 other locations along the deck. The joints deteriorated over the years and caused major deterioration in the floor beams and columns directly below the joints. However, subsequent rehabilitation eliminated all the intermediate expansion joints. Costs of repairs and strengthening of the existing bridge were a major factor that played into the decision to replace the bridge. The existing bridge was listed on the National Register of Historic Places.

Existing Bridge, Looking North

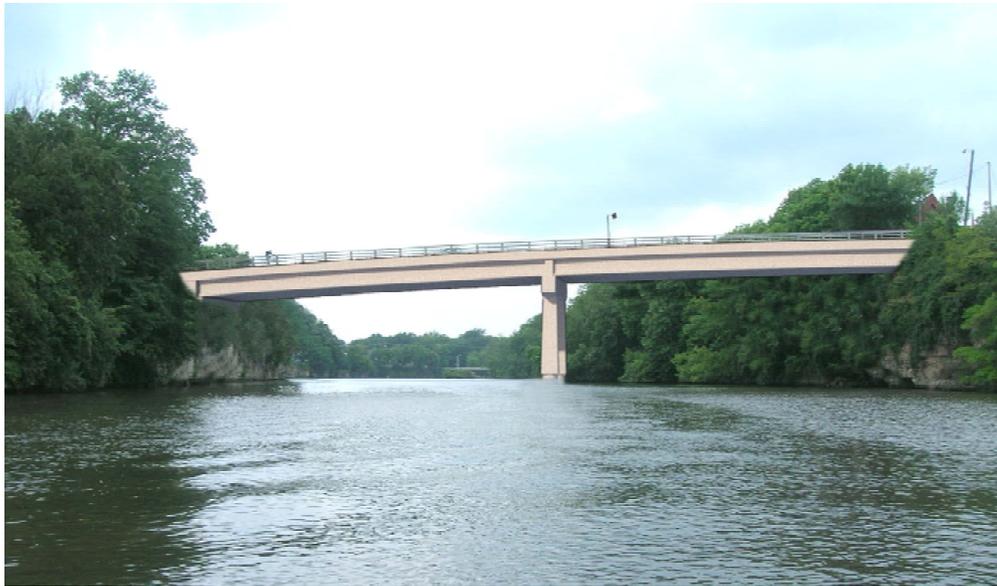
Figure 3

### **A Prestressed Concrete Girder Alternative**

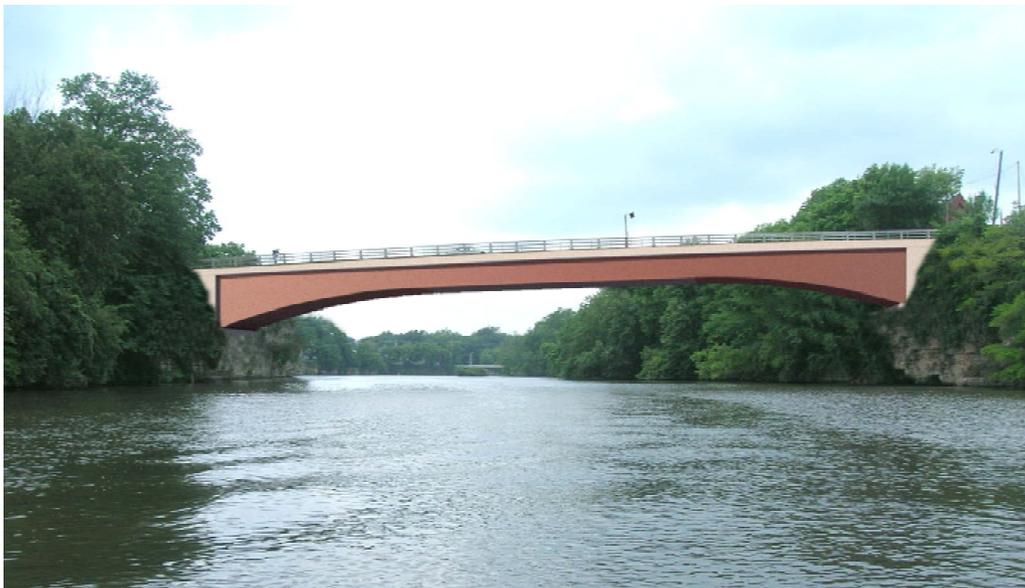
Figure 4

### **A Haunched Steel Girder Alternative**

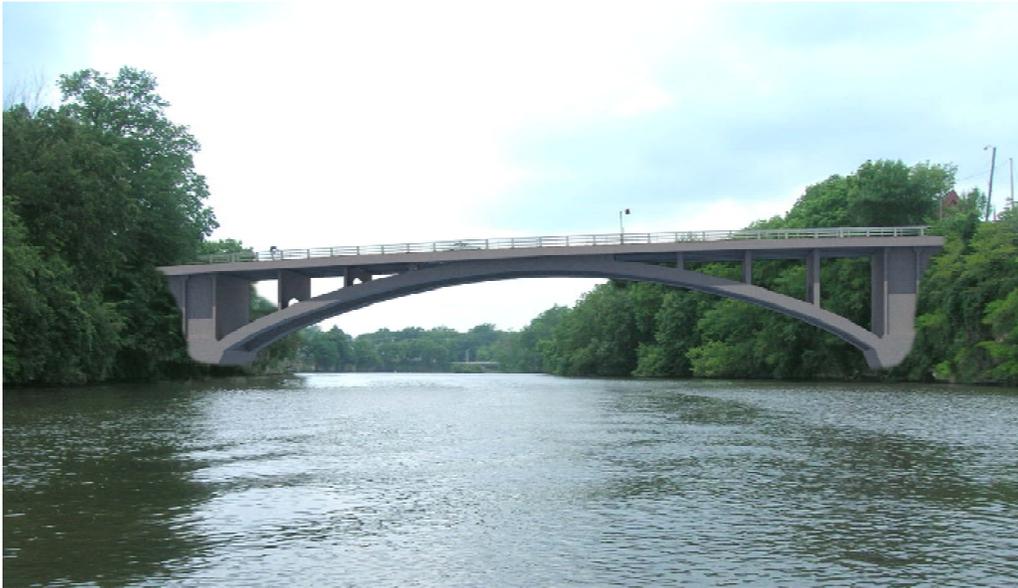
Figure 5

## **A Concrete Deck Arch Alternative**

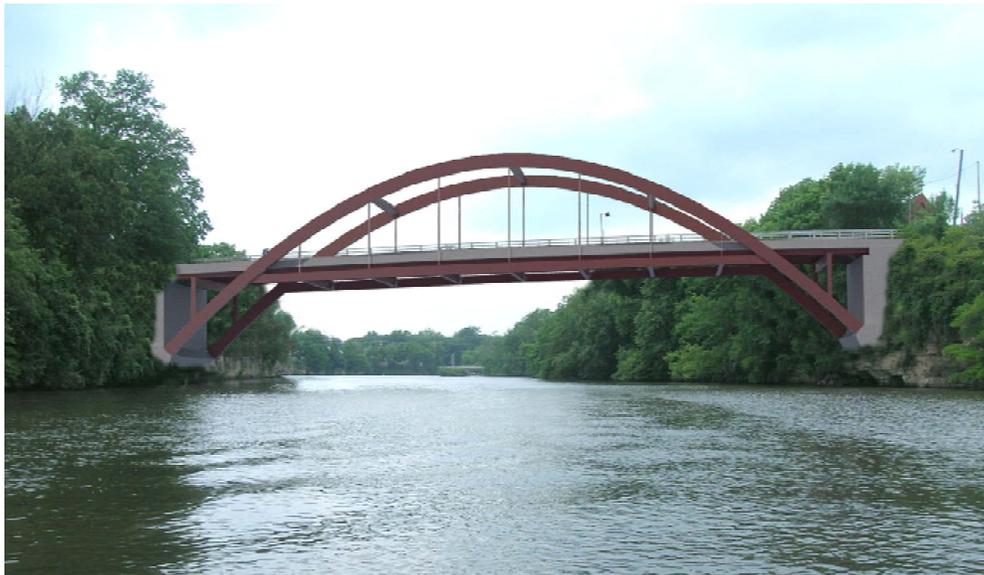
Figure 6

## **A Partial Thru Steel Arch Alternative**

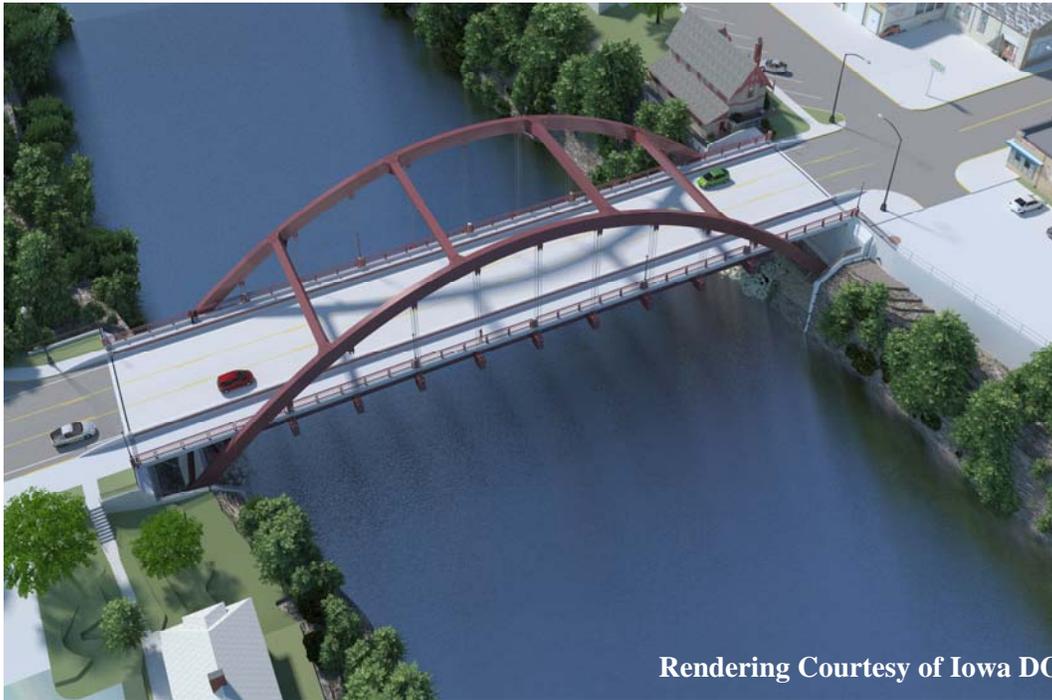
Figure 7

Therefore, taking all considerations into account, the Iowa DOT decided on the Partial Thru Steel Arch option. Preliminary plans were prepared. The replacement bridge required the construction of numerous retaining and stabilizing walls to allow for the skewbacks of the arch to be placed as well as to protect the adjacent properties. A preliminary rendering of the final steel superstructure is shown in Figure 7.

Conceptual rendering of the Partial Thru Steel Arch Bridge

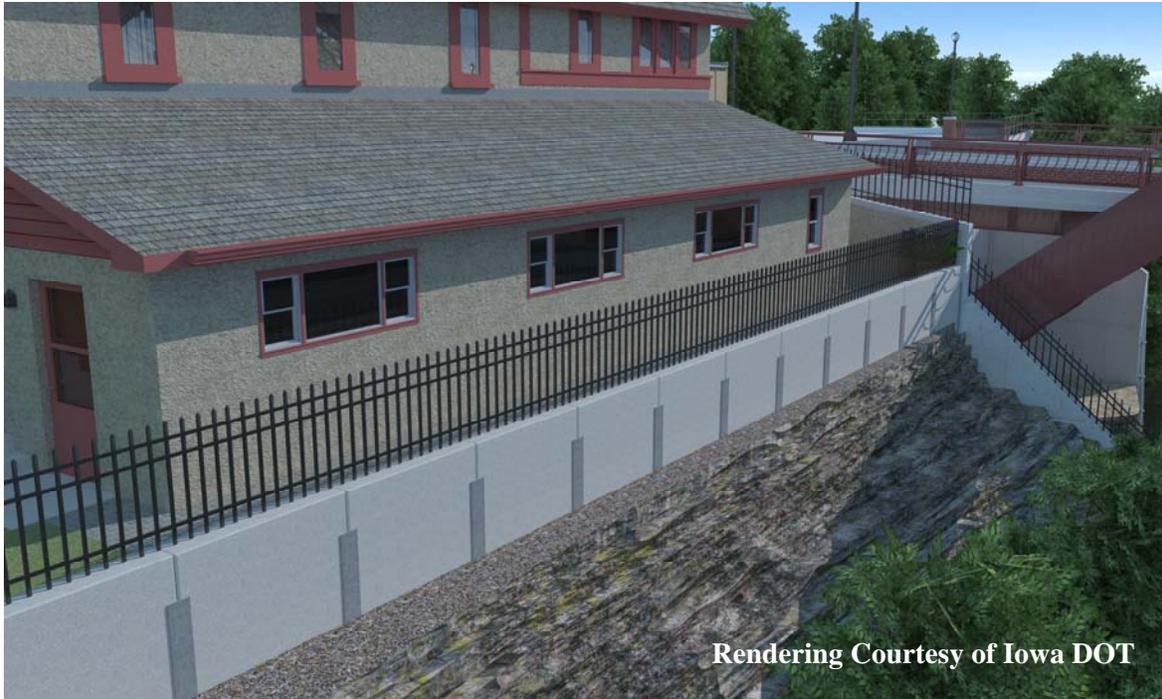
Figure 11

The existing stacked stone retaining wall located on the river side of the church providing access around the building was also at risk. This wall showed evidence of sloughing off the rock below and it was deemed at risk of failure during construction, especially as construction would require removing part of the wall to make room for the foundation of the bridge. In order to both replace the wall and provide additional support for the church during construction, a micropile system with lagging wall was installed along the south side of the church. This wall would extend to the rock nail and concrete fascia walls at the edge of the bridge footing. See Figure 11.

Rendering of the Micropile Wall on the South Side of the Saint Matthew's Church

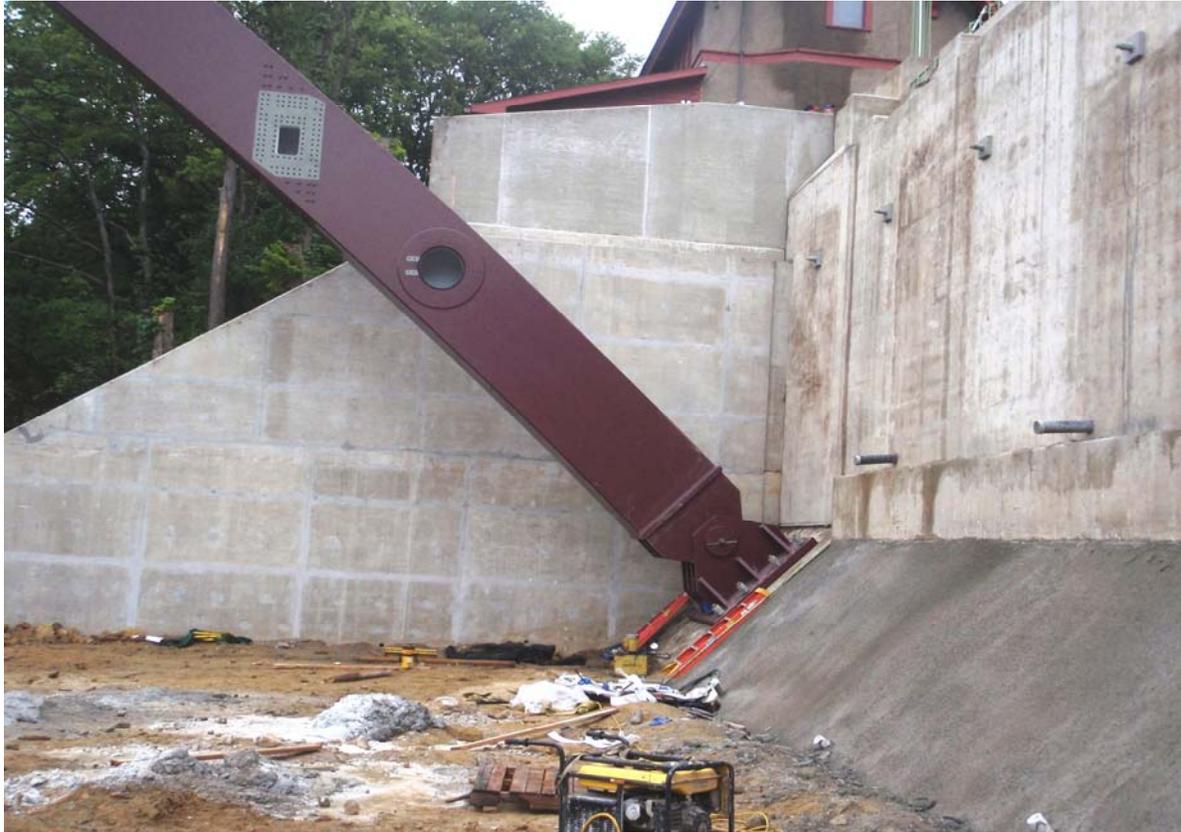
Figure 15

A third cause of the more square arch rib is the use of pinned bearings as opposed to fixed bearing connection. Often, with longer spans, the reduced “k” value for the “ $kL/r$ ” ratio obtained by use of a fixed bearing will more than offset the additional steel required to resist the higher moments developed at the arch skewback due to the fixity of the bearing. However, after much iterative analysis, it was determined the reduced moments from a pinned connection saved more steel weight than a fixed design. The additional benefit of the pinned bearing connection is the effect it has on the load transfer to the

substructure. Removing the moment from the primary direction greatly reduced the size of footing required. Due to the tight geometric constraints, a smaller footing footprint was required to lessen the impacts to the adjacent properties, particularly near the historic church on the north side. See Figure 15.

Pinned Bearing Constructed in Place

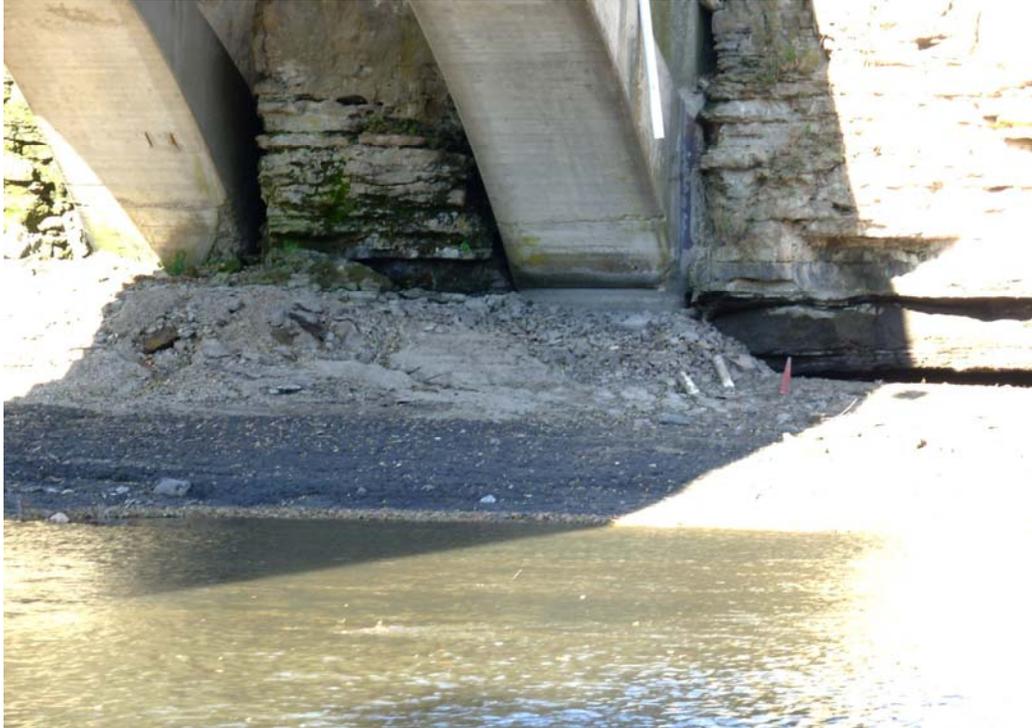
Figure 16

The site of the Iowa Falls Arch Bridge was very conducive to the high load foundations required for an arch bridge. The walls of the Iowa River channel are very steep and formed of a competent weathered limestone. This rock allowed for a very high bearing capacity. However, the river below created a complication. The Iowa River flow is controlled by a dam just downstream from the bridge site. As opposed to the natural rise and fall of the stream, the dam has kept the river to a fairly constant depth under the bridge. This has allowed the water to infiltrate the weathered limestone and undermine portions of the existing historical bridge's abutments. See Figure 16.

Existing Arch Bridge North Abutment Showing Undermining

Although the new bridge was proposed to have a longer span, thus removing all areas presently undermined, it was desirable to design a structure less susceptible to undermining than a spread footing founded on the rock wall.

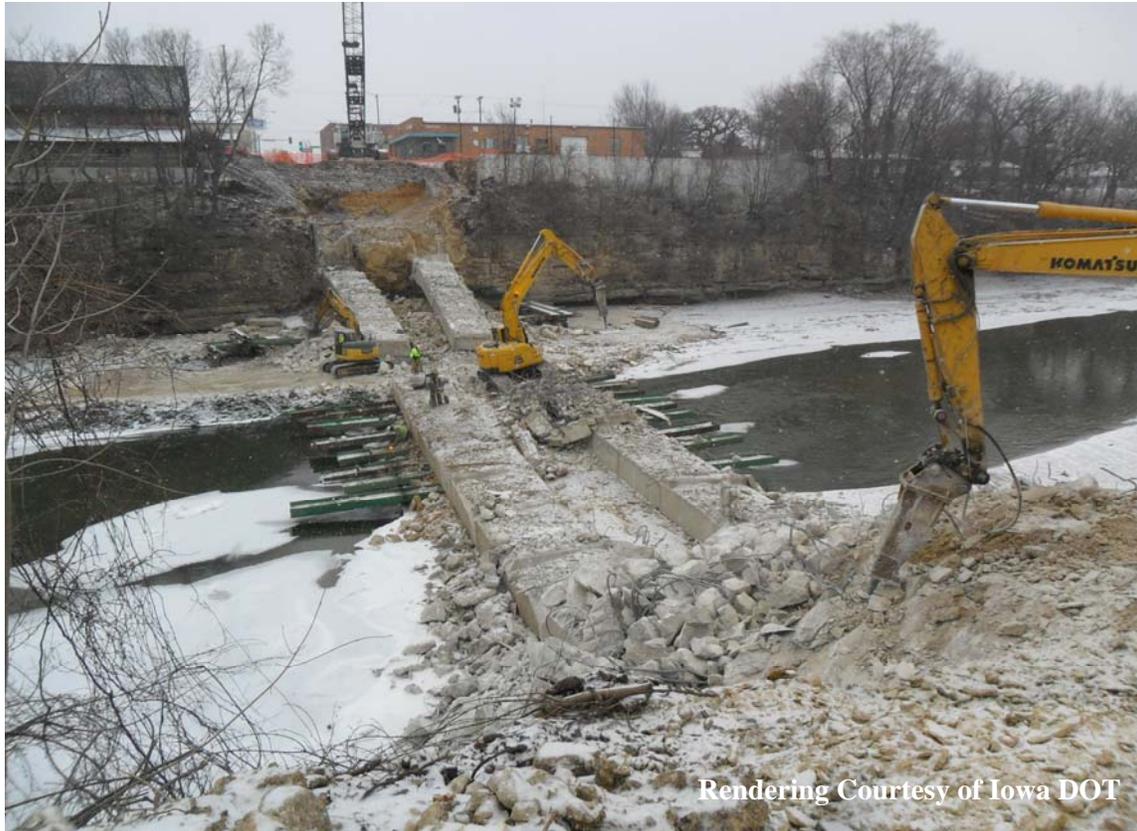
Figure 19

In accordance with the contract plans, the contractor first constructed the micropile retaining wall on the south side of the historic church. Following this construction, the contractor was able to proceed with the demolition of the arch. Conventional methods were used for the removal of the existing deck and columns. The concrete from the deck removal was then used to line the channel underneath the bridge, as it was the contractor's intent to drop the arch pieces onto the rubble pad built under the bridge. The arches were jack hammered at strategic location near the end thus allowing them to fall under their own weight onto the earthen pad constructed underneath the existing bridge. See Figure 19. The contractor then proceeded to perform the excavation for the abutment and construct the rock walls around the abutments. Concurrently with the excavation and abutment construction, the contractor constructed the falsework supports to aid in the erection of the steel arch, and the deck framing.

### Demolition of the Existing Bridge

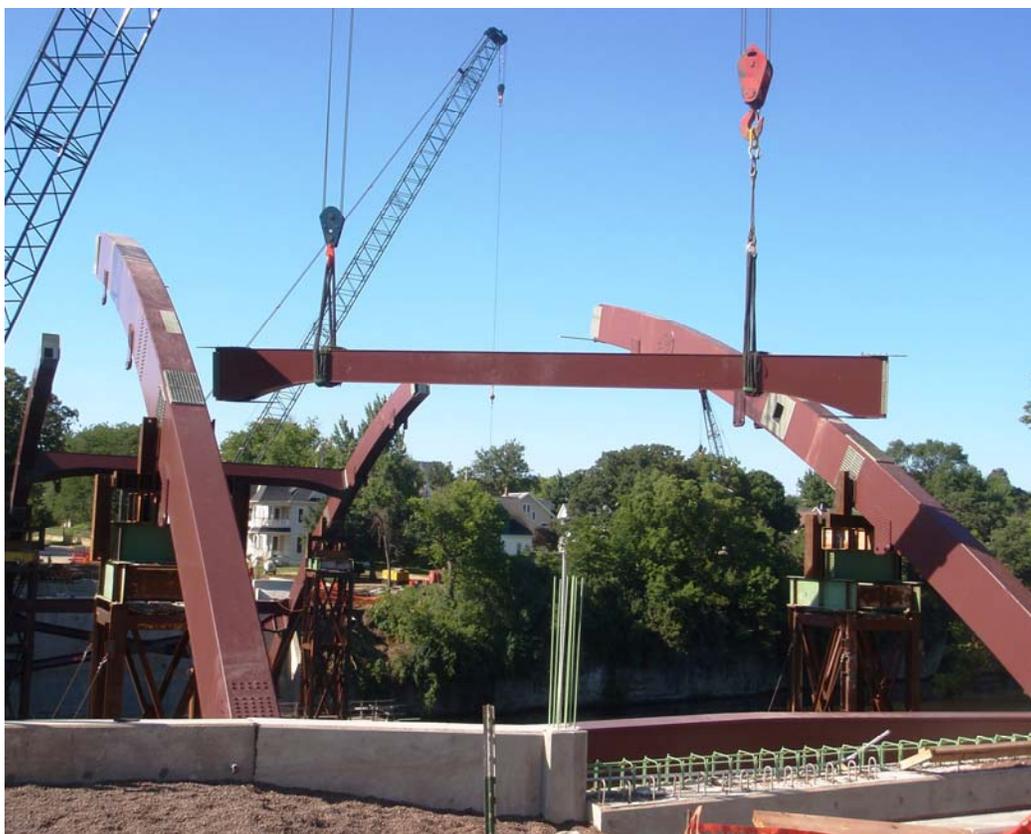
Figure 20

The steel erection began in mid-July with the placement of the south bearings. Utilizing falsework towers in the river, the first two segments of the arch were erected from both sides of the river. The falsework towers were designed to allow the segments of the arch to be adjusted vertically to facilitate the setting of the crown section. See Figure 20. After both arch ribs were erected along with the end floor beams, lower cross bracing and the cross struts, the contractor started erecting the floor system. The floor system was erected in a panel by panel method from south to north.

### Structural Steel Erection
