DESIGN AND CONSTRUCTION OF THE CAPILANO CLIFFWALK BRIDGES

DESIGN AND CONSTRUCTION OF THE CAPILANO CLIFFWALK

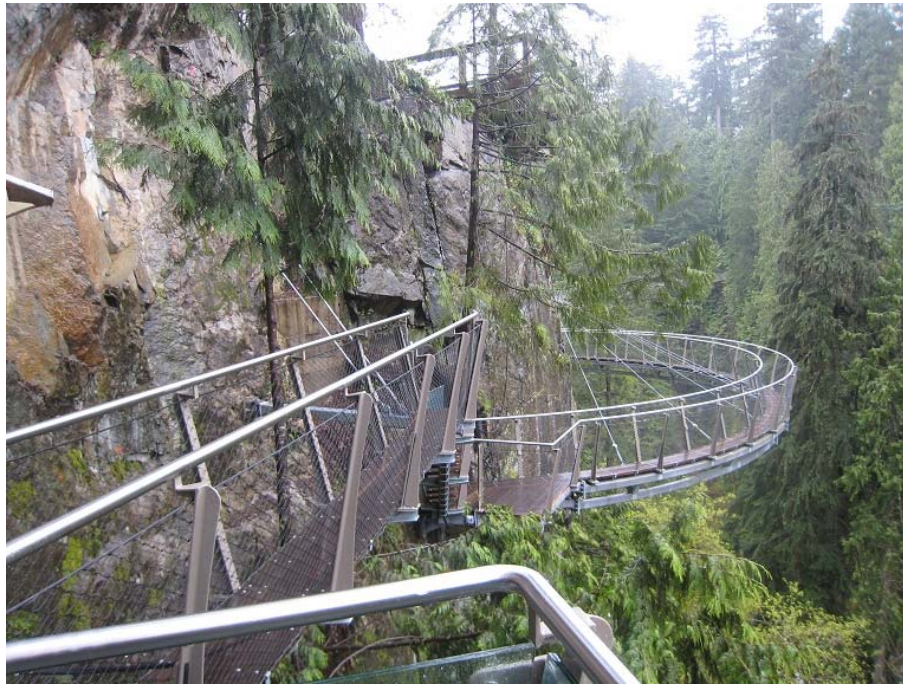
Cliffwalk is a pedestrian walkway, which at its highest point, is 30 stories above the Capilano River. It travels along the granite cliff on the east face of the Capilano Canyon. The 700 ft long steel structure is 1.64 ft wide and is cantilevered approximately 10 ft out from the cliff face. The structure brings visitors down along the cliff by a spiral stairway; 8 bridge spans; 5 straight stairways; 7 observation platforms (two with glass decks); and a 100 ft long cable supported semi-circular bridge; and it provides countless thrilling experiences (See Figure 1).

Figure 1. Cliffwalk general view.

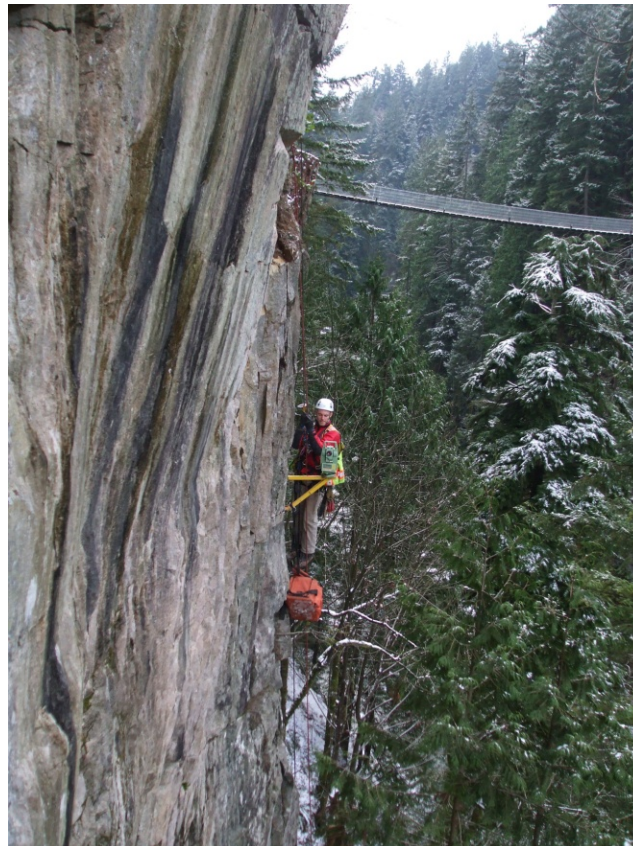
For ease of access, lightweight equipment was required for surveying along the face of the cliff. A Leica TCRA 1103 total station was selected for its relatively low weight within its class of instrument, and customized survey legs were built for setting up the instrument on very high angled ground (See Figure 2). A majority of the survey data was collected using the reflectorless capability of the total station; however, it was not always possible to have direct sightlines to all features on the cliff. At these instances, a surveyor would rappel down the cliff face with a target reflector to gather additional data that could not be seen directly from the ground.

Figure 2. Typical topographic survey along the cliff face.

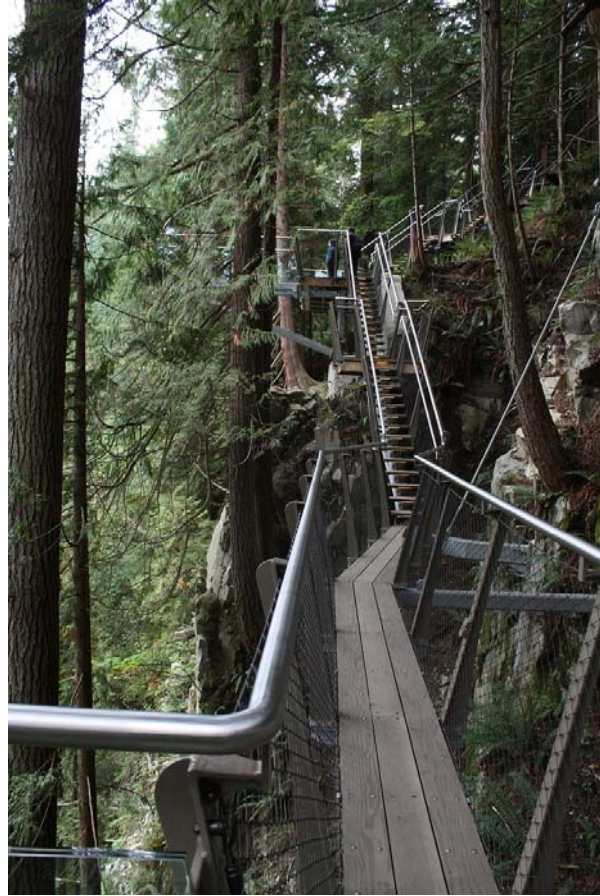
The final design consists of a descent of 29 ft (3 stories) down from the entrance of the Cliffwalk to the curved bridge, and then an ascent of about 58 ft (6 stories) back to the trail system at the exit of the structure (See Figure 4).

Figure 4. Ascending stairs.

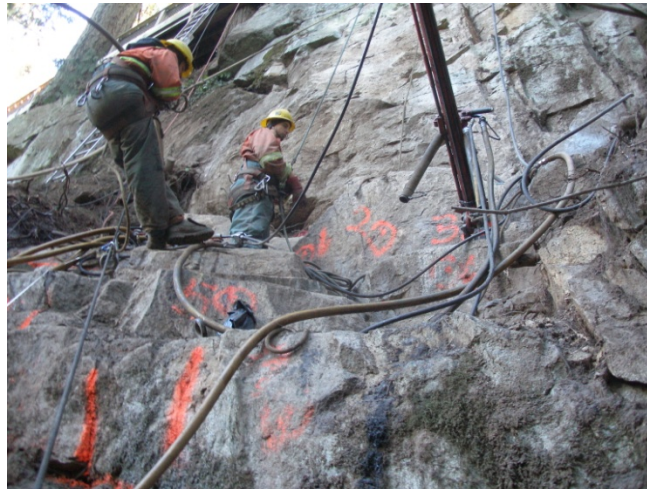
Figure 5. Typical rock bolting construction.

The rock bolts are all galvanized steel bars, either 1" or 1¼" in diameter and up to 18 ft long, depending on the rock conditions and the loads applied by the structure. The bolts are anchored with cement grout over the full length of the bar so that the combination of galvanizing and embedment in cement provides corrosion protection for the steel. The total length of rock bolts installed on the project for both rock reinforcement and securing the foundations is approximately 1673 ft.

At each foundation location, rock bolts were installed to support the applied loads – either tension at the guy cables or compression at the cantilever beams. The design load of each bolt is 50% of the ultimate strength of the bolt, which is a standard practice. The installation procedure was to first install the bolts and conduct pull tests to verify the capacity of the grout anchorages. The testing of rock bolts was done as per the Post Tensioning Institute. Then the anchor plate was attached to the face and the bolts were tensioned against the plate. The objective of post tensioning the bolts was to prevent any movement of

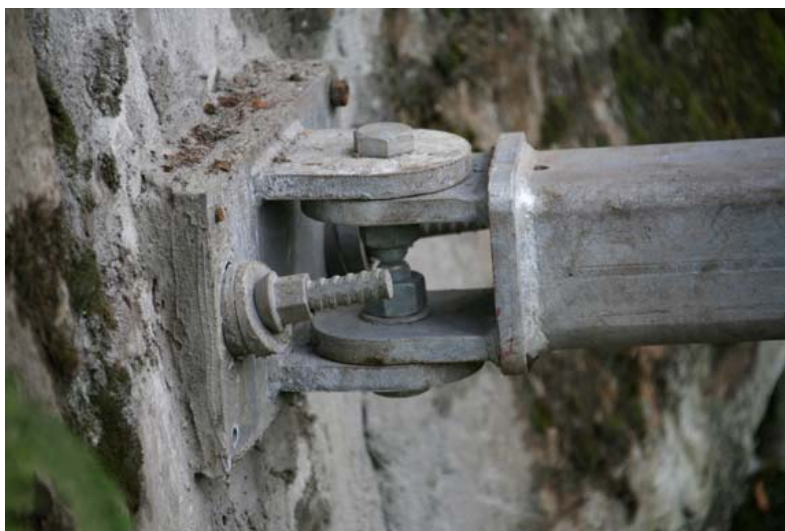
The propped cantilevers have steel anchor plates that are attached to the rock face via rock bolts to support the tension ties and the compression strut beam (See Figure 6). Once the plates were installed, their locations were surveyed and this information, in conjunction with the topographic survey, was put into a 3D model in AutoCAD and then into a 3D steel model in ProSteel to finalize the geometry and connection details for the structural steel frame. The ProSteel software was able to lay out the complex structure and produce shop drawings while assembling all the connection details and the bill of materials for fabrication.

Figure 6. Strut beam plate and rock anchors.

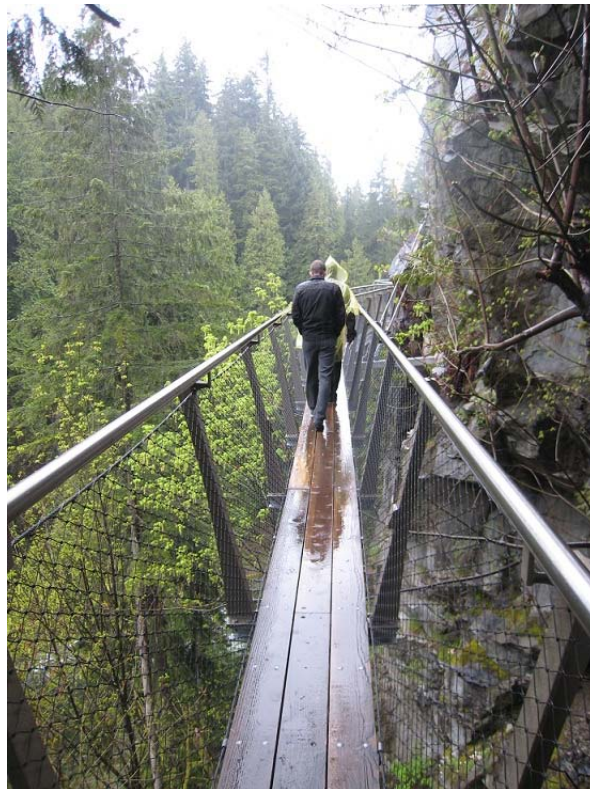
The deck and walkway designs were similar to the bridge structures that made up the Treetop Adventures, one of the other attractions of the park. Considerations were focused on safety, aesthetics, and practicality. An example of this was the design of the railing and post system. The 1.64 ft wide deck has hand rails set at 4 ft above the deck with inclined posts, providing 2.62 ft of clearance between the hand rails (See Figure 7). This is wide enough to allow two people to pass each other, a requirement when visitors are stopping to enjoy the scenery of the canyon. The local fire department was consulted during the design, and these access requirements were deemed satisfactory in conjunction with the emergency plans.

Figure 7. Typical walkway and handrail system.

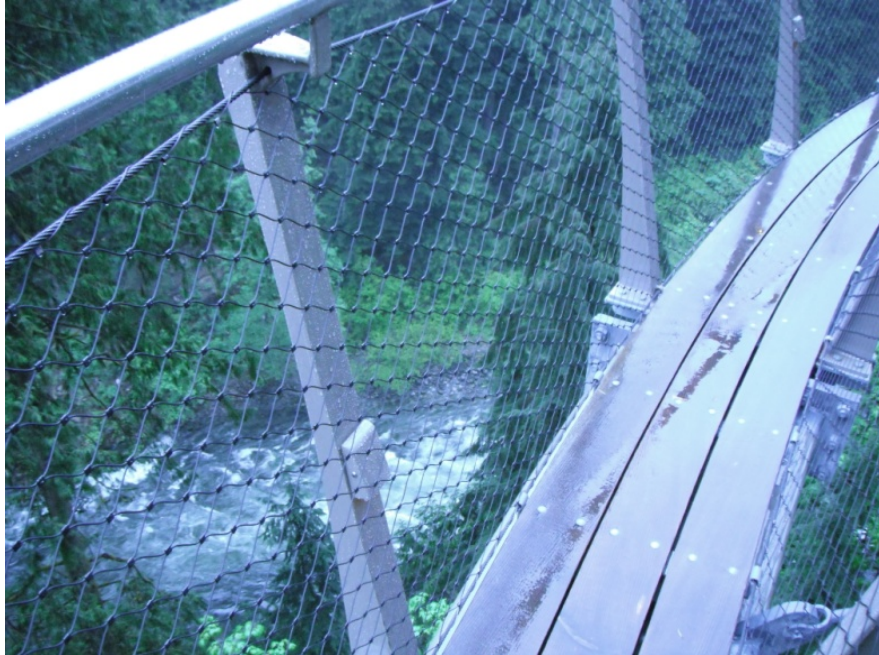
The final design utilizes a proprietary system X-TEND© available from Carl Stahl® DécorCable (See Figure 8). This system is a stainless steel woven wire mesh that can be designed to take on any tensioned 3D geometric shape and provided a barrier system that conformed to the ever changing geometry of the Cliffwalk. The woven wire mesh is treated with a black oxidation process and the mesh became virtually transparent when viewing from all angles, meeting the visual requirements of the project while providing a very durable and safe barrier. The barrier system also consists of more than 1476 ft of continuous 2” diameter polished stainless steel handrail along both sides of the entire walkway.

Figure 8. Stainless steel woven wire mesh.

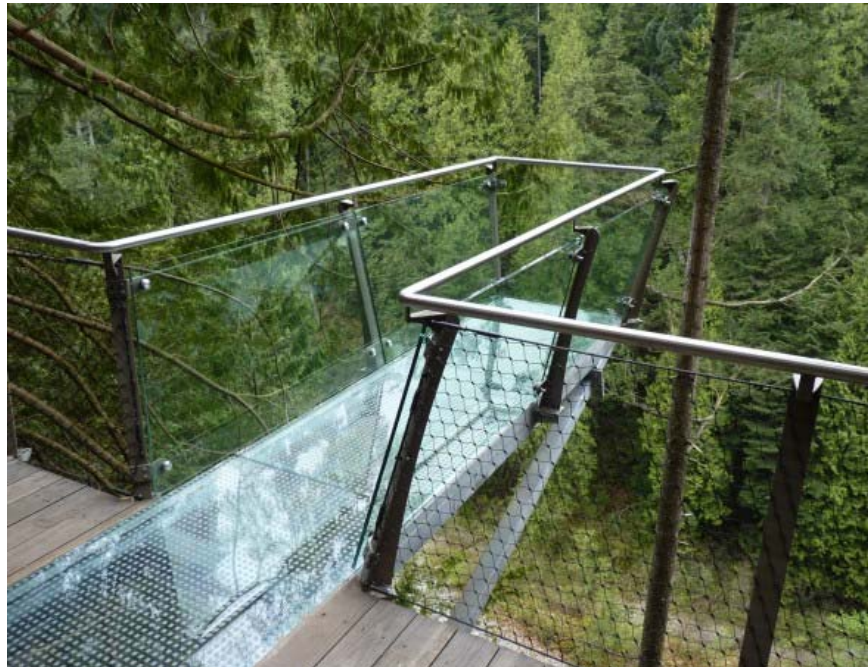
There are two viewing platforms on the structure with glass decks to provide a more thrilling experience (See Figure 9). These glass decks have a baked-ceramic anti-skid coating to prevent them from becoming slippery in the wet West Coast rainforest. Glass guardrail panels are also installed at these glass deck locations for a better viewing experience.

Figure 9. Glass deck viewing platform.

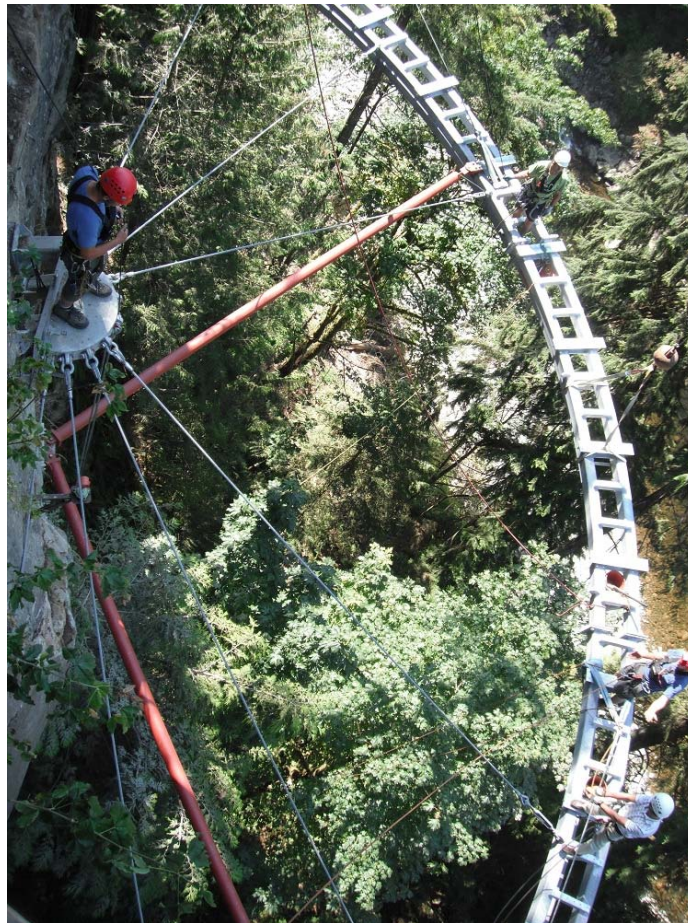
Two temporary adjustable compression bracing members were designed to help maintain the geometry of the semi-circular curve while also resisting the tension in the main support cables prior to all the segments of the compression ring being installed (See Figure 11). These bracing members were large turnbuckles with an adjustment length of $\pm 6''$ and the threaded portion of the member was reinforced with an outer sleeve to prevent buckling. The braces were pinned to a temporary anchor in the rock face at approximately the same elevation as the top chord / deck of the curved bridge, and they were bolted at the other end to the guardrail post holes at the bridge floor beam frames. They were set horizontally rather than with a vertical angle in order to simplify any geometry adjustments and to be able to better predict the loading in the cables during the construction stages.

Figure 11. Temporary bracing members (red) for the construction of the curved bridge.

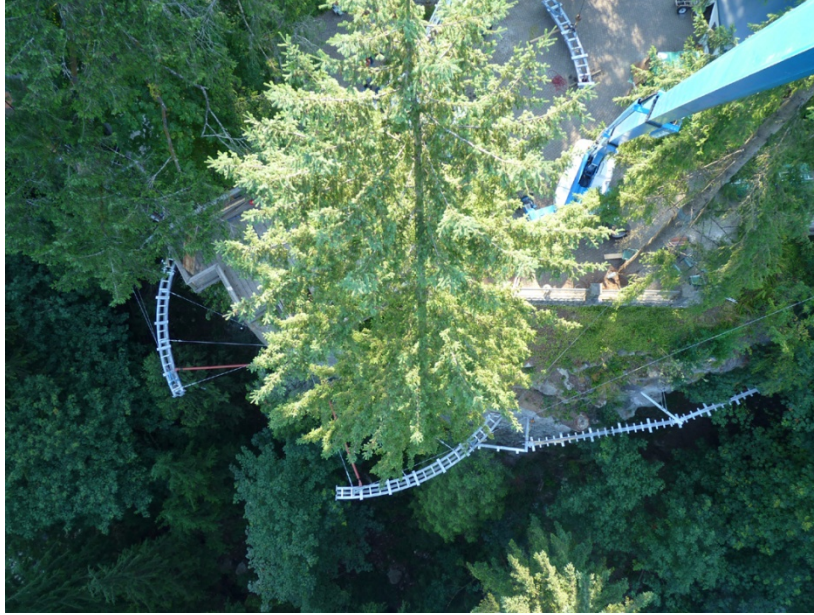
The construction started with the installation of the end segments which were cantilevered from the rock face (See Figure 12). The steel plates of these end segments were anchored with five rock bolts that were drilled and grouted at the abutment location of the curved bridge on the cliff face. The Link-Belt crane was used to support the bridge end segments while a jib crane was used to install the compression bracing and the first set of cables. The compression bracing and cables were adjusted throughout to bring the geometry of the bridge into position. The process of installing the segments and adjusting the cables was repeated for all six bridge segments.

Figure 12. Erection of the curved bridge.

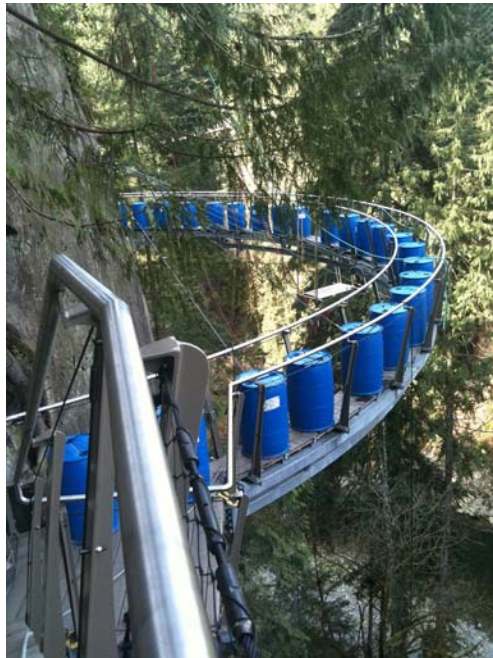
Nondestructive load testing was performed on the curved bridge and on two of the straight bridge sections to evaluate the load capacity and deflections of the structure. The chosen straight bridge sections are supported by a strut beam bolted to the rock face which produces the largest reaction comparing to other strut beam foundations on the project. The simulated load applied for the testing was equivalent to 0.6 psi, which was the design live loading and was achieved by filling 45-gallon barrels with potable water (See Figure 13).

Figure 13. Load testing the curved bridge with water barrels.

Instrumentation used in the testing included vibrating wire strain gauges, thermometers, tilt meters and a cable tension meter. Every third barrel was initially filled as part of the loading sequence while readings were taken from the instrumentation and a visual inspection was conducted until all the barrels are filled. Both the straight bridges and curved bridge were unloaded from one end to simulate checkerboard loading effects. The structures performed very well and the measured forces in the cables were found to agree closely with the predicted values.

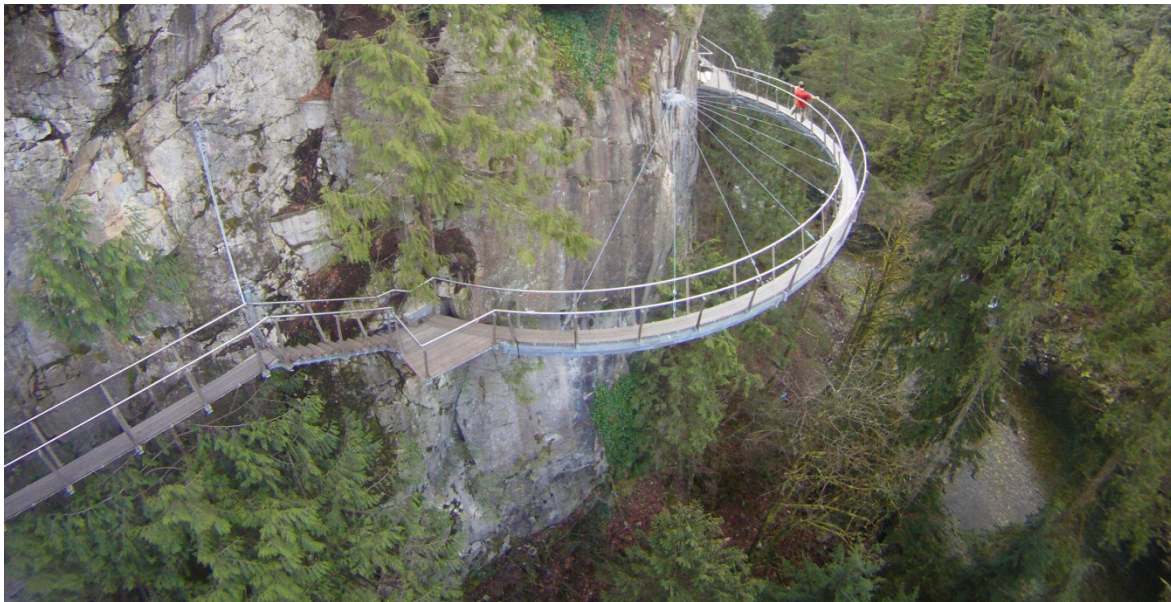
Figure 14. Constructed curved bridge testing the curved bridge with water barrels.
