# **RE-DECKING, STRENGTHENING AND WIDENING OF A 380M LONG TWIN TRUSS BRIDGE IN, TORONTO, ONTARIO, CANADA**

# RE-DECKING, STRENGTHENING AND WIDENING OF A 380M LONG TWIN TRUSS BRIDGE IN, TORONTO, ONTARIO, CANADA

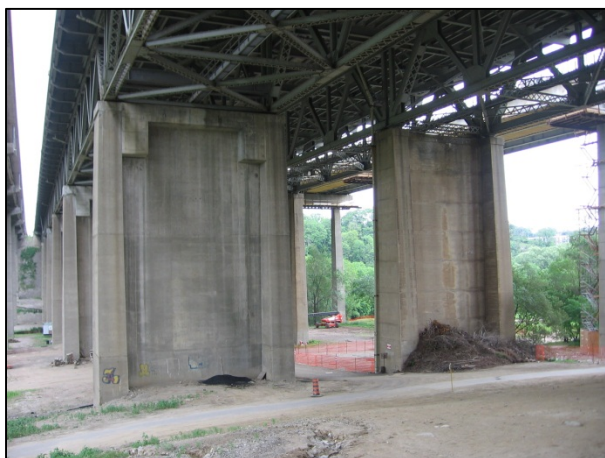
The Core Structures of Hogg's Hollow Bridge is the longest and highest bridge in the Toronto section of Highway 401. It has a total length of approximately 378 m, comprising 8 main spans each 42.7 m long supported on 6.4 m deep steel

trusses, consisting of concrete deck slabs supported on a system of steel stringers and floor beams (Figure 3). The two end approach spans, each about 20m long, are simply supported concrete deck on steel-I girders. The H-shaped reinforced concrete shaft type piers vary in height from approximately 5 m tall, near the approach spans to approximately 30 m tall near the centre of the bridge in the valley (Figure 3). The piers are supported on either piles or spread footings.

Figure 3: Truss Spans of the Hogg's Hollow Bridges

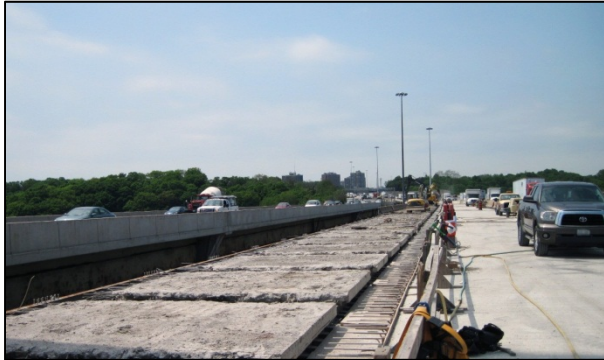
1. A 5 stage construction was implemented to maintain a full 12 lane traffic on Highway 401 over the construction zone including the reinstatement of the highway configuration at the completion of the deck replacement work at the final stage;
2. To provide sufficient deck width, a 2.6m widening of the WB Core deck was constructed during Stage 1 work;
3. A “half-and-half” approach was required to complete work within each of the first 4 work zones to allow passage of emergency vehicles on very short notice in the event of a major accident, resulting in any cross sectional strips including foundation works to be constructed in 8 segments, as shown in Figure 4;
4. Access and egress points were introduced at each work stage to allow safe entrance of construction vehicles into work zones, and to allow them to exit the work zones with

Figure 4: Sub-staging within 1 of the 4 working stages

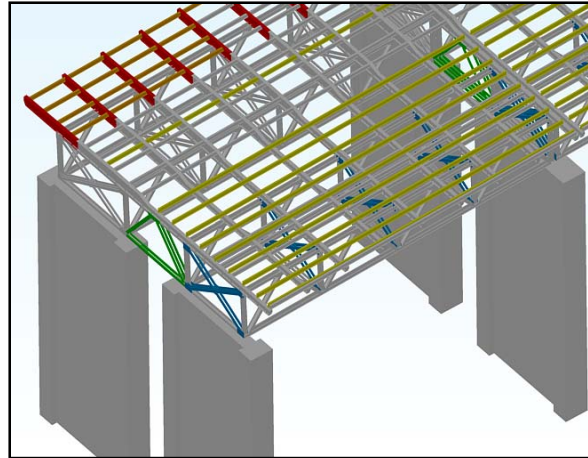
An overall view of the structural steel work can be seen in Figure 5, with the concrete deck removed. The scope included:

- Floor beam extension (as shown in Figures 5 in red);
- Additional cross frames to optimize the effects of the two parallel trusses (as shown in green);
- Replacement of selected existing cross frames of existing trusses (as shown in blue);
- Strengthening of existing diagonal members;
- Complete replacement of the stringers system (as shown in yellow and orange);
- Complete replacement of the end spans;
- Replacement of existing expansion joints and supporting structural steelworks;
- Bearing replacements and jacking systems;
- Access platforms; and
- Miscellaneous steel works

Figure 5: Schematic Diagram showing Scope of Steel Work required

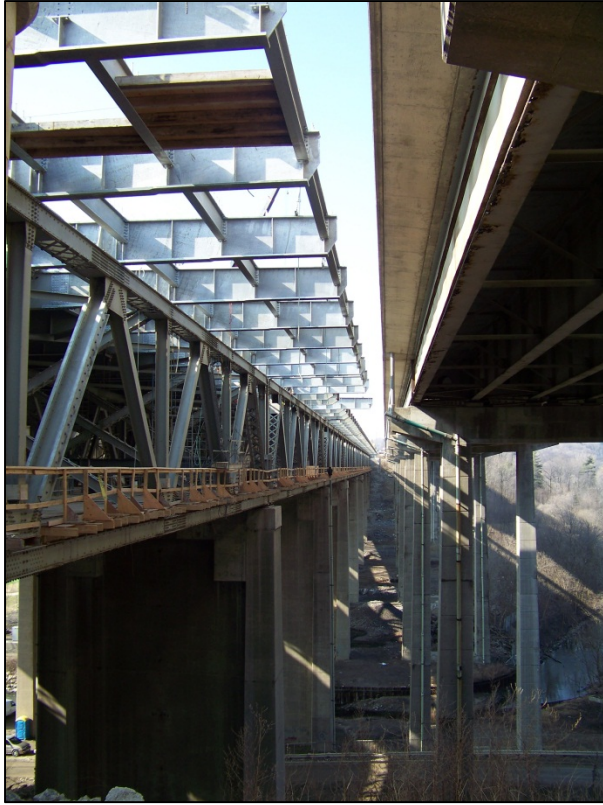
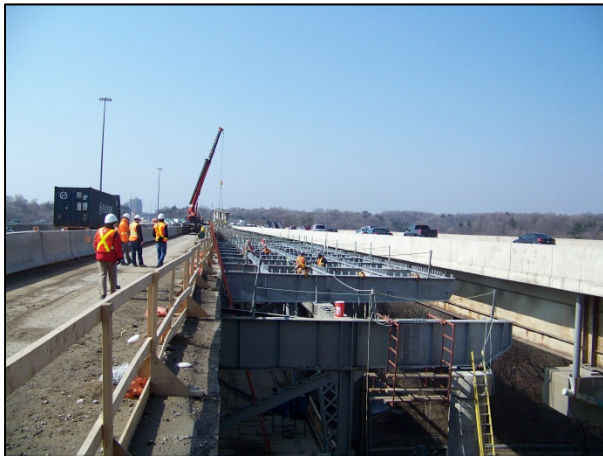
The floor beam extension was a major feature of this bridge project. The floor beams of the WB and EB structures were already linked together in a previous project to eliminate the original median gap. In this contract, each floor beam of the WB structure was cut at a location between the truss members and spliced with an extension piece to create a significantly larger overhang on the north edge of the structure, thus providing a wider deck for traffic and staging purposes. The completed floor beams, making use of previous works as mentioned above, created a continuous floor beam system supported on 4 truss points, instead of 2 shorter beams supported on 2 truss points, which minimized the impact of a one-sided, unbalanced widening of this structure (Figures 6 and 7).

Figure 6: Floor Beam Extension

Figure 7: Floor Beam Extension

This innovative solution was implemented to avoid the use of diagonal rakers due to the unknown condition of the existing joints and risks associated with continuous heavy traffic to be supported by the trusses. The use of rakers, such as the one used to widen the Leaside Bridge in the City of Toronto, as shown in the Figure 8, would require the use of a diagonal member to connect the tip of a floor beam extension to a node of the bottom chord of the truss, acting as a strut, which would be a more complex and costly design.

The floor beams were cut and spliced inside of the truss support. In order to maintain safety and stability of the floor beam system when a certain floor beam was cut, a rigorous sequence was adopted to maintain the safety and stability of the overall structure. This was accomplished by constructing temporary transfer girders to allow the loads normally carried by the cut floor beam to

be shared by adjacent floor beams when it was being extended.

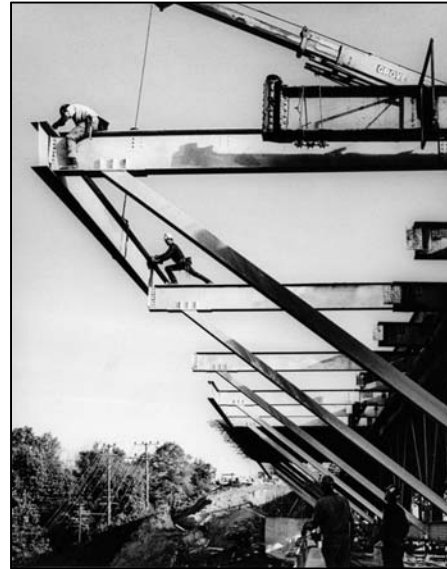
Figure 8: Deck widening of Leaside Truss Bridge in Toronto in the late 1960's

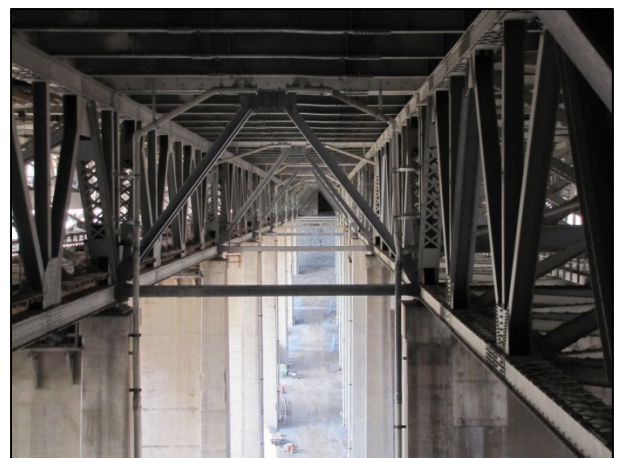
The EB and WB Trusses were connected via new cross frames at the pier locations to provide sufficient lateral resistance to earthquake and other horizontal loadings (Figure 9). Similar connection along the span was not structurally required and inherently risky, and was therefore not implemented.

Figure 9: Additional Cross-Frames at Pier Nodes

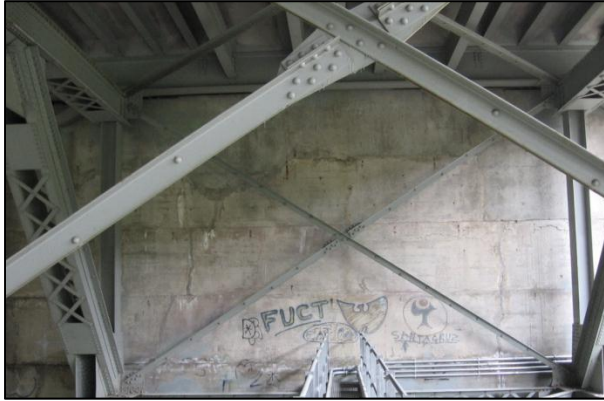
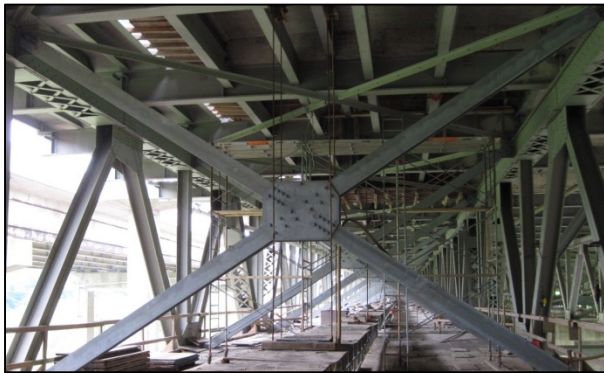
Existing cross frames consisted of steel angles. The structure was strengthened by replacing these weaker steel angles with stronger steel members to control excessive vibration to the eastbound lane trusses. Figures 10 and 11 show the member conditions before and after the strengthening work.

Figure 10: Existing Intermediate Cross Frames

Figure 11: New Intermediate Cross Frames

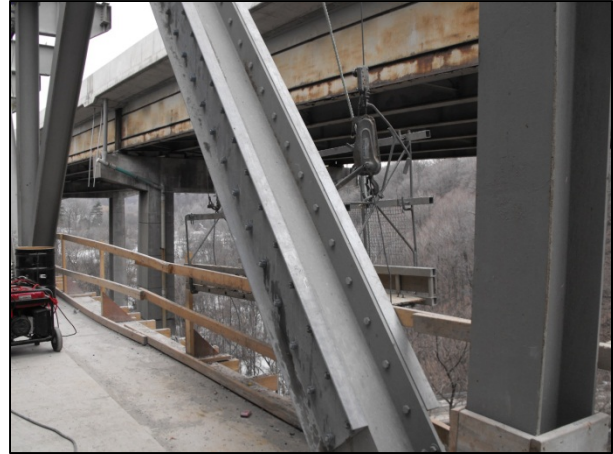
Structural evaluations showed that the existing diagonal members of the trusses were deficient in loading capacities according to the CHBDC. The cross-sections of these members were beefed up by splicing of steel plates and sections at appropriate locations (Figure 12). The increased section of these members improved the slenderness ratio and hence the compressive strength of these members.

Figure 12: Strengthening of Diagonal Members of Steel Trusses

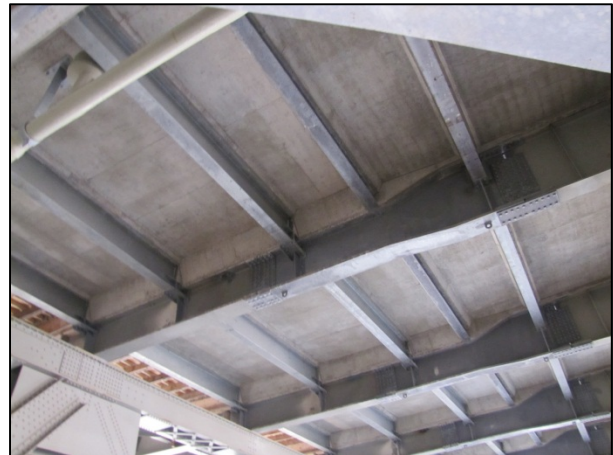
A major portion of the deck stringer system was replaced partly due to the poor conditions of these members, and partly to accommodate the new deck as well as to suit the newly reconfigured floor beam system (Figure 13).

Figure 13: New Stringer System

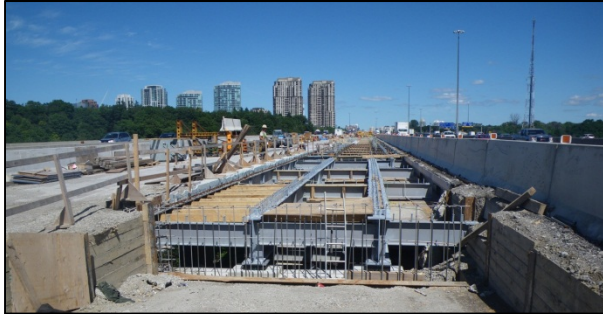
The two 20m long end spans were replaced including construction of new abutments behind the existing abutments due to their poor condition and questionable structural stability, as well as the failure of the existing girders to meet loading and fatigue requirements stipulated by the code. As the work was constructed in stages (8 in total for

each span), a lot of effort and resources were spent in splices, laps, as well as shoring of the highway for the deep excavation required to build the substructures. See Figure 14.

Figure 14: End (Approach) Spans to be constructed in 8 laterally-connected segments

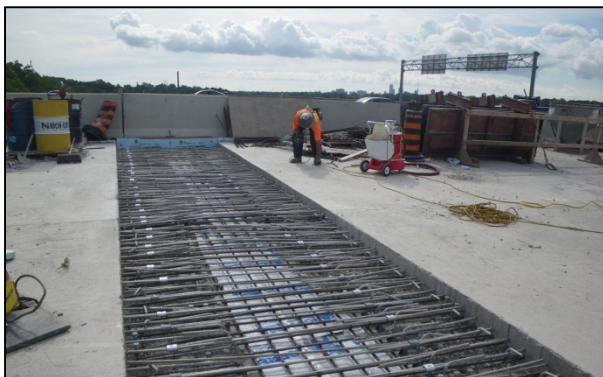
5 of the 11 existing expansion joints were replaced, while the remainder joints were eliminated by accommodating some of the thermal movements in the flexibility of the supporting steel members and the deck made continuous over these supports. Nevertheless as the new expansion joint hardware components were only supported at intermittent points of the stringer system, they were not only just anchorages for the joints, but were also structural steel members by themselves and were designed and detailed accordingly, including deflection control of these members under moving traffic loading.

Figure 15 below shows the reinforcing details of a link slab with the expansion joint removed.

Figure 15: Elimination of Existing Expansion Joints using Flexible Link Slabs

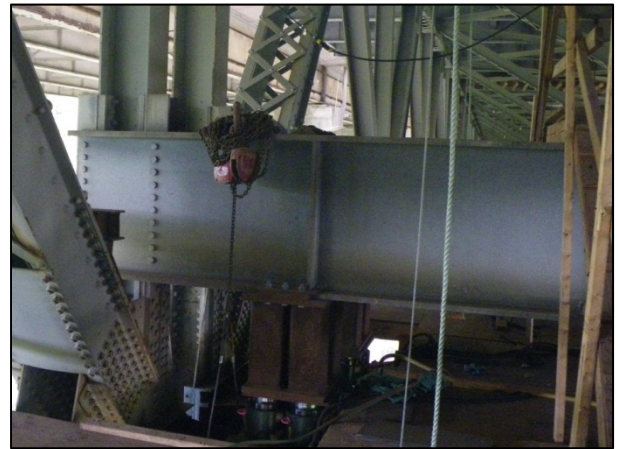
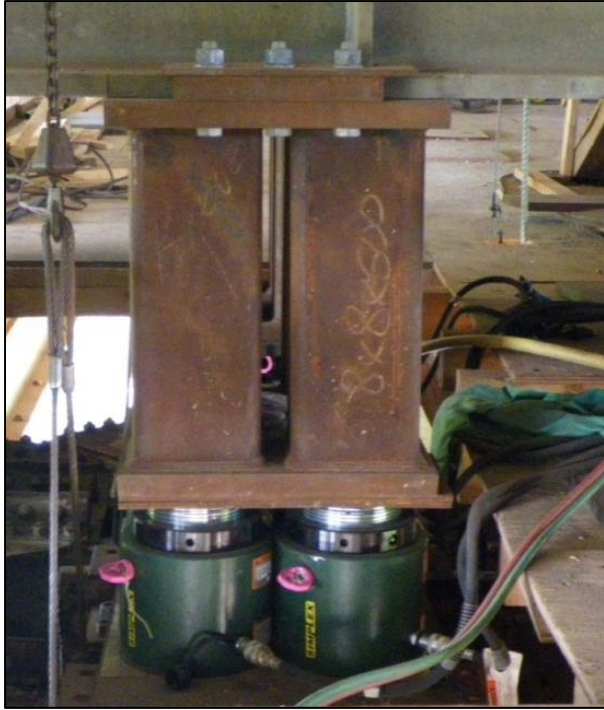
As there were only 2 trusses supporting each of the EB and WB bridges, the bearings at these pier truss nodes were designed to withstand significant dead and live loads (axial loads close to 1,000 tonnes on some bearings). The replacement of these bearings was undertaken with precision and with the help of sophisticated jacking systems. Each location was jacked up using 4 computer-coordinated jacks and additional jacking members were installed in advance to provide sturdy jacking points to facilitate this work, see Figures 16 and 17 below.

Figure 16: Additional Beam Installed to Facilitate Jacking and Replacement of Bearings

Figure 17: Coordinated Quadruple Jacks at each Bearing Location

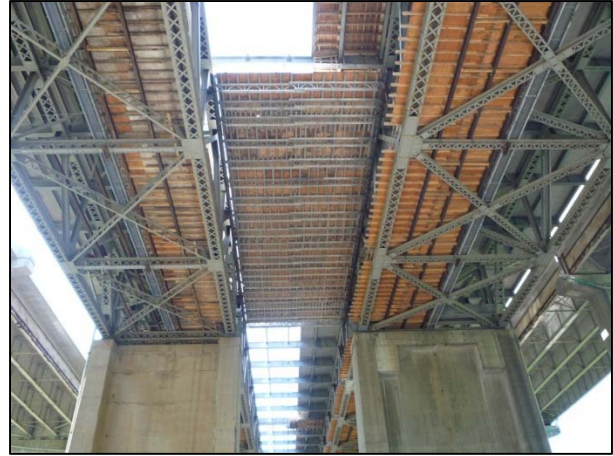
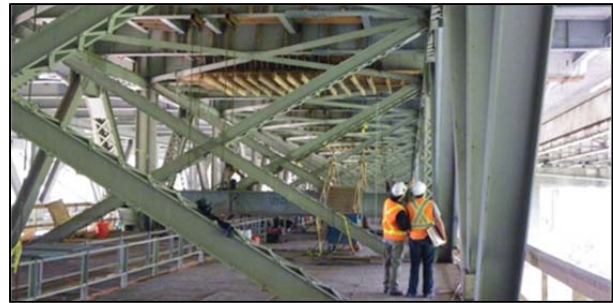
To allow access to all members of the trusses, including bearings and joints, material and equipment storage, protection of workers and users of the golf course located below the deck, a structural platform was constructed below the deck suspended from the trusses, complete with timber flooring and safety enclosures. The work by itself is a key structural steel item of this contract adding significant cost to the job.

Figures 18 and 19 show some details of the access platform below the deck.

Figure 18: Access Platform at Lower Chord and Spanning Between Trusses

Figure 19: Both Workers and Inspectors can make use of the platforms to access various structural members

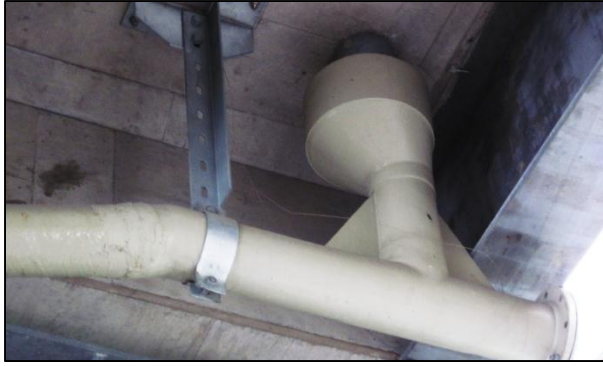
- Remove and replace deteriorated gusset plates and header angles at selected nodes of the trusses;
- Replace entire deck drainage system (figure 20);
- Clean, repair and coat existing pitted steel members;
- Replace individual rivets with high friction bolts; and
- Locally repair damaged or deteriorated steel members.

Figure 20: New Deck Drainage System
