STRENGTH AND FATIGUE RESISTANCE OF CLUSTERED SHEAR STUDS

SUMMARY

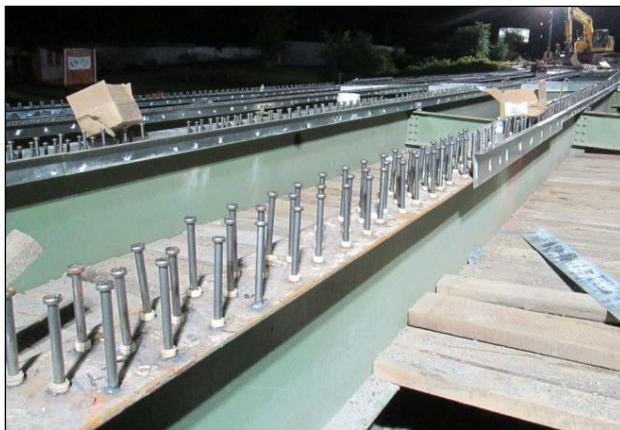
Figure 1. Steel girder with closely spaced studs

along the length of the bridge leads to a very small longitudinal spacing between studs. An example of this case is shown in Figure 1.

The stud spacing shown in Figure 1 can complicate the use of precast concrete deck panels. As such, this study will include an investigation to see if improvements can be made to better facilitate precast decks. A discussion of the current AASHTO shear stud fatigue and strength design provisions will be presented, as well three international design specifications for shear studs.

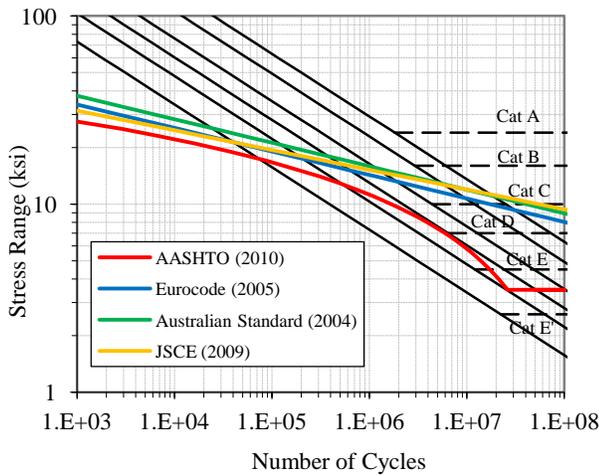
appear to be quite different. Figure 2 shows the stud fatigue design curves according to AASHTO (1), the Eurocode 4 (6), Australian Standard (7), and the Japan Society of Civil Engineers (JSCE) (8), all superimposed with the other AASHTO fatigue design curves. Since the JSCE design equation depends on various geometric and material properties, the following typical values were used to compare the provisions: shear stud diameter and height of 7/8" and 6", respectively, and a concrete compressive design strength of 4.0 ksi.

Figure 2. Shear stud S-N design provisions from AASHTO and various international codes

As shown in Figure 2, the AASHTO stud fatigue curve is a semi-log plot, while the other three specifications follow a log-log curve, with slopes varying from -8 to -9.5. These slopes are much shallower than the slope of -3 for the typical AASHTO fatigue details. Since the AASHTO stud curve is semi-log, it becomes much more conservative at a higher number of cycles. This is especially apparent at approximately 26.3 million cycles, where the infinite life fatigue equation governs, and likely where new bridges would be designed. At this large number of cycles, AASHTO requires more than twice as many studs as the other international provisions (9), which suggests AASHTO may be too conservative. The AASHTO stud CAFL of 3.5 ksi also appears to be very conservative, especially since the other international provisions do not have CAFLs for shear studs.

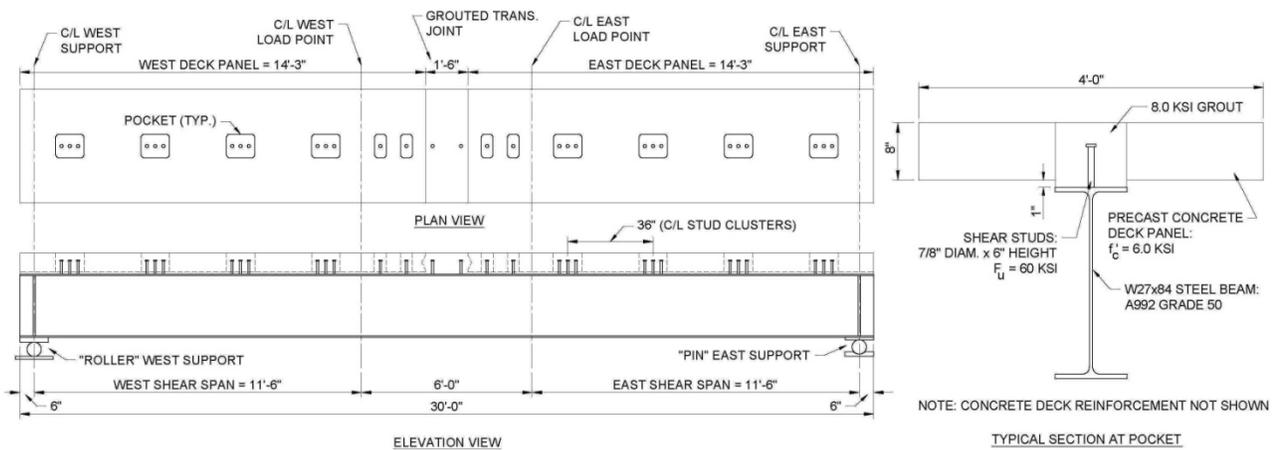
Figure 3. Full-scale test specimen with 36" cluster spacing

Figure 3 presents a plan, elevation, and section view of the 36 in. cluster spacing specimen after construction of the beam is completed. Sixteen of the seventeen specimens shown in Table 1 are similar to that shown in Figure 3. The 12 in. spacing specimen with 24 studs per shear span (first line of Table 1) is slightly different from shown in Figure 3. It has two studs, instead of one, placed across the width of the flange to account for twice as many studs as the other specimens. The studs are spaced transversely at 3.5 in. (4d), to meet the AASHTO Specifications (1). The remaining specimens differ only in their number of studs per cluster and cluster spacing.

As shown in Figure 3, each of the fatigue and static specimens have two load points with an 11'-6" shear span on each side of the beam. The fatigue specimens are tested cyclically under load control to produce an initial constant stress range at the base of the studs until the beam reaches failure. The static specimens are tested in displacement control, with the load slowly increasing from zero to a maximum load reached when the specimen fails.

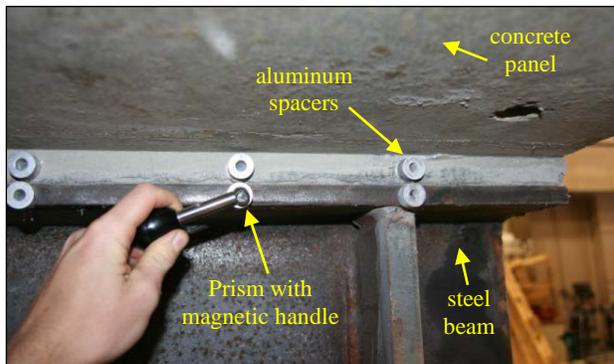
For this project, the FARO is used to measure the relative slip and lift off between the grouted haunch and the top flange of the steel beam. This is accomplished by mounting one aluminum spacer to the haunch and one to the edge of the top flange. The FARO instrumentation setup is shown in Figure 4.

Figure 4. Photo of FARO instrumentation on beam

As shown in the figure, the spacers are mounted every 6 in. along the length of the beam for a total of 124 spacers. The prism can then be “nested” into each spacer and its 3-D coordinates can be recorded. Data points are collected at predetermined load and cycle count intervals for the static and fatigue tests, respectively.

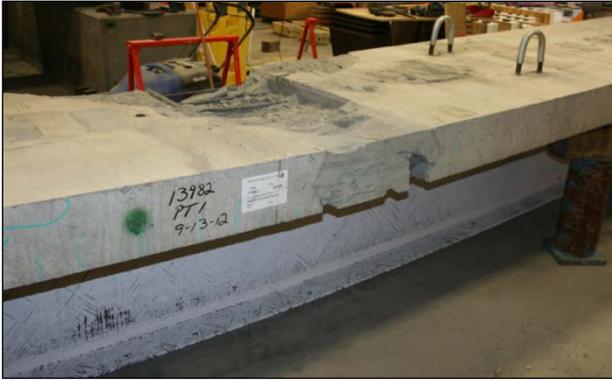
Figure 5 shows a photo of beam 1S2 after testing was complete. The crushed concrete and grout at midspan, along with the noticeable deflection in the beam, are shown in the photo. The whitewash showed that at midspan the beam yielded approximately 2/3 up the web and yielding in the bottom flange extended approximately 8 ft. from midspan in both directions. Strain gage data provided good agreement with these visual observations.

Figure 5. Photo of 1S2 completed static test

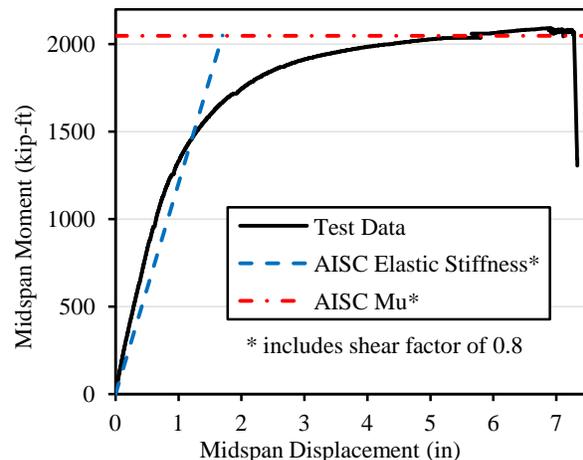
Figure 6 presents a moment-displacement curve for beam 1S2. The midspan moment was calculated using the load from both actuators, and the displacement was taken from the midspan vertical LVDT. As shown in the plot, beam 1S2 reached a maximum midspan moment of 2090 kip-ft. at a displacement of 6.9 in. Also included in Figure 6 are the theoretical elastic stiffness and the moment capacity (M_u) calculated using the AISC Specifications (14).

Figure 6. M-Δ data for 1S2 static test

The moment capacity (M_u), using a 0.8 shear factor, was calculated to be 2050 kip-ft., which is about 2% less than the measured moment reached at failure during testing (2090 kip-ft). If the 0.8 shear factor is not used the moment capacity increases to 2160 kip-ft., which is slightly unconservative when compared to the test results. Because the calculated elastic stiffness and M_u provide good agreement with the test results, applying a 0.8 shear factor to a stud's strength appears reasonable.

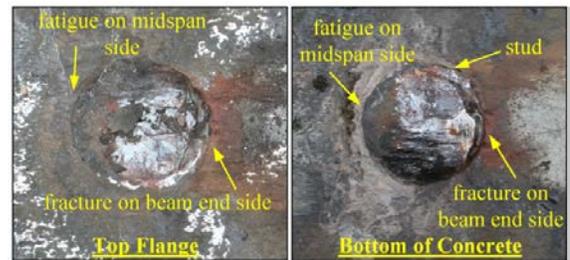
Figure 7. Photo of shear stud fracture surfaces

As shown in Figure 7 the studs typically failed by a crack initiating at the toe of the weld flash on the midspan side of the stud. The cracks then appeared to propagate down into the top flange leaving a divot as shown in the figure. Dull, smooth surfaces were present on the midspan side of both surfaces indicating fatigue cracking. The cracks appeared more shiny and jagged on the beam end side, indicating fracture. In a few other instances, fatigue cracks initiated at the top of the weld flash on the midspan side of the stud. In these cases, the cracks either propagated through the stud metal or down into the top flange metal until the stud fractured.

After each of the fatigue tests were completed, the concrete deck panels were removed from the steel beam. A jackhammer was used to remove the grout from around the studs at the midspan transverse joint and at other pockets where the studs had not failed. By doing this, the fracture surfaces of the failed shear studs could be examined. Figure 7 presents a photo of the two fracture surfaces of a failed stud.

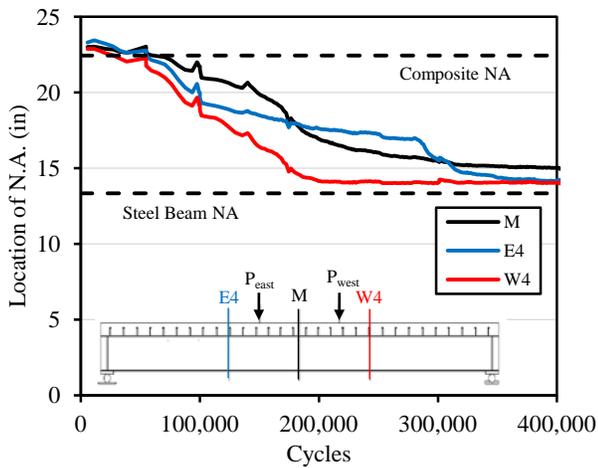
Figure 8. Location of steel neutral axis for east and west shear span sections

As shown in the figure, the N.A. for all three sections start near the composite section N.A. The location of the W4 section N.A. then decreases more rapidly than the other sections until it reaches that of the steel beam at approximately 200k cycles. This shows that composite action in the west section has essentially gone to zero. The location of the E4 section N.A. decreased at a slower rate, but did reach that of the steel beam at approximately 400k cycles.

When testing began, the steel beam and concrete decks were expected to behave as one composite section. As the shear studs failed, the steel beam and concrete deck were expected to behave as two separate flexural members on top of one another. Figure 8 presents a plot of the location of the N.A. of different steel cross sections for beam 1F1. The cross sections closest to midspan in each shear span, E4 and W4, are presented in the figure. One section from each shear span was chosen to determine which shear span failed first. The N.A. location for these two sections, along with the midspan section, M, are shown. The composite section and bare steel beam N.A. are also provided for reference.

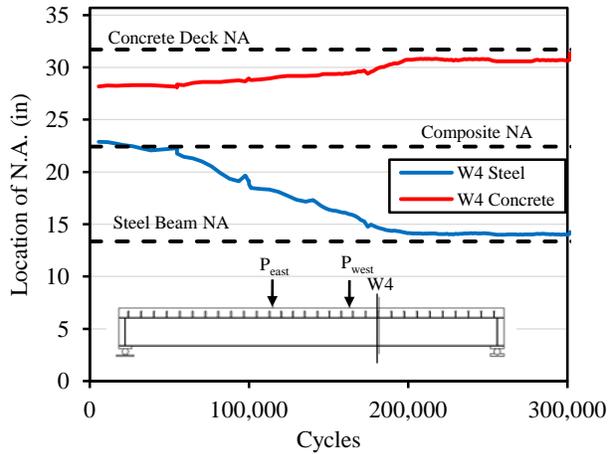
Since it was determined the west shear span failed first, the cross sections on that side of the beam were examined further. Figure 9 shows the location of the steel beam and concrete deck N.A. for the W4 section. In addition to the composite and bare steel beam N.A., the concrete deck N.A. is included as well.

Similar to the previous plot, Figure 9 shows that both the steel beam and concrete deck begin as a

Figure 9. Steel and concrete N.A. locations for section W4 of beam 1F1

composite section. As the number of cycles increases, the location of the N.A. for both elements trend toward their respective noncomposite neutral axes, reaching that point at approximately 200k cycles. Since the location of the N.A. for both elements behave similarly, it suggests that either one can be used as an indicator for the amount of composite action in the beam or as a measure for the fatigue damage being done to the shear studs.

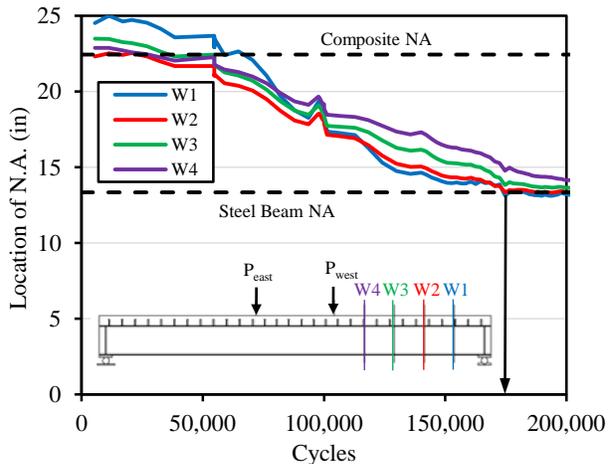
Figure 10 is similar to the other two figures, but includes all four sections on the west shear span since it was shown that the west shear span lost composite action first. The purpose of this figure is to determine if different sections throughout the shear span lost composite action at different times during testing.

Figure 10. Location of N.A. for west shear span sections of beam 1F1

The four cross sections behave similarly, but the sections closest to the end of the beam (W1, for example) do begin to lose composite action at a slightly faster rate those closer to midspan (W4). This is shown at approximately 100k-150k cycles. During this cycle range, section W1, which is closest to the end, has the lowest N.A. The section second closest to the end, W2, has the second lowest N.A., and so on. This trend seems reasonable since the shear studs closer to the end of the beam have to resist larger a horizontal slip to maintain compatibility than those located closer to midspan.

Based on the strain gage data and the location of neutral axes, a definition of failure for the fatigue tests was developed and is as follows: A beam is considered to have reached “failure” if one or more of the cross sections experience a complete loss in composite action. In this case, beam 1F1 failed at 175k cycles. This is shown by the downward vertical arrow in Figure 10.

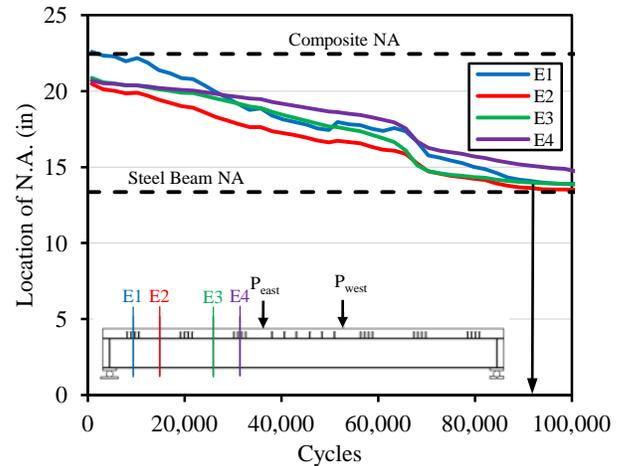
Figure 11 shows the N.A. locations for the east shear span sections of beam 4F1. Only the east shear span sections are shown because it was determined the east shear span lost composite action before the west shear span. As shown in the beam diagram in the figure, sections E2 and E3 were located halfway between the shear stud clusters, while E1 and E4 were located at the center of the clusters.

Sections E2 and E3 appear to lose composite action faster than the other sections. This is likely because

Figure 11. Location of N.A. for east shear span sections of beam 4F1

there are no studs located at these sections. Section E2 does begin to lose composite action slightly faster than section E3 because it is closer to the end of the beam. Similar to beam 1F1, although the sections lose composite action at different rates, the three sections closest to the end of the beam all seem to reach a point of no composite action at the same time. This occurs at 91k cycles and is considered failure for the beam. Similar behavior was also present in beam 3F1. This beam was tested at a smaller stress range of 16 ksi, rather than 20 ksi, and reached a point of failure at 747k cycles.

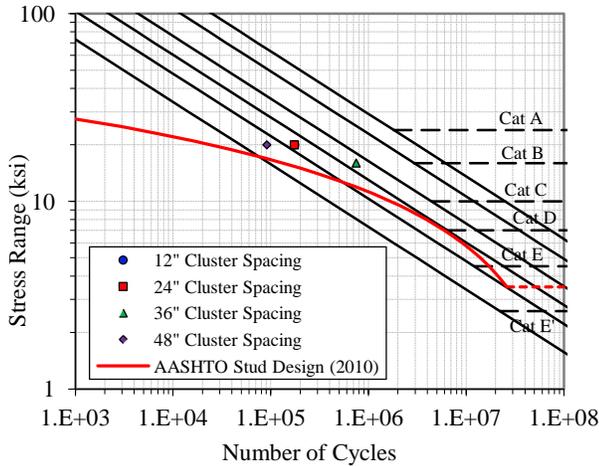
The data contained in Table 3 was used to construct an S-N plot of the test results. This is shown in Figure 12. The AASHTO design equation for shear studs and the typical detail categories are also included in the figure. In the figure, the 12 in. cluster spacing data point is hidden behind the 24 in.

Figure 12. S-N plot of completed full-scale tests

spacing point because the two produced such similar results. All four completed tests fall noticeably above the AASHTO stud design equation. The 48 in. spacing beam did have a fatigue life clearly less than the other two data points at the same stress range. This could be a result of a shear lag effect due to the large cluster spacing, or could simply be due to scatter present in all fatigue data. It is difficult to draw any definitive conclusions because there is only one data point for each of the four cluster spacing beams.

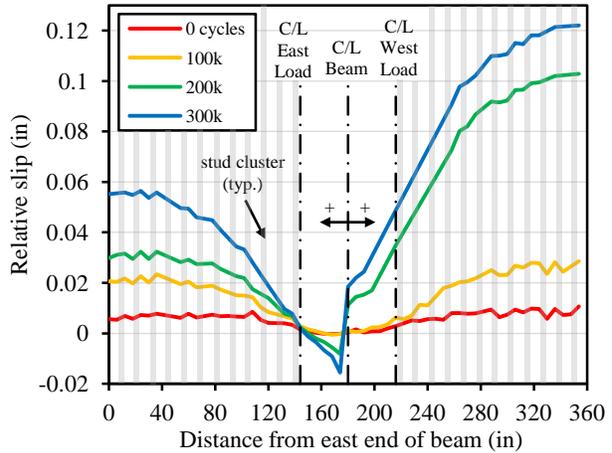
Figure 13 presents the slip data recorded with the FARO laser system for beam 1F1, which has a uniform stud spacing of 12 in. In the figure, slip data were recorded at the maximum load of the fatigue cycles conducted every 100k cycles. Positive values represent a slip toward each respective end of the beam. Values are referenced from measurements taken of the beam under self-weight only. Shaded vertical lines are also included in the figure delineate the locations of the shear stud clusters.

Figure 13 shows that the slip in the beam behaves as expected. Through 100k cycles, the slip remains at approximately zero in the constant moment region at

Figure 13. Slip results at peak loads for beam 1F1

midspan and increases gradually on each shear span to reach a maximum value at each end. At 200k cycles, the slip in the west shear span has increased substantially, and it continues to increase through 300k cycles, when it reaches a maximum value of approximately 0.12 in. at the west end of the beam. When the beam reached failure at 175k cycles, the maximum slip was probably slightly less than 0.1 in. It is interesting to note that the slip continues to increase after completely losing composite action. Beam 2F1 displayed similar gradually increasing slip results to those in beam 1F1.

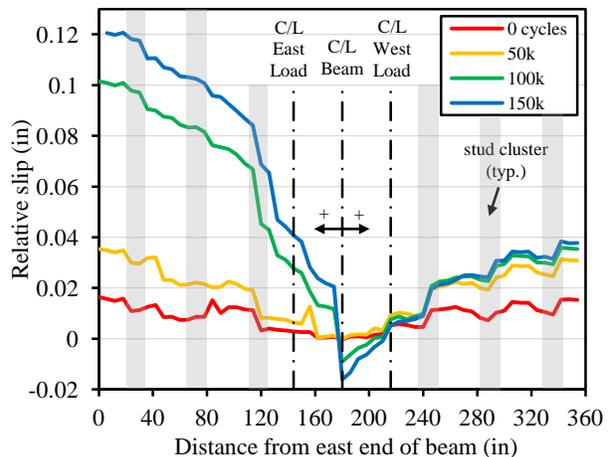
Figure 14 shows the FARO slip results for beam 4F1. Since this was the fourth beam tested, there was a better understanding for the expected fatigue life. Because of this, data were taken every 50k cycles instead of every 100k as was done for beam 1F1. Similar to the previous figure, shaded vertical lines indicate the location of the stud clusters.

Figure 14. Slip results at peak loads for beam 4F1

The results presented in Figure 14 do appear similar to those shown for beam 1F1. The slip in each shear span is approximately zero near midspan and increases to reach a maximum at each end of the beam. On the east shear span, there is a large amount of slip damage shown at the stud cluster closest to midspan. On the west shear span, however, the slip results almost look like steps. The slip increases at the clusters and remains fairly constant between them. This behavior is expected since the shear studs at the clusters are sustaining damage. When the beam reached failure at 91k cycles, the maximum slip in the east shear span was approximately 0.1 in. The step-like slip behavior was also present in beam 3F1.

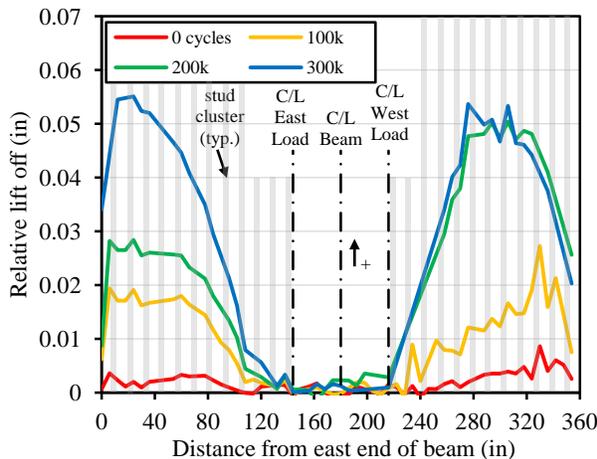
Similar to the slip results, the FARO laser system data was also used to construct plots of the relative lift off between the top flange and the haunch. The FARO lift off results for beam 1F1 are shown in Figure 15. In the figure, values are referenced from the beam under self-weight only. Positive values indicate the haunch is moving upward from the top flange. Data points were collected at the maximum load of the fatigue cycles every 100k cycles.

Figure 15. Lift off results at peak loads for beam 1F1

In the plot, no noticeable lift off is present over the constant moment region at midspan. For both shear spans, the lift off then gradually increases toward the end of the beam. It reaches a maximum value at about $\frac{1}{2}$ to $\frac{3}{4}$ of the length of the shear span before decreasing until the end of the beam.

The lift off results support the strain gage data that suggested the west shear span failed first. From the

200k cycle mark, the lift off does not increase any more. This seems reasonable since the beam reached failure at 175k cycles. The east shear span, however, continues to undergo damage since it has not yet reached failure. The lift off reaches a maximum value in the west shear span of approximately 0.05 in. Beam 2F1 exhibited similar behavior as shown by beam 1F1.

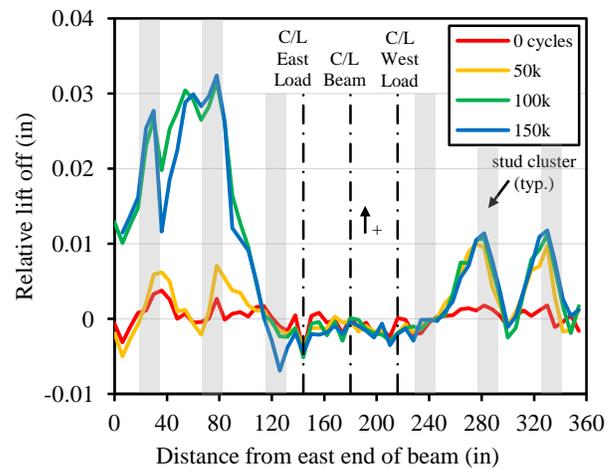
For comparison purposes, Figure 16 presents the lift off results for beam 4F1. Data points were collected every 50k cycles. Similar to the previous figure, shaded vertical lines are shown to represent the location of the stud clusters.

Figure 16. Lift off results at peak loads for 4F1

The most noticeable difference between the lift off results between the two beams is the presence of the peaks. These are most clearly seen in the west shear span, but are also present in the east span as well. The locations of the peaks appear to coincide with the stud clusters. At first, this appears counterintuitive because it seems the lift off should be closer to zero at the clusters and should peak between them.
