# **FRACTURE RESILIENCE AND REDUNDANCY OF BUILT-UP STEEL GIRDERS**

# FRACTURE RESILIENCE AND REDUNDANCY OF BUILT-UP STEEL GIRDERS

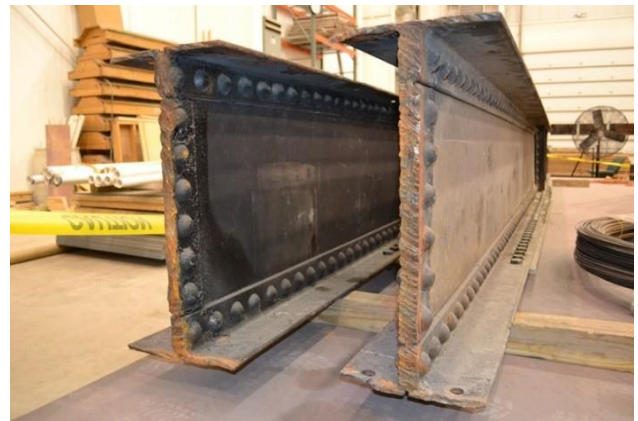
Fifteen large-scale built-up specimens were tested as part of this research. Specimen lengths ranged from 24'-0" to 40'-0", with web depths ranging from 23" to 46". Three historical specimens were obtained from a bridge which was being removed from service (see Figure 1). The remaining twelve specimens were fabricated with new material. Thirteen of the specimens used component dimensions and proportions typical of built-up construction. Two of the specimens, intending to determine an upper bound to fracture resilience, used proportions which were extraordinary and unrealistic. Both riveted and high-strength bolted specimens were evaluated. Other parameters which were investigated included the number of bottom flange cover plates per specimen, the contribution of friction between built-up member components, and the method of hole fabrication (punched vs drilled).

Figure 1: Typical historical built-up specimens

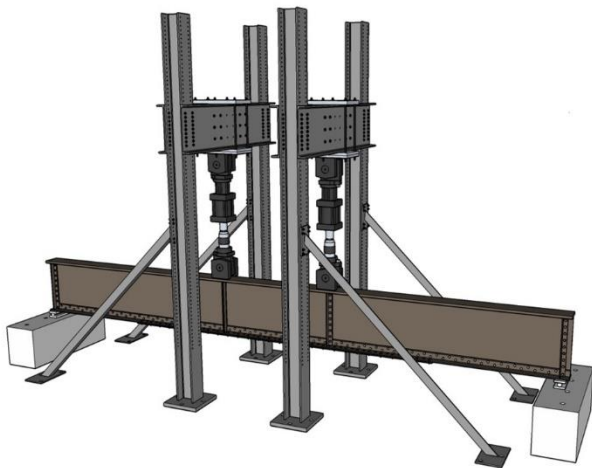
Specimens were loaded in four-point bending using two 220 kip hydraulic actuators as shown in Figure 2. This created a constant moment region which facilitated the measurement of stresses in bottom flange components both before and after a component failure. Foil strain gages were used to measure the stresses at key locations in each of the bottom (tension) flange components both

longitudinally and transversely. This resulted in the ability to evaluate the localized stress distribution near a failed component both in and out-of-plane.

Figure 2: Test setup

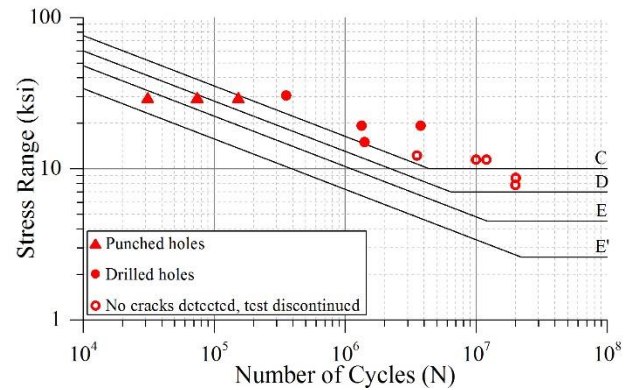
The specimens were tested at calculated net-section stress ranges (using traditional mechanics of materials calculations on the partially failed cross-sectional geometry) which varied from 6.6 ksi to 25.6 ksi. The range of stress ranges was used in an effort to capture fatigue behavior over a wide spectrum. After experimental and analytical evaluation, it was found that localized stresses were amplified near the failure region. Therefore, the resulting amplified stress ranges (which reflected true conditions in the components) were between 7.8 ksi and 30.5 ksi. The resulting fatigue data was plotted against the AASHTO fatigue curves and can be seen in Figure 3.

Figure 3: After-failure fatigue life

The fatigue data from the different specimens was evaluated to determine which parameters impacted the remaining fatigue life of built-up steel specimens. The parameter that had the largest impact on the remaining fatigue life was the method of hole preparation in the built-up specimen components. Other parameters investigated that did not appear to have an influence on the remaining fatigue life were: the contribution of friction, non-symmetric cross-section, the number of tension flange components, and the fastener type (rivets vs. high-strength bolts).

It was found that specimens with drilled holes had a substantially higher fatigue life than specimens with punched holes. This corroborates previous research in which punched holes were found to have a lower fatigue life than drilled holes or holes that were subpunched and reamed [2]. The AASHTO category E' fatigue curve was found to be a reasonable lower bound for specimens having punched holes, and the AASHTO category C fatigue curve was found to be a reasonable lower bound for specimens having drilled holes. In all cases, the remaining fatigue life tests illustrated that built-up members with partially failed cross-sections are able to sustain a substantial amount of fatigue cycles prior to any other component damage.

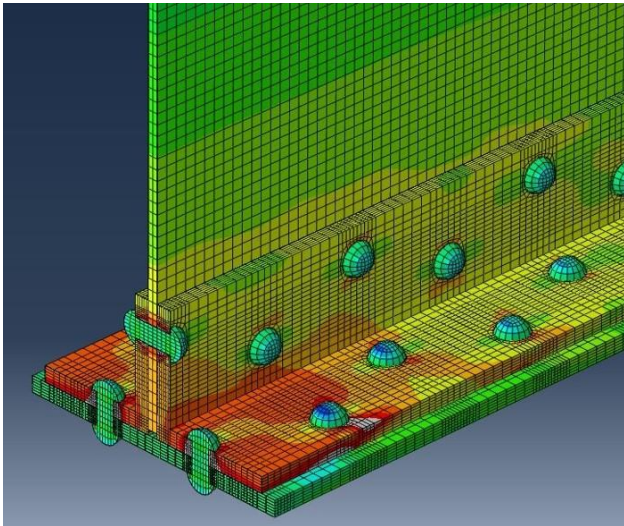
The longitudinal stress distribution in the components adjacent to a failed component was found to vary significantly throughout the transverse direction as well as the thickness of individual components (see Figure 4). In order to account for this variation throughout each component cross-section, the net-section stress of each component was found by summing the stress over the entire cross-section and then dividing by the net cross-sectional area. The resulting net-section stresses of each component were compared at discrete locations along the length of the member, with relation to the component failure location. It was found that the largest localized net-section stress was found in adjacent components in the same plane as the failure, and in the plane of the nearest fastener on either side of the failure plane.

Figure 4: Stress distribution at failed cover plate

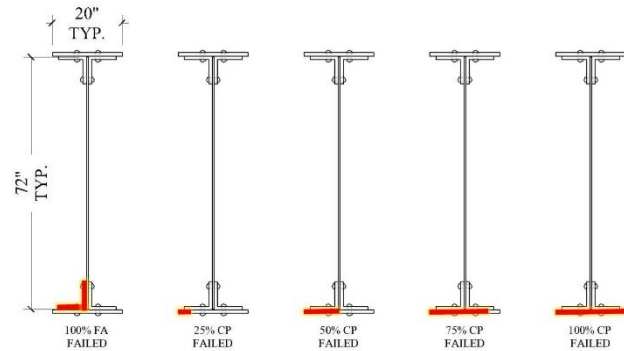
The effect of non-symmetric cross-sections on the localized stress distribution near a failed component was investigated to determine whether the resultant stress increase could affect the remaining fatigue life. Two scenarios were considered in which a non-symmetric cross section could result: the failure of a tension flange angle, and the partial failure of a tension flange cover plate. A series of ten different failure situations were evaluated for three different beam sizes; a fully failed flange angle, and nine different stages of cover plate failure. Figure 5 shows a portion of a typical model set.

Figure 5: Non-symmetric cross-section model set

The net-section stress in a single flange angle was used to compare the resulting stress increase from each of the failure scenarios. When the various stages of failure were analyzed, it was found that only scenarios where the cover plate was more than 60% failed was the stress increase in the angle greater than what would result from a fully failed cover plate (considered a symmetric cross-section). Since this scenario would represent a case where a fatigue crack was of substantial size, the crack growth rate would be expected to be rapid at this stage. The total crack length was plotted based on number of cycles for various experimentally tested specimens. The resulting duration in which the crack length would be expected to be greater than 60% of the cover plate width was found to be approximately 5%. Because of the minimal duration at which the stress increase was found to apply, the effect of non-symmetric cross-sections was

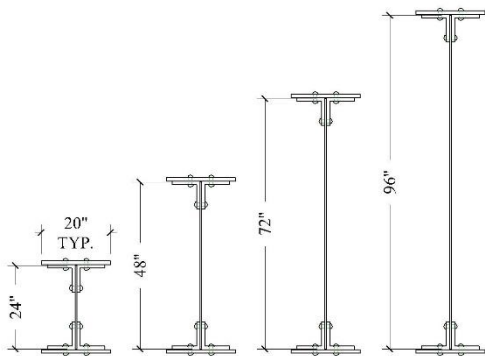
Due to the results of previous parameters, only symmetric cross-sections were considered in the web height parameter study. Four different web heights were evaluated, (24", 48", 72", and 96") as shown in Figure 6. Each of the models had a single cover plate on both the tension and compression flanges. A completely failed cover plate was simulated for each of the models. The remaining net-section stress was measured in the tension flange angles adjacent to the failed cover plate. The resulting net-section stress in each of the models was found to be less than 3% between each of the models. Therefore the height of the web was not considered to be a significant parameter in the stress distribution of partially failed built-up members.

Figure 6: Web height model set

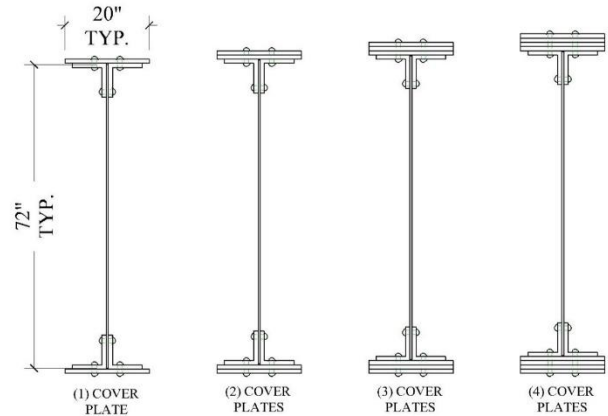
The effect of the quantity of tension flange components (cover plates and angles) was investigated to determine their effect on the redistribution of stresses adjacent to a failed component. Models were evaluated with 1, 2, 3, and

4 cover plates for three different model sizes (see Figure 7 for typical configuration).

Figure 7: Quantity of flange components model set

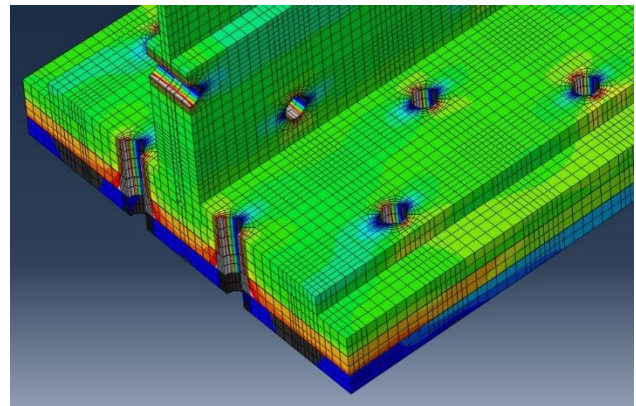
It was found that the number of cover plates of a steel built-up member has a significant effect on the stress distribution in the localized region near a failed component. Figure 8 shows the stress distribution at the failure plane for a model with three cover plates in which the lower cover plate is failed. When a component of a built-up member is failed, the load is transferred through the fasteners, into adjacent components. Based on the results of this model set, the majority of the load was found to be distributed to the component most adjacent to the failed component (e.g. for a member with two cover plates which experiences a failure of the lower cover plate, the majority of the load is distributed into the upper cover plate, while the flange angles see a minimal increase in longitudinal stresses).

Figure 8: Three cover plate model with one cover plate failure

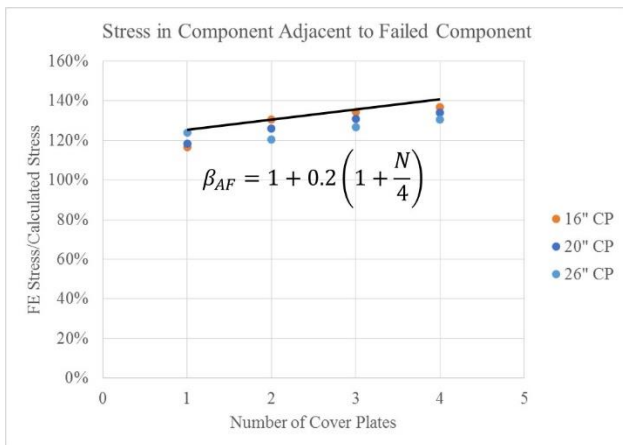
was found which relates the actual net-section stress of an adjacent component to its calculated net-section stress. The calculated net-section stress of a partially failed built-up member in bending can be found using simple mechanics of materials calculations ( $\sigma = My/I$ ) in addition to the resulting cross-sectional geometry. The intent was to determine an amplification factor which could accurately describe the large stress distribution which is transmitted into the adjacent component. In order to determine the relationship, the data for twelve different models with 1, 2, 3, or 4 cover plates was collected (see Figure 9). For each model, the resulting net-section stress was normalized by the calculated net-section stress which is calculated using the resulting partially failed geometry of the member. The linear relationship  $\beta_{AF}$  (Equation 1) should be used to amplify the calculated net-section stress to conservatively account for the resulting net-section stress in a partially failed built-up member in flexure as shown in Equation 2.

Equation 1: 
$$\beta_{AF} = 1 + 0.2 \left( 1 + \frac{N}{4} \right)$$

Figure 9: After-failure stress distribution factor
