STRENGTHENING CONTINUOUS STEEL GIRDER BRIDGES WITH POST-INSTALLED SHEAR CONNECTORS

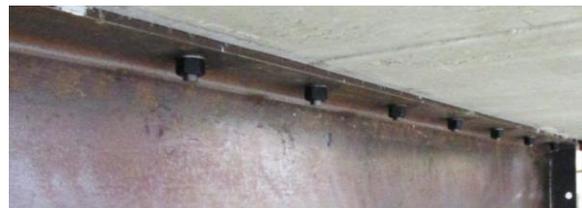
Figure 14 – Installed Adhesive Anchor Connectors

The adhesive anchor shear connectors used in this study were comprised of 7/8-inch diameter ASTM A193 Grade B7 threaded rods and a structural adhesive. Figure 14 shows a photograph of a typical group of connectors after installation. The following steps describe the installation process:

1. Drill a 1-inch diameter hole through the top flange of the steel beam. This can be done using a portable drill with a magnetic base.
2. Through the hole in the flange, drill a 15/16-inch diameter hole into the concrete deck to the desired depth. This can be done using a rotary hammer drill. At least a 2-inch cover to the top of the concrete deck should be maintained, following the provisions in the AASHTO LRFD specifications for shear connectors.

6. Allow the adhesive to cure as specified in the instructions. After curing, install the washer and nut. Tighten the nut to the torque specified by the installation instructions.

7. Strike the threads below the nut with a grinder. This will prevent the unlikely event of any nuts that may loosen over time falling on traffic or pedestrians passing under the bridge.
