**SCANNING,
PLATING, AND
HEAT-
STRAIGHTENING,
OH MY!
(REPAIRING
AND
STRENGTHEN-
ING MEDIUM
SPAN TRUSSES)**

Tools for designers to use as they approach truss rehabilitation projects are presented through a series of case studies. Tools or approaches include, large distortion heat-straightening, laser-scanning, repair plate integration into gusseted connections, and a pair of tight space repair details (lower-chord “U” fixtures and upper-chord “mill-to-bear” external plating.

SCANNING, PLATING, AND HEAT STRAIGHTENING, OH MY! (REPAIRING AND STRENGTHENING MEDIUM SPAN TRUSSES)

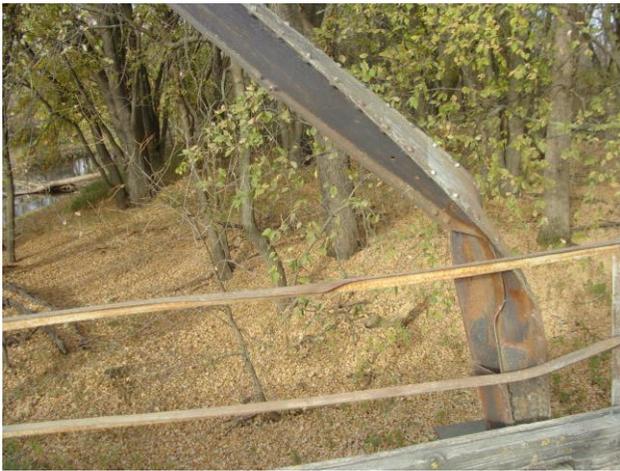
Figure 2 – Damaged End Post

An errant vehicle on a snowy, icy road impacted the end post of this 1899 through truss over the North Fork of the Crow River near Kingston, Minnesota. The vehicle nearly collapsed the pin connected truss. With only a single traffic lane on a timber deck and a three ton load capacity, the truss is composed of relatively light members.

Originally, we felt that the lower portion of the end post would need to be replaced to put the bridge back in service. However, the contractor suggested using heat straightening to return the end post to its original geometry. We agreed to see how the heat straightening progressed. After shoring the hip joint and a week of field work, the heat straighteners were somewhat amazingly able to return the end post to its original alignment.

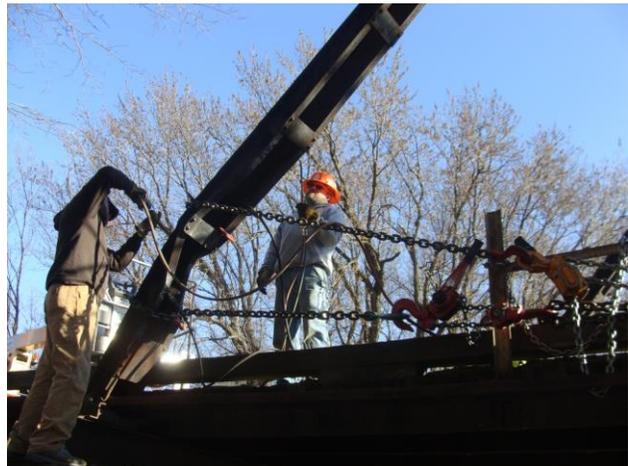
Figure 3 – Heat straightening operations underway

However, longitudinal cracks were observed in the web of the primary channels after heat straightening operations. Due to the cracking and because we were uncertain of the impacts of heat straightening on the chemistry of the 19th century steel, supplementary plates were bolted to the web of the channels to carry the entire end post load. As a result of this decision, the heat straightened portion of the end post just needed to brace the new supplementary web plates. We didn't need to

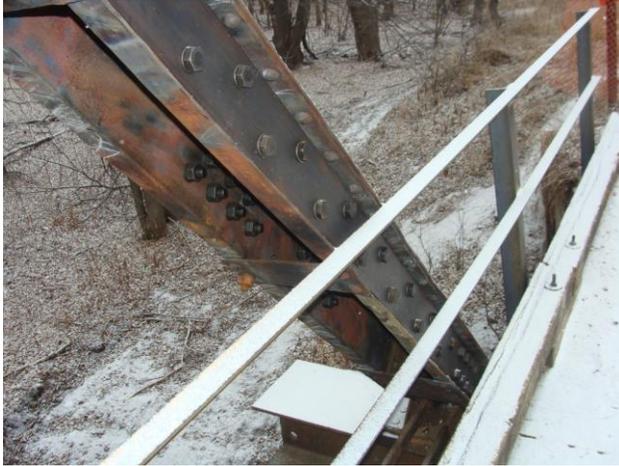
develop an end post splice near the lower chord. Consequently it was a simpler solution to plate the web compared to replacing portions of the channels and splicing new material to original.

Figure 4 – Straightened end post with strengthened channels.

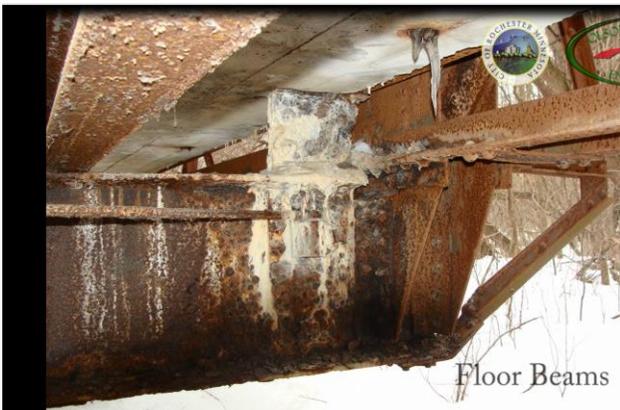
However, by 2011 the structure was showing its age with extensive deterioration of the floor system, the lateral bracing, and the knee bracing.

Figure 5 – Deteriorated components on the north truss.

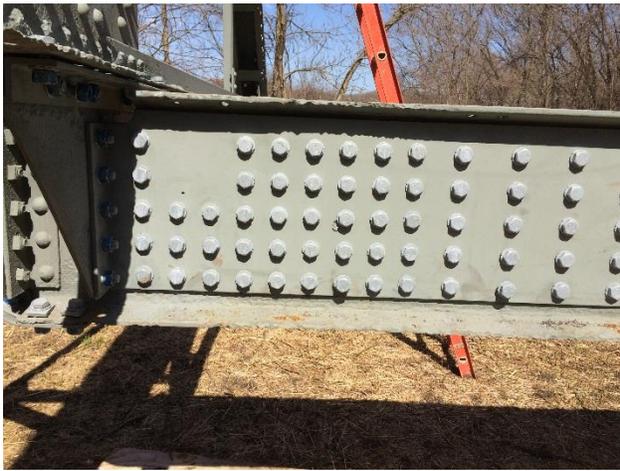
The floor system for the Quarry Hill Nature Center Bridge was rehabilitated by removing the old deck and stringers and lateral bracing. The new floor system included a cast-in-place slab spanning from floor beam to floor beam. The floor beam deterioration at the ends of the beams was addressed by sandwiching supplemental web plates on both sides. The new plates arrived at the site with a shop applied zinc primer and were placed against the

original web after it was blast cleaned and primed in the field.

Figure 7 – Supplemental floor beam web plate prior to final paint coats

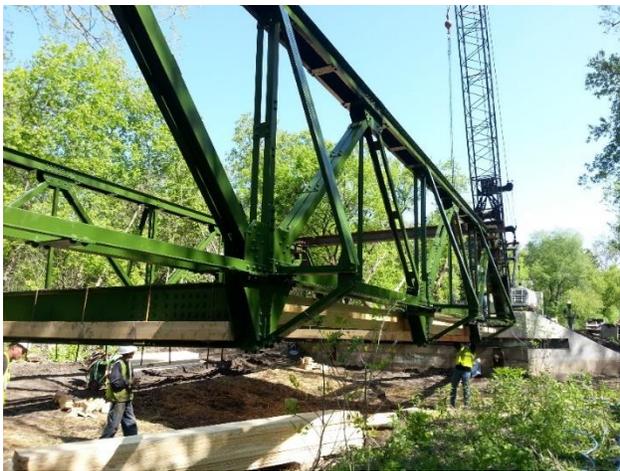
Figure 8 – Painted pony truss being moved back onto the substructure units

The new structural deck with a low profile grade and curb detail will minimize the amount of deicing agents and water seepage that contributed to the deteriorating floor components below.

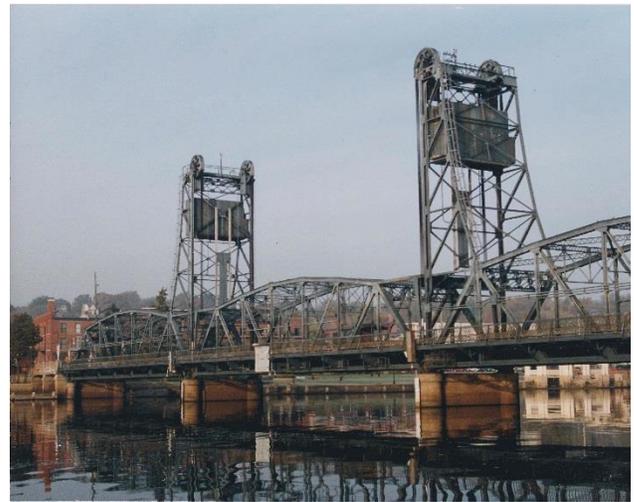
Figure 9 - Looking northwest at the lift span

The Stillwater Lift Bridge is a heavily traveled two lane bridge over the St. Croix River between Stillwater Minnesota and Houlton, Wisconsin. The vertical lift span and steel truss approach spans were designed by Waddell’s firm in 1931, and the bridge has been rehabilitated several times since then.

It is not unusual for below deck truss chords to exhibit corrosion and section loss. Chloride contaminated runoff can readily seep down verticals and diagonals to reach the lower chord. Once at the lower chord, it can readily seep through the connection and deteriorate adjacent components. As part of a 2012 rehabilitation project, structural steel repairs were required at several locations.

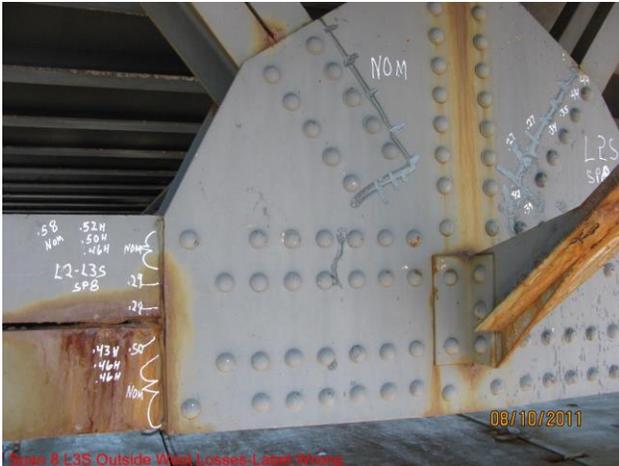
Figure 10 – Lower chord panel point

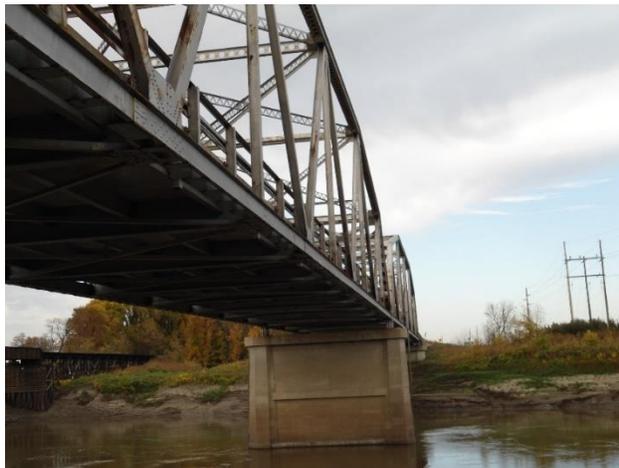
Figure 14 – Looking west along the north face of the bridge

The Oslo Bridge carries Minnesota Trunk Highway 1/North Dakota State Highway 54 over the Red River of the North. The two main through truss spans were constructed in 1959 at a length of 220 feet each.

The objective of the design was to improve the load carrying capacity of the bridge, address some minor deterioration and paint the superstructure. The bridge deck was in good condition and was not to be removed as part of the project. The rehabilitation design was to follow current AASHTO LRFD specifications and include HL93 loading. The 220 foot main spans were originally designed with the AASHTO Standard Specifications where truck and lane loadings were considered independently. The simultaneous application of truck and lane loadings as part of the HL93 loading significantly increased the live load demand on the bridge, which in turn required the strengthening of the floorbeams, select gusset plates and both the upper and lower chords.
