# ACCELERATED BRIDGE CONSTRUCTION (ABC) OF THE SHORE LINE BRIDGE BOSTON, MA

# ACCELERATED BRIDGE CONSTRUCTION OF THE SHORE LINE BRIDGE, BOSTON, MA

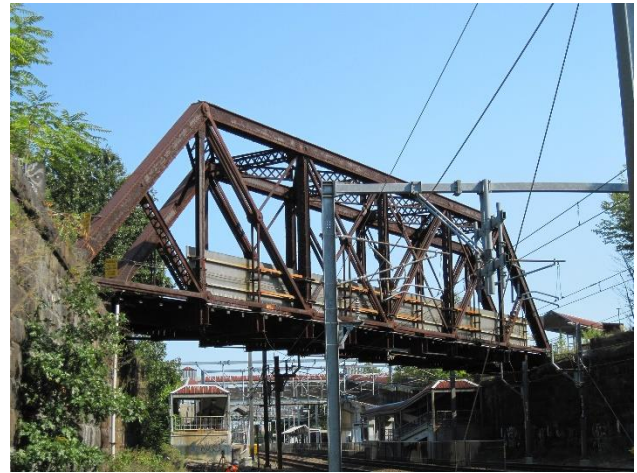
The historic Shore Line Bridge was a steel single-span, six-panel, pin-connected eyebar, Baltimore through truss with a span of 140 feet, a width of 18 feet, and with a 56-degree skew. The four interior panels had intermediate floor beams suspended from sub-tie hangers braced by sub-tie diagonal members that linked three floor beams together. The floor beams were built-up steel I-shape sections. Multiple eyebars provided the load resisting capacity of the

particular element of the truss. The increase in load of the interior panels was supported by using an increased number of eyebars that share pin connections, vertical members, upper chords and hangers.

**Figure 2: Existing Bridge Built in 1898**

The sub-ties met at pinned connections at the center of each panel. Sway bracing and upper lateral bracing, made of built up beams with lacing, provided stability at alternate upper truss panel points. Two built-up steel I-shape stringers were located at approximately third points below the deck. Angles located below the floor beams and stringers provided lower lateral bracing linking the three floor beams of each central panel. Portal bracing provided lateral support at the inclined end posts as well. The truss compression members are built-up steel sections with lacing bars. The deck was open with tracks supported on timber ties and timber planks were used as a walk way on each side of the single track.

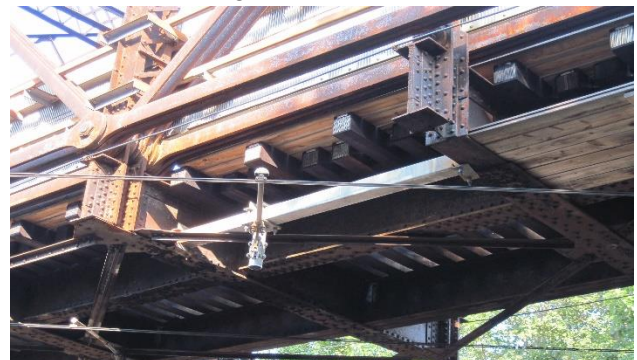
**Figure 3: Truss Underside with Amtrak 25,000 Volt Overhead Catenary Wires**

In addition, 25,000 volt Amtrak overhead catenary wires, spanning between portals on independent foundations outside the bridge envelope, were supported on the underside of the bridge. The presence of these high-voltage overhead catenary wires limited the means to perform repairs on the existing bridge. Furthermore, there were several fiber optic utility cables, signal and communication trough, and several unidentified underground cables running under the bridge that required identification and possible relocation during construction. The presence of MBTA's Fairmount Line Readville Station outside the bridge restricted any changes to the horizontal and vertical alignment of the track on the bridge.

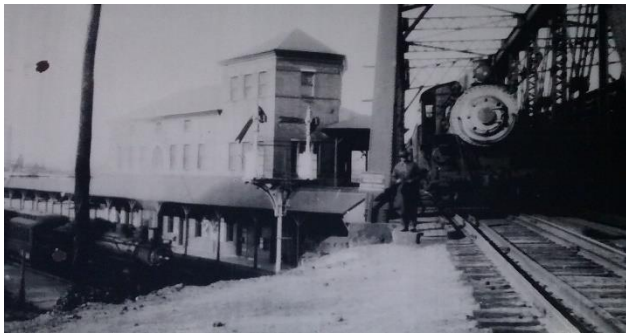
**Figure 4: Historic photo**

Initially invented in 1871 by engineers of the Pennsylvania Railroad, the Baltimore truss was so named because the Baltimore & Ohio Railroad used it extensively. In use into the 1930s, the pin connections of this type of bridge were replaced by riveted connections. Eyebars were replaced by I-beams.

The Shore Line Bridge was constructed at this location was part of a project to eliminate at grade crossings for the lines approaching Boston from the south as mandated by legislation from 1896 (Allen 1900:55; Tuttle 1901:163). It was fabricated by the Pennsylvania Steel Company, an early pioneer in the production of steel and a well-known bridge design and fabrication company. J.J. O'Brien and Company erected the bridge under the supervision of G. R. Hardy, Bridge Engineer of the New York, New Haven & Hartford Railroad (MACRIS 2012; McGinley Hart 1990; Tuttle 1901:182).

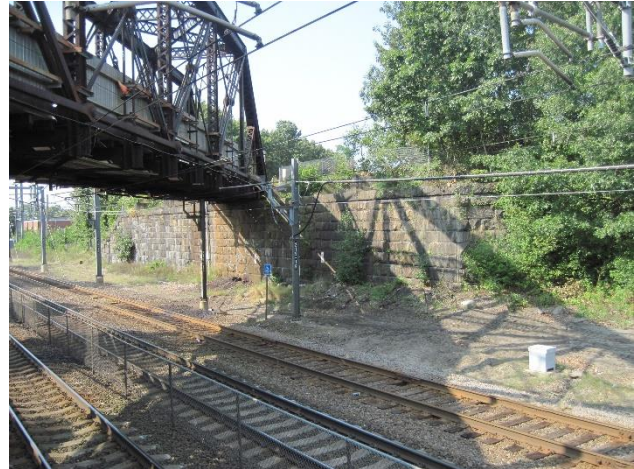
The existing substructure contains a gravity abutment constructed of granite masonry blocks. The east and west abutments are approximately 170 feet and 154 feet long, respectively. The back of the abutments are vertical, not battered as is typically the case. Both abutments have a constant width of approximately 10 feet over their heights except at the toe where the overall width increases to 13 feet and 11 feet for the east and west abutments, respectively. The height of both abutments is approximately 18 feet measured from existing grade to beam seat. The embedment depth at the abutment toe is approximately 6 feet and 5 feet for the east and west abutments, respectively. The height of the back wall at both abutments is approximately 3 feet. There are wing walls at three of the abutment corners.

**Figure 5: Truss View with West Abutment**

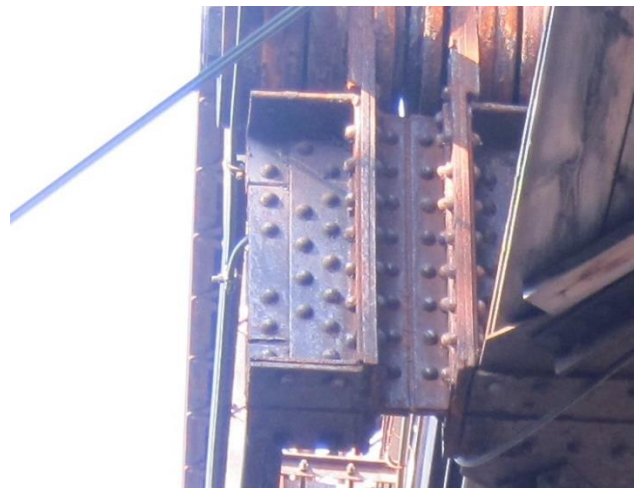
Located in the middle of the abutment, the bridge carries what was once the center track of a five-track crossing over the Shore Line. The five-track crossing was supported by six trusses as evidenced by the lengthy abutment and described in contemporary accounts (McGinley Hart 1990; Tuttle 1901:182). The two trusses that comprise the bridge are the sole remnants of the original six-truss bridge. A closer examination of the structure revealed that each truss once provided support for the adjacent tracks using continuous floor beams. Evidence of this method of construction is clearly seen in the cut-off ends of each floor beam. Cut-off gusset plates below the floor beam indicate that bottom lateral bracing was shared across the bridge.

**Figure 6: Cut-off Floor Beam Ends**

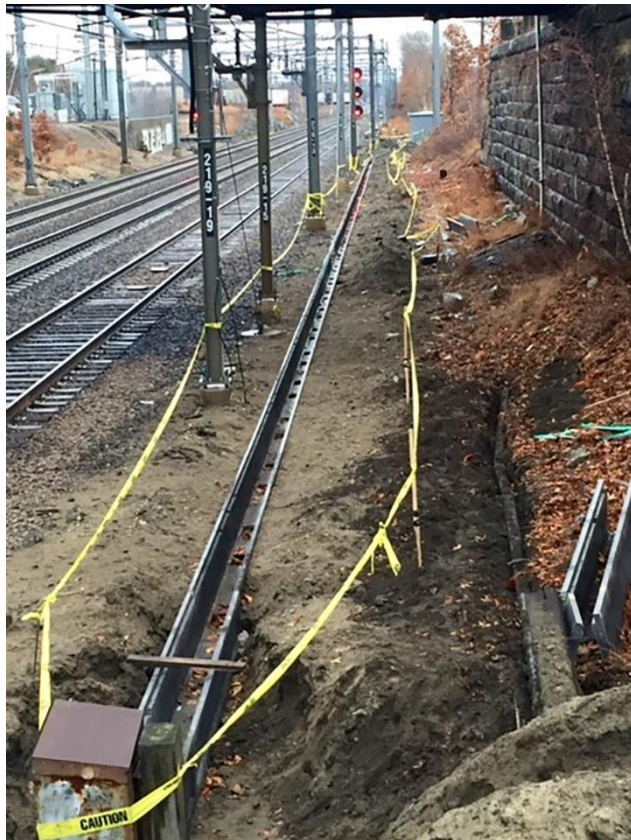
**Figure 7: Relocation of Amtrak System Cables**

- High-voltage wires from the underside of the existing bridge were relocated to new portals outside the bridge envelope.
- New independent foundations to support the Amtrak new catenary poles were designed for the relocation of the catenary lines off the bridge. The relocation of the catenary support was part of Phase I of construction.
- Cables identified as interfering with construction were relocated as part of Phase II.
- A safety shield system and support of excavation between the Northeast Corridor tracks and the existing abutments was designed. After their erection as part of Phase III, the contractor

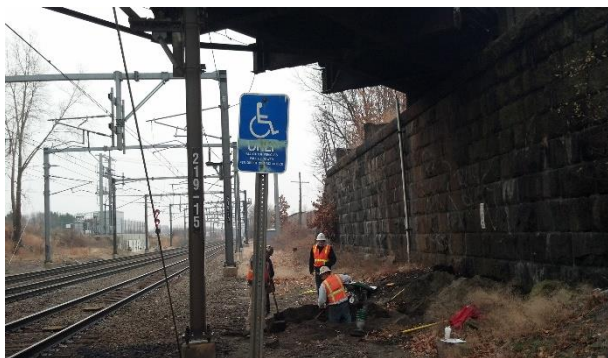
**Figure 8: Test Pits to Discover Presence of Unknown Utilities**

The subsurface investigation program was completed and included test pits to explore the underground cables. Several cables were identified and relocated during construction. In addition, an underground storage tank (UST) was found in close proximity to the bridge abutment could have impaired the heavy lifting operation. The UST was abated and filled with concrete.

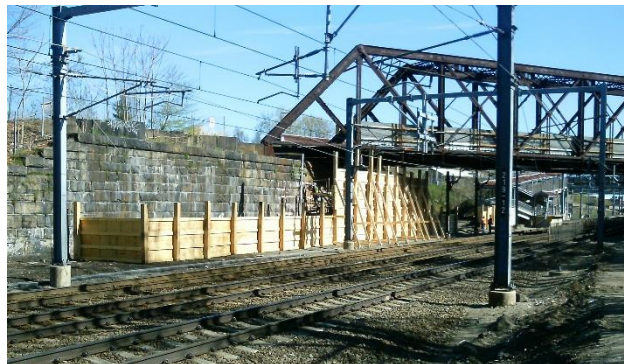
**Figure 9: Vertical Safety Shield System**

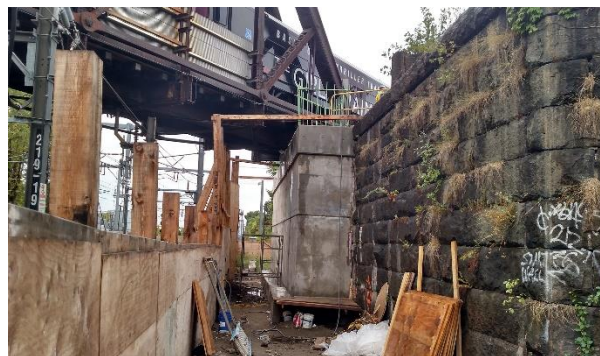
- The proposed abutments, each with two, 6 foot diameter drilled shaft footings were 48 feet apart and approximately 100 feet deep, supporting concrete walls 55 feet wide in front of each existing abutment. The new abutments were designed with the assumption that the existing abutments act as a fill with no soil retaining capacity. Also, the number and locations of the drilled shafts were selected in such a way that the contractor could perform the work from the bridge superstructure level over weekends.

**Figure 10: Proposed Abutments**

A conceptual bridge replacement study revealed that the most cost effective solution was to construct new abutments on drilled shaft foundation in front of the existing abutment. This would shorten the bridge span to 116 feet, reducing the superstructure lifting weight and eliminating the need to rehabilitate the existing abutments. However, the bridge's 56-degree skew remain unchanged. The design proceeded with the following construction activities:

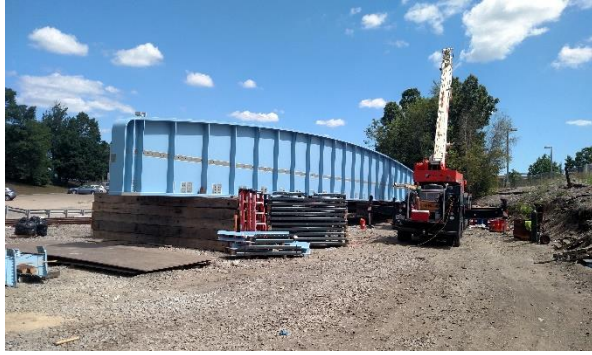
- The bridge steel superstructure was designed as pre-fabricated bridge elements, completely assembled in the fabrication shop, disassembled and shipped to the site where it was reassembled in a staging area adjacent to the bridge. The staging area was selected to allow the new superstructure to be lifted and placed on the new bearing within the bridge replacement weekend.

**Figure 11: Prefabricated Steel Bridge Superstructure in Staging Area**

The bridge was preassembled in the shop and all necessary adjustments/corrections were made. Ballast plates were welded to the floor beams to the extent practical. The bridge was disassembled and shipped to the site for reassembly. In the staging area, final welds including CJP were completed and all necessary paint touch ups and spray applied waterproofing were made prior to lifting the bridge.

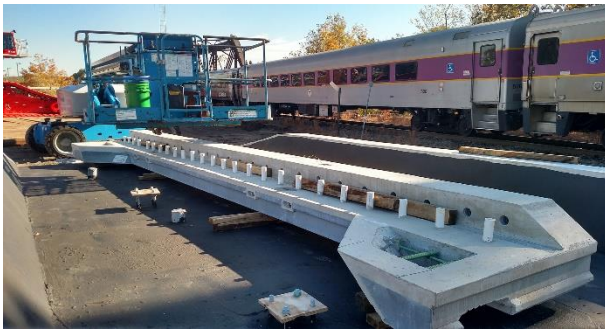
**Figure 12: Prefabricated Backwalls**

- The precast backwalls were shipped to the site.
- The precast approach slabs were cast in the staging area.
- Phase IV was the final construction phase and was performed in one long weekend shutdown to the Fairmount Line.

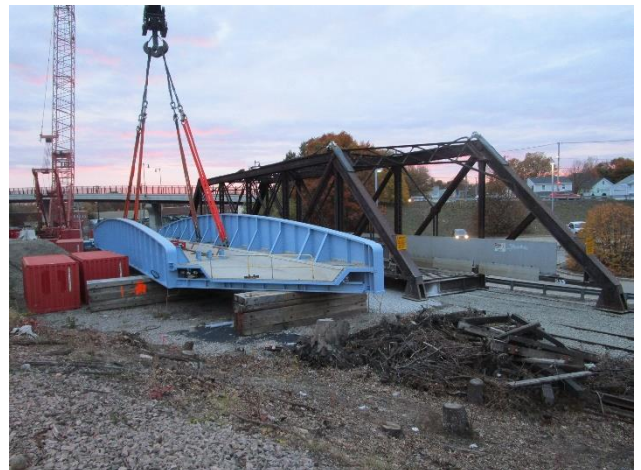
**Figure 14: New Superstructure in Lifting Position**

- Lifting cranes were moved into position to lift the new superstructure
- The catenary was de-energized after last Amtrak train
- Newly assembled, proposed superstructure was lifted and placed on the bearings
- The catenary was re-energized and Amtrak trains resumed
- Backwalls, approach slabs, and laying ballast on the new bridge was completed Sunday and Monday
- Fairmount Line resumed normal operation on Tuesday morning

The crew worked during the next day placing the bearings, and precast back-walls. Overnight on Saturday, after the last Amtrak revenue train, the new superstructure weighing 615,000 pounds was placed into position and completed the installation in two hours. Over the next weekend the precast approach slab, ballast, and track were placed to open the bridge for service.

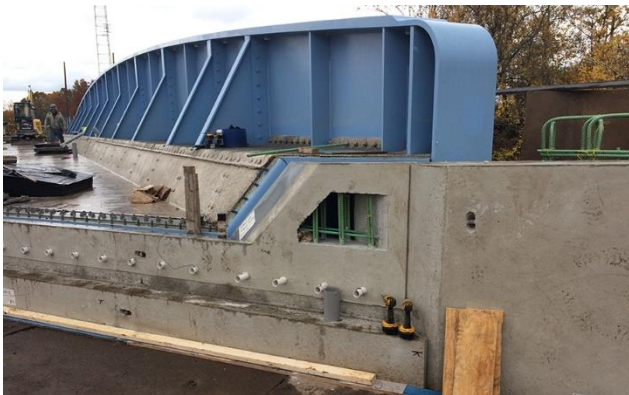
**Figure 15: Backwall Placement**

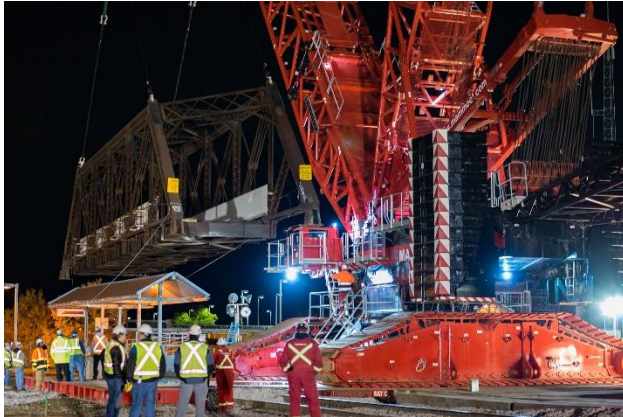
The massive Mommooet LR11000 Crane with super-lift began the pick of the existing 470,000 pound truss and completed the relocation to a designated location in roughly two hours.

**Figure 16: Existing Superstructure Removal**

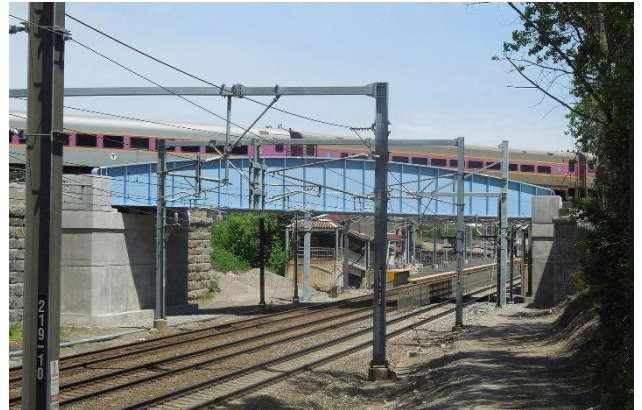
**Figure 17: Completed Shore Line Bridge**

As previously mentioned, the Shore Line bridge is a highly traveled bridge with Amtrak lines below. The severe site constraints posed several challenges, beginning with the steel superstrate design. Existing track alignment could not be changed due to the presence of the station. In addition, the MBTA requires all open deck bridges to be a ballasted deck system when reconstructed. Underneath the bridge, Amtrak dictated the minimum distance between the bridge deck and the high voltage catenary. The bridge deck was sandwiched within these constraints. This required shallow floor beams and sloping of the beams for drainage. The U frame analysis was utilized to check the rigidity of the kickers and the unsupported length of the top flange required a balancing act as not to increase the lifting weight of the bridge. To compensate for the flexibility of the deck and to provide lateral stability, the ballast plate was designed as a horizontal diaphragm. To further reduce the weight and provide aesthetic appearance, the through girder height was made parabolic (fish belly) shape.
