LAUNCHING THREE TRUSSES OVER THE BNSF NORTHTOWN RAIL YARD

Launching Three Trusses over the BNSF Northtown Rail Yard

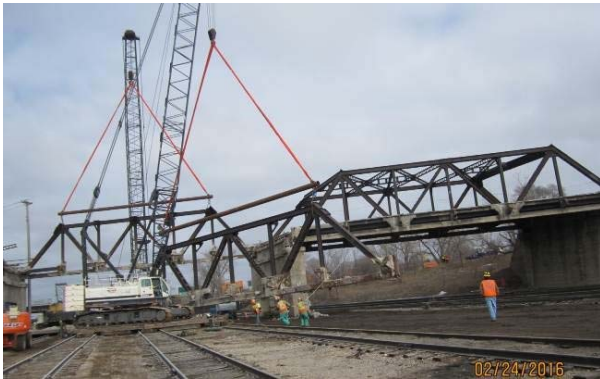
Figure 3 - Removal of Eastern Trusses

- The three eastern existing truss spans were cut into plains in the yard, as shown in Figure 3, utilizing 10-day closure windows for the yard tracks.
- The removal of the two western existing truss spans and the launch of the new truss was performed on steel launch beams that Lunda fabricated from existing materials they had in their inventory and with obsolete plate girders obtained from the steel fabricator.

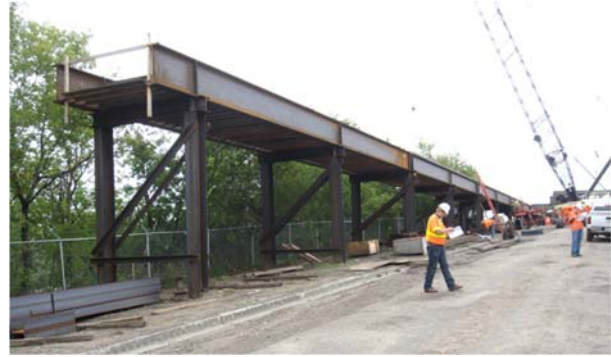
Figure 4 - Western Approach Embankment

The launching system was sized for the roughly 800-ton new truss structure but first utilized to remove the two existing most western steel trusses including their concrete deck system over the BNSF's main line tracks to the western approach embankment for demolition. Figure 4 depicts the western approach embankment where the existing trusses were demolished and the new truss assembled.

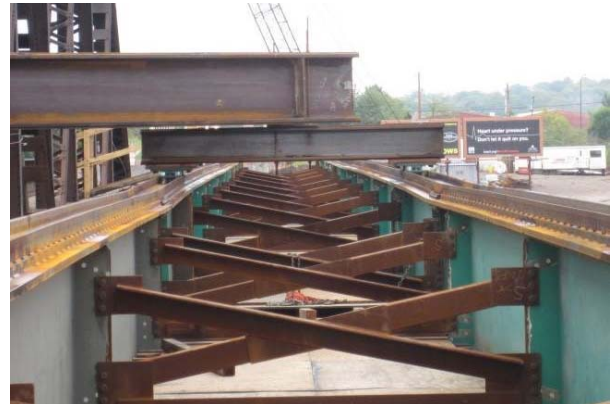
Figure 5 - Launching Beams

The launching assembly consisted of twin plate girders bolted together with cross bracing near each truss plain (Figure 5). Lunda selected Hilman rollers as the moving vehicle that traveled in channel sections acting as tracks and welded to the top of the launching beams (Figure 6).

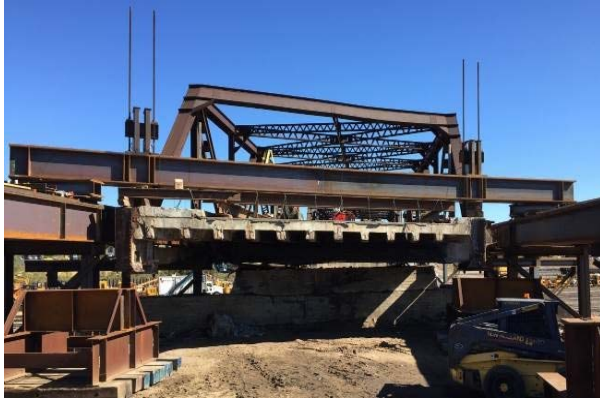
Figure 7 - Transverse Beam Setup

Transverse beams spanned between the launching assemblies located on each side of the truss. The transverse beams were connected to the truss that was being launched with post-tensioning bars located at each corner of the truss. These post-tensioning bars were used to raise and lower the

truss with hydraulic jacks. The transverse beam setup is shown in Figure 7 as used for the removal of Truss 5. Setup for Truss 4 and the new truss were similar.

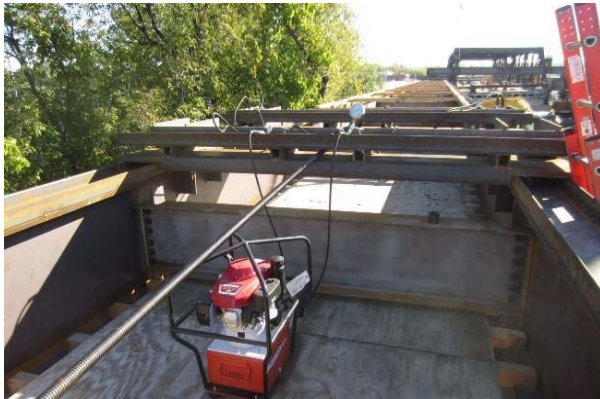
Figure 8 - Longitudinal Jacking Setup

The longitudinal jacking setup in Figure 8 consisted of a series of post-tensioning bars coupled together and supported on wood blocking spanning between the top flanges of the twin launching beams. Two jacks located at the end of the launching beams pushed against the transversely spanning jacking beam that in turn is connected to the leading post-tensioning bars. The jack force is resolved into the launching beams through a fixed reaction beam behind the jacks.

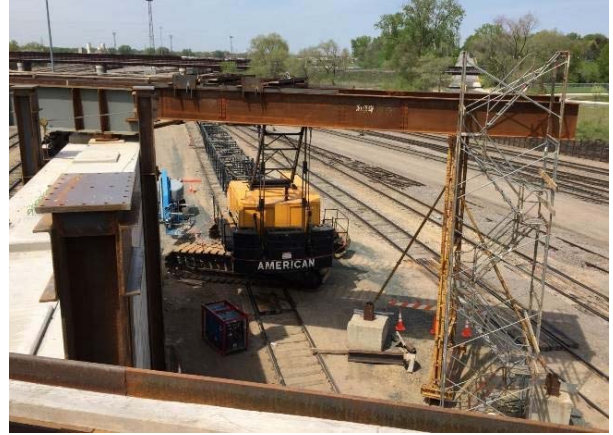
Figure 9 - Setup for New Truss Launch

The selected system was a pull-only system; therefore, it was setup on the western approach embankment for the truss removals and then moved east of new eastern truss pier for the launch of the new truss as shown in Figure 9.

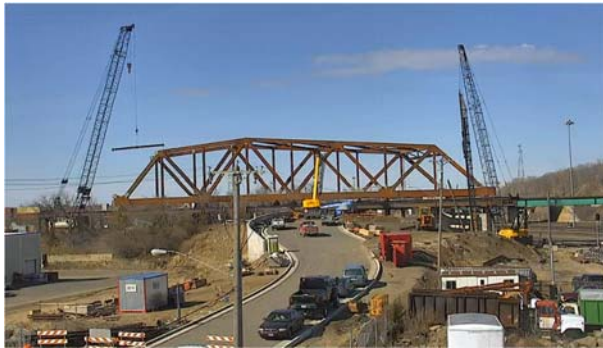
Figure 11 - Field Assembly of New Truss

Field assembly on the western approach embankment progressed from the east to west with the crane shown on the left side of Figure 11 supplying the stick built truss elements. After completion of the steel assembly intermediate blocking was removed and the stay-in-place metal decking was installed to act as a working platform for rebar, post-tensioning and concrete installation and as a protective shielding for the railroad traffic.

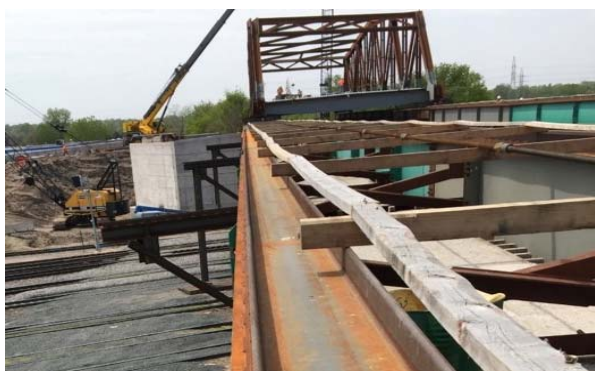
Figure 12 - Lateral Girder Launching System

The new truss was then launched 310 feet using two 4-hour windows in May of 2017. Once in its final plan position the truss was set down on steel columns attached to the west abutment and the eastern truss pier so that the launching beams could be removed. Lunda then slid the twin plate launching girders laterally using transverse brackets and Hilman rollers that had been pre-mounted on the launching falsework towers (Figure 12).

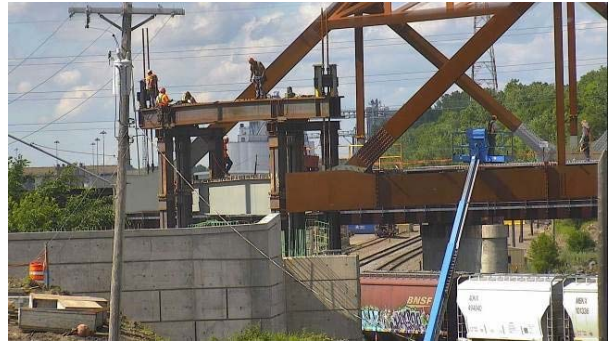
Figure 13 - Lowering New Truss onto Bearings

From there the launching girders were removed by crane. In June of 2017 the truss was lowered onto the permanent bearings as depicted in Figure 13 using the vertical jacking system of post-tensioning bars and hydraulic jacks.

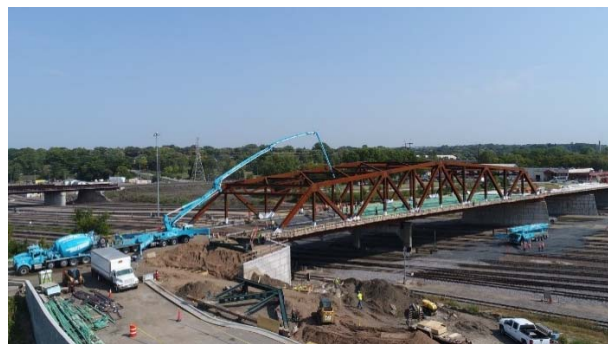
Figure 14 - Concrete Deck Pour

The lower chord post-tensioning conduits and hardware, and the reinforcing steel was then installed in the steel shell. After the bottom chord concrete was poured and cured, the post-tensioning tendons were stressed by mid-August. The reinforcing for the concrete deck was installed before the deck concrete was poured, then sidewalks, railing and fencing were installed. Figure 14 shows an aerial photo of the deck pour using two pump trucks.

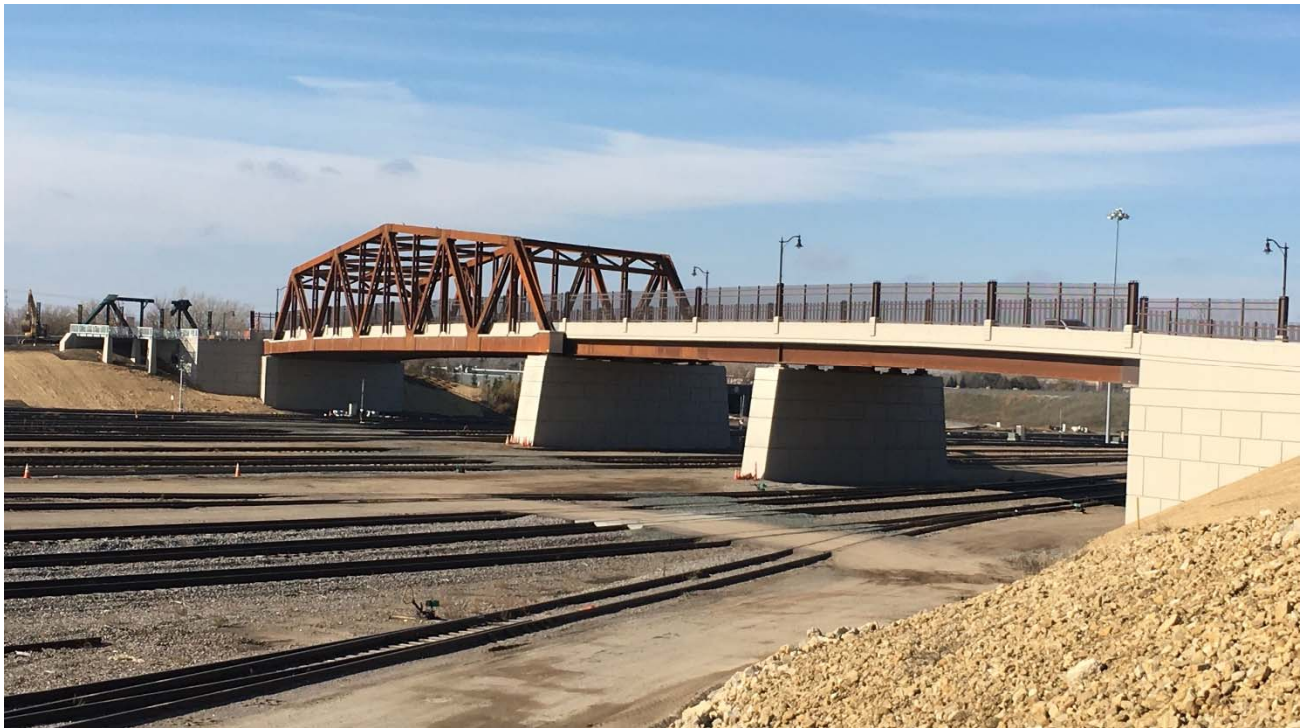
Figure 15 – Completed Project

Figure 15 shows the completed project including a small plaza near the west abutment incorporating portions of the original Warren trusses that had been fabricated using Carnegie steel.
